BOLIVAR DAM PROJECT PHOTOGRAPHS

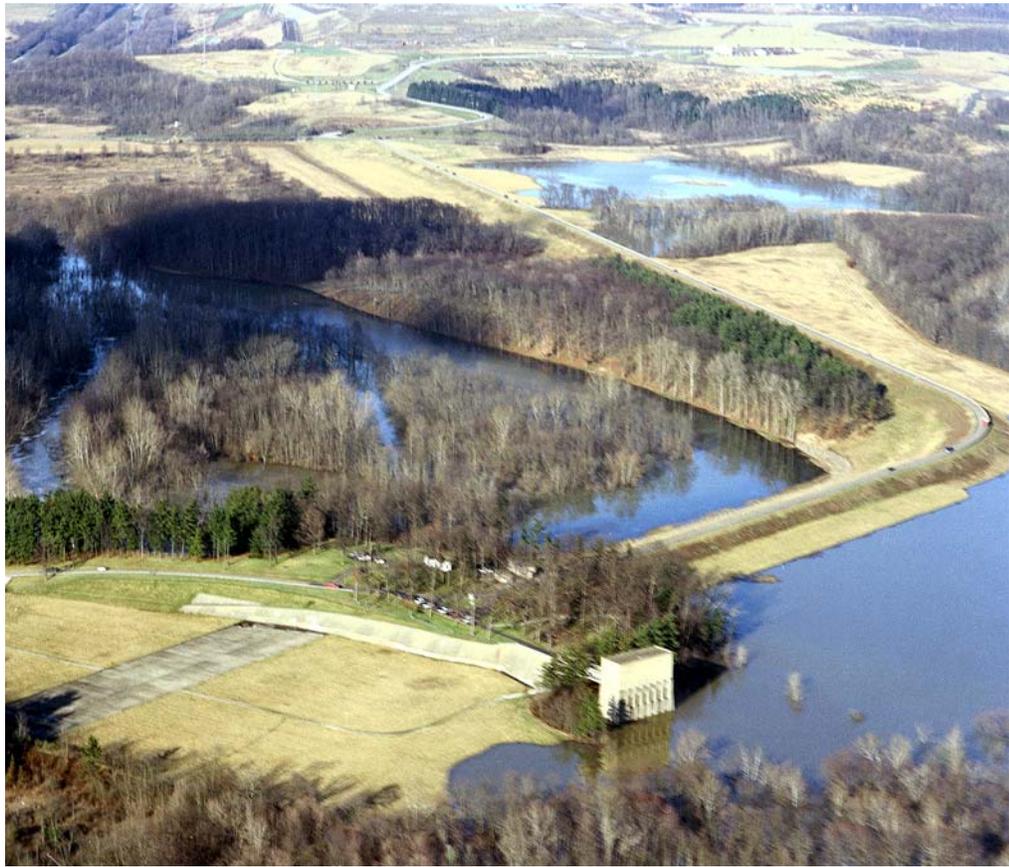
Photo No. 1 **Bolivar Dam, Ohio** **January 2005**
Aerial view of Bolivar Dam during the pool of record.

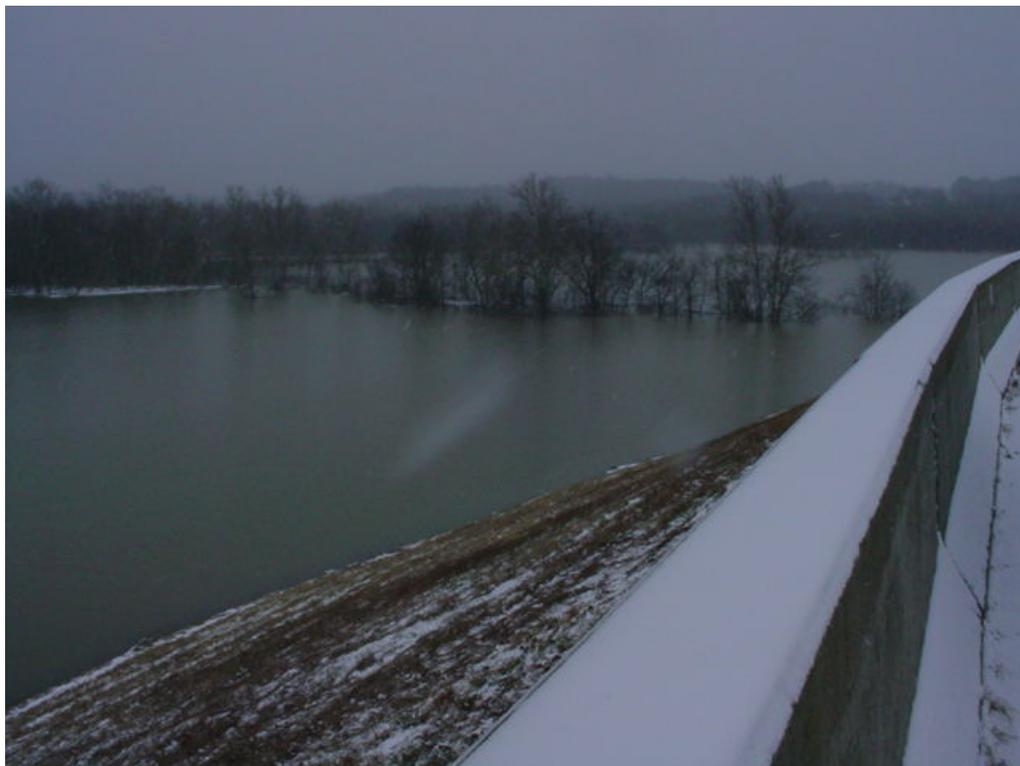
Photo No. 2 **Bolivar Dam, Ohio** **January 2005**
View of Bolivar Lake, upstream side of the dam.

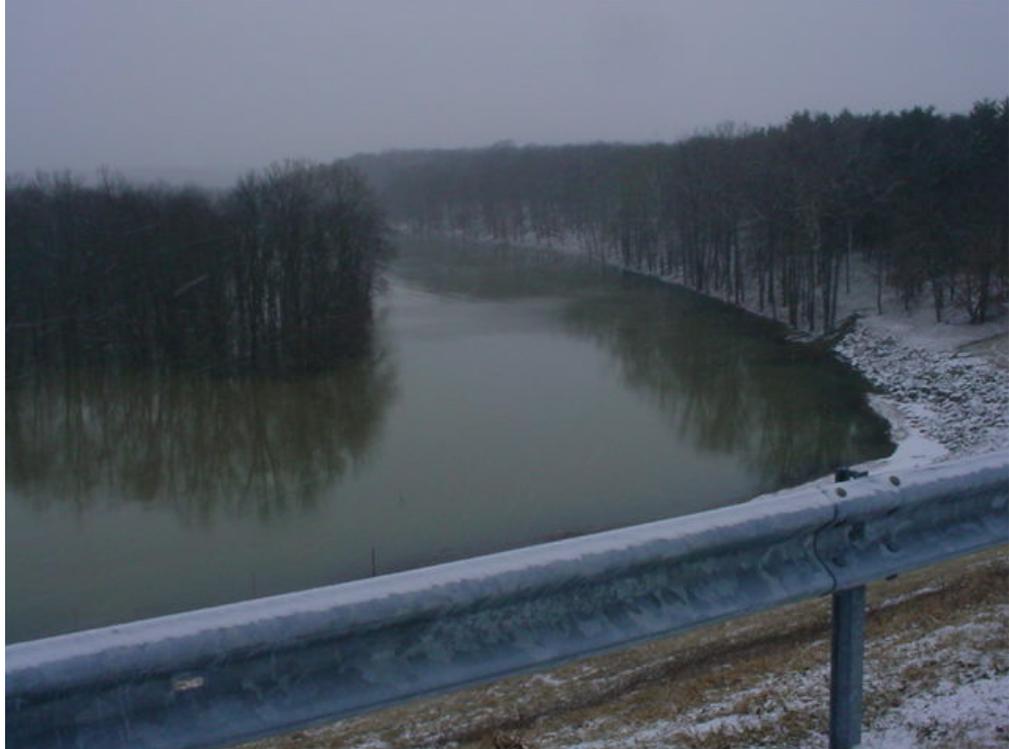
Photo No. 3 **Bolivar Dam, Ohio** **January 2005**
View of the downstream toe of Bolivar Dam, in which, the pool of Dover Dam inundated the area.

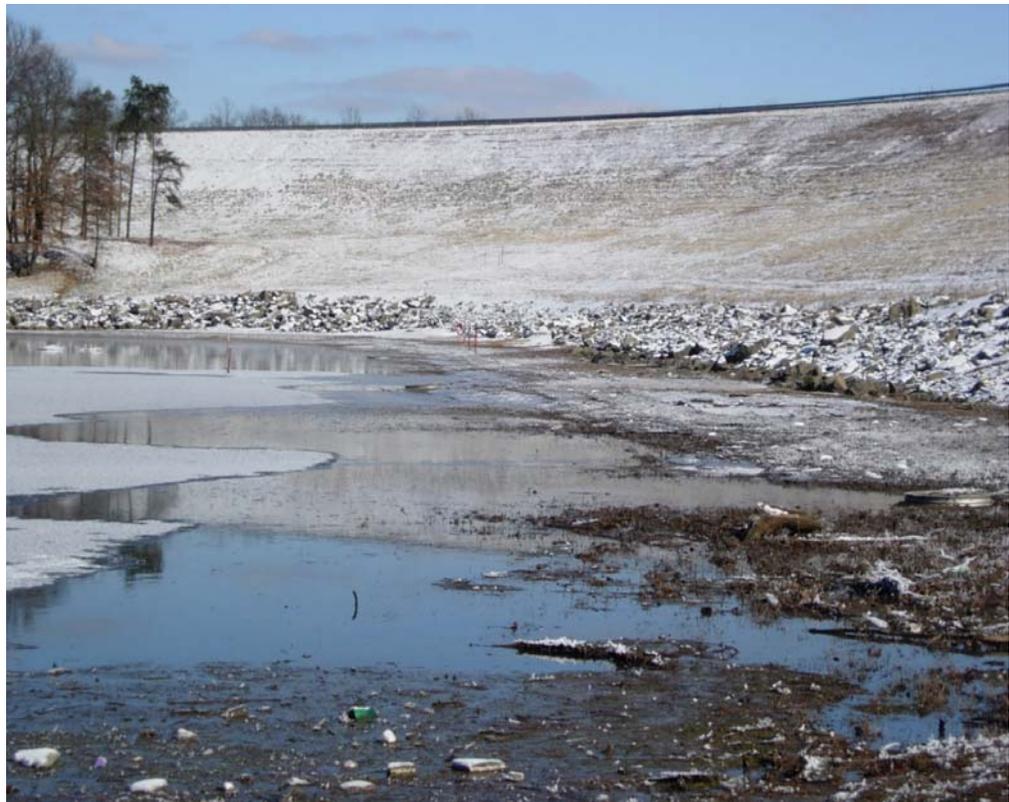
Photo No. 4 **Bolivar Dam, Ohio** **January 2005**
Closer view of the downstream toe of Bolivar Dam.

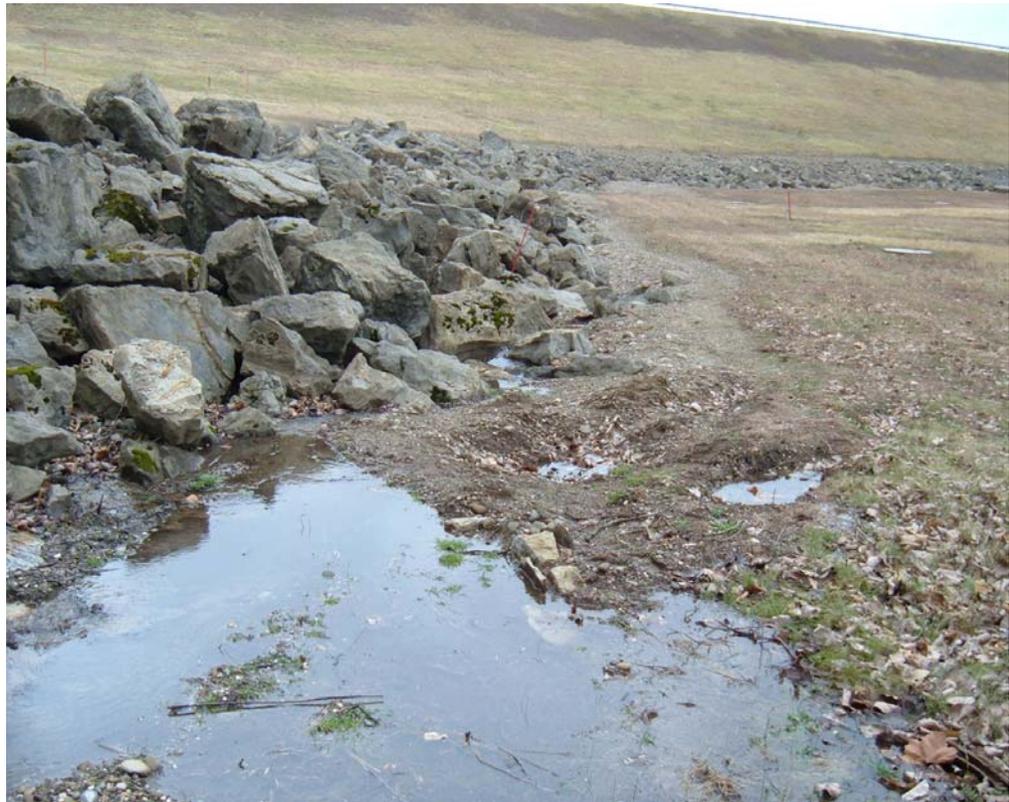
Photo No. 5 **Bolivar Dam, Ohio** **January 2005**
Through seepage in terrace embankment area and general view of rock toe.

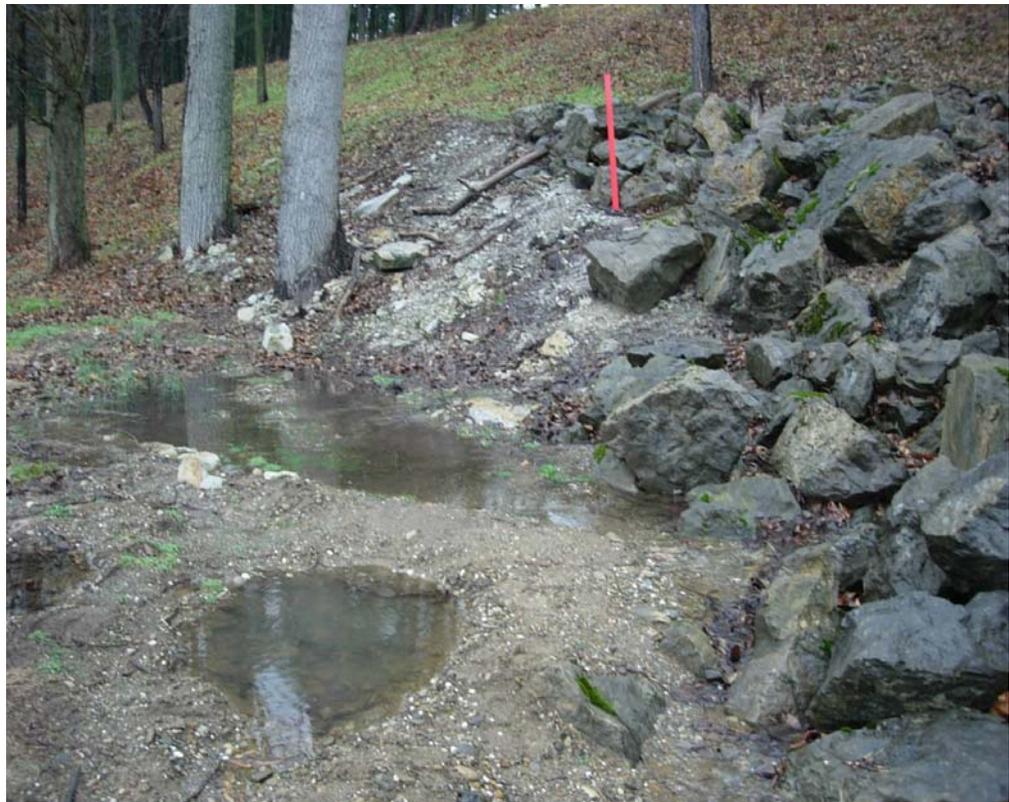
Photo No. 6 **Bolivar Dam, Ohio** **January 2005**
Through seepage at terrace embankment area. Note trees and lack of maintenance of rock toe in background of picture.

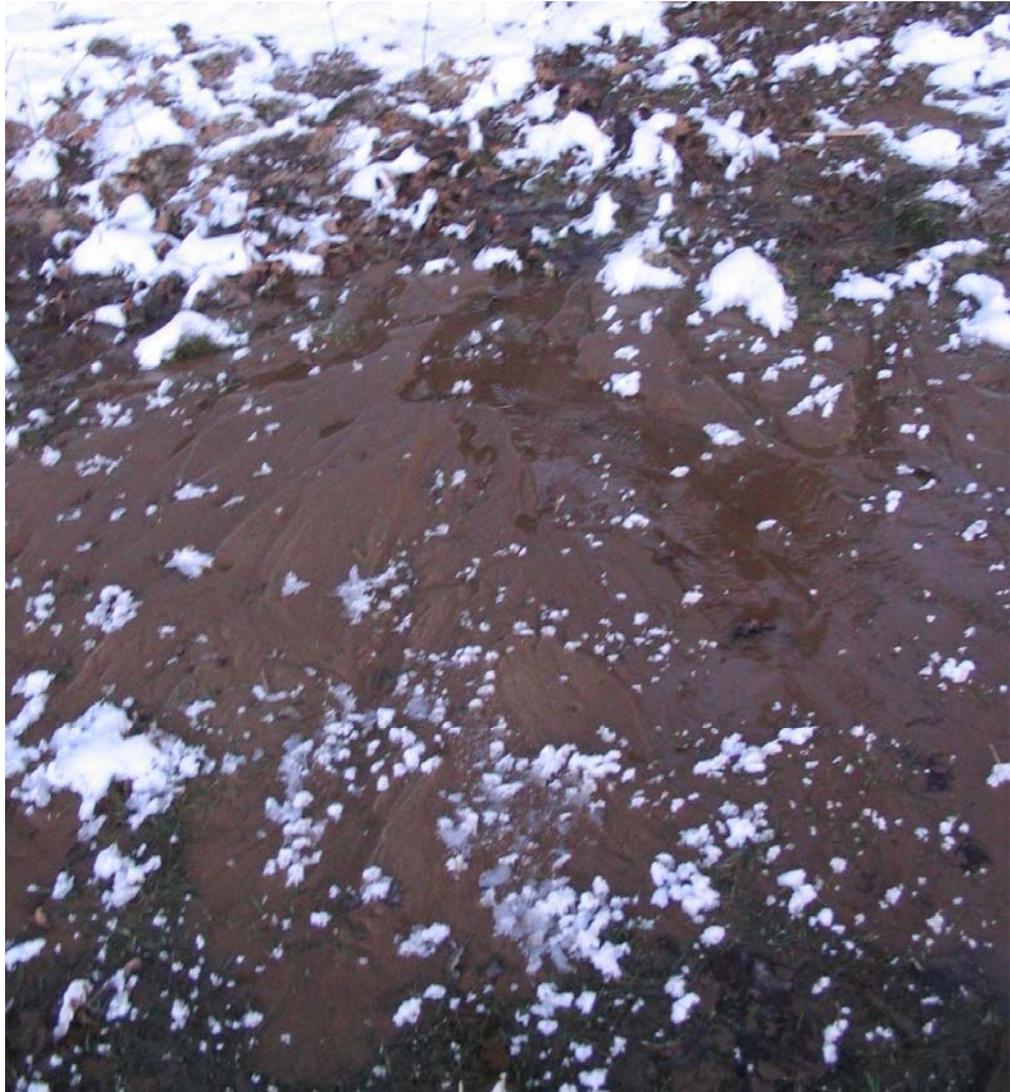
Photo No. 7 **Bolivar Dam, Ohio** **January 2005**
Material shown consists of fine grained sand and was piped out of the terrace toe during the pool of record. This condition was pervasive for approximately 700 ft. of the terrace toe between approximate stations 36+00 and 43+00.

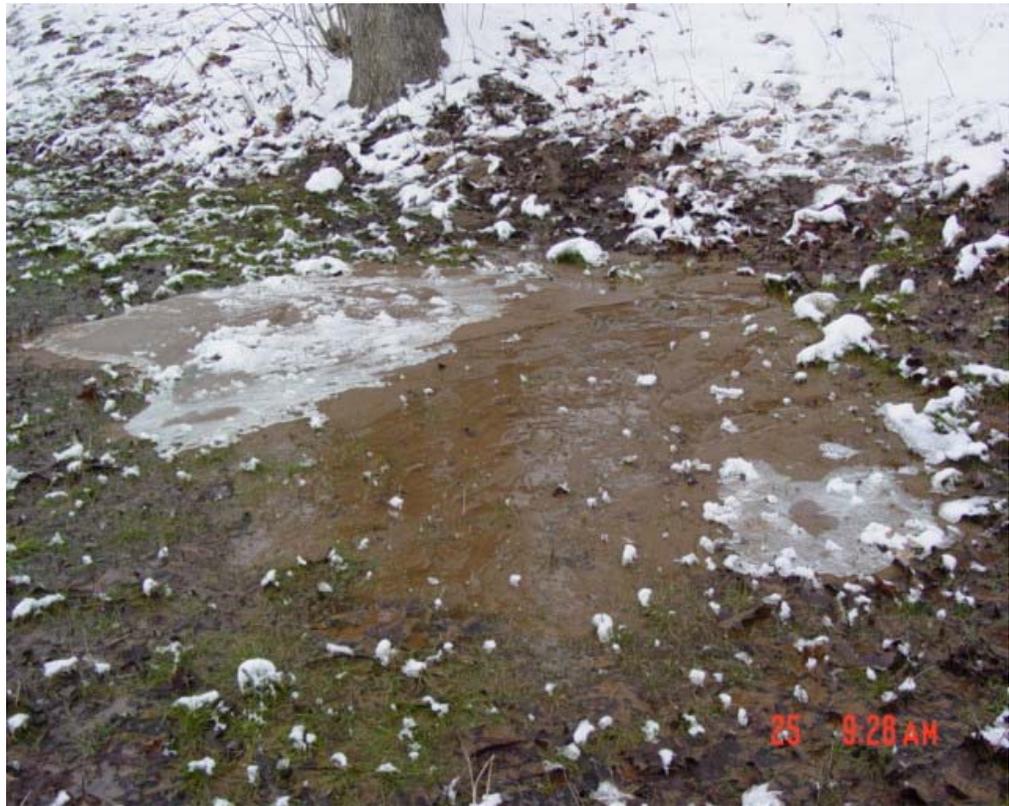
Photo No. 8 **Bolivar Dam, Ohio** **January 2005**
Additional view of material moved from toe of terrace slope

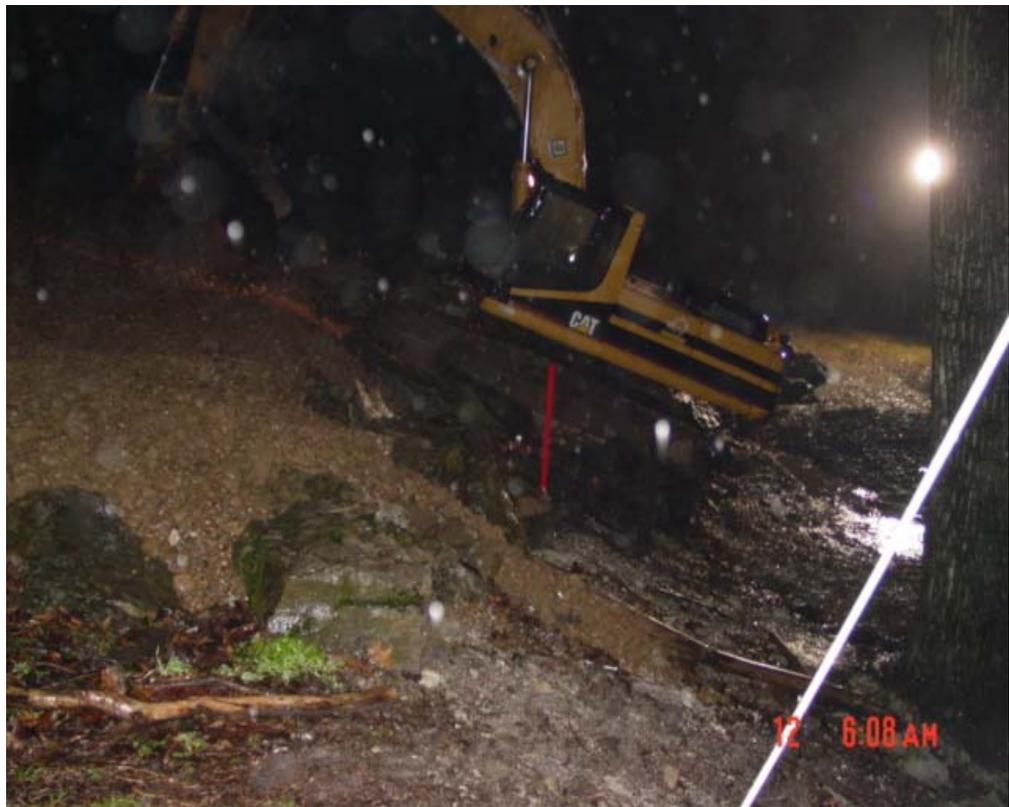
Photo No. 9 **Bolivar Dam, Ohio** **January 2005**
Heavy equipment brought in to place emergency sand and gravel blanket at approximately station 50+00.

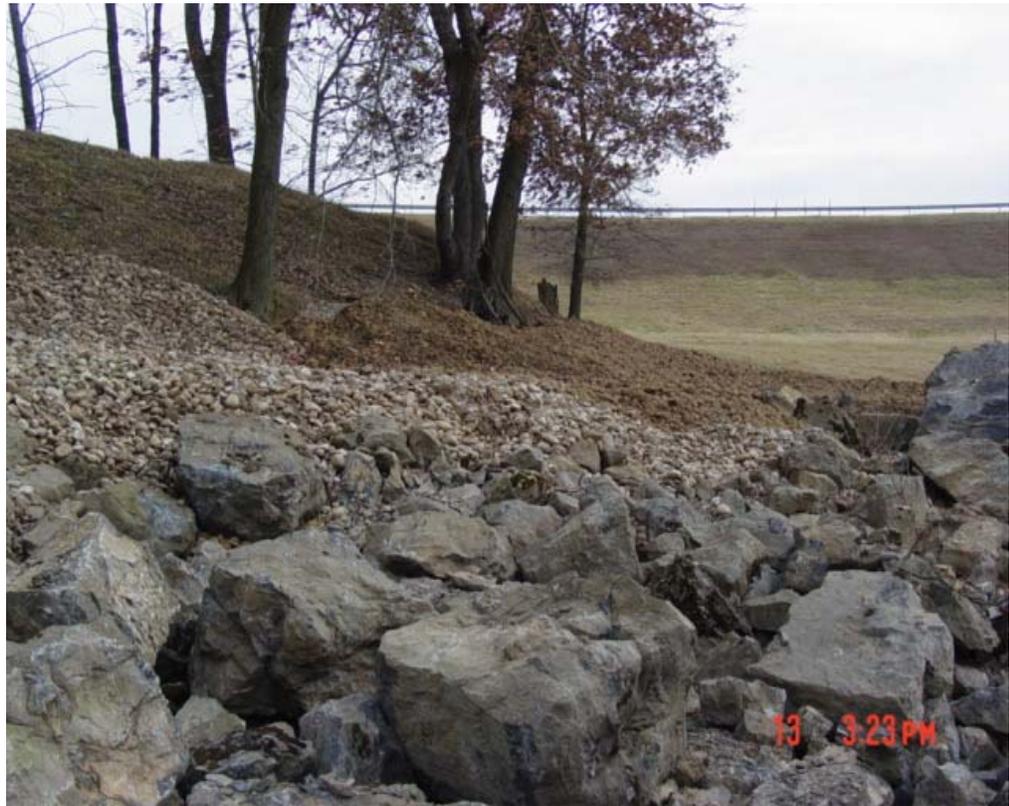
Photo No. 10 **Bolivar Dam, Ohio** **January 2005**
Completed emergency filter blanket constructed during pool of record.

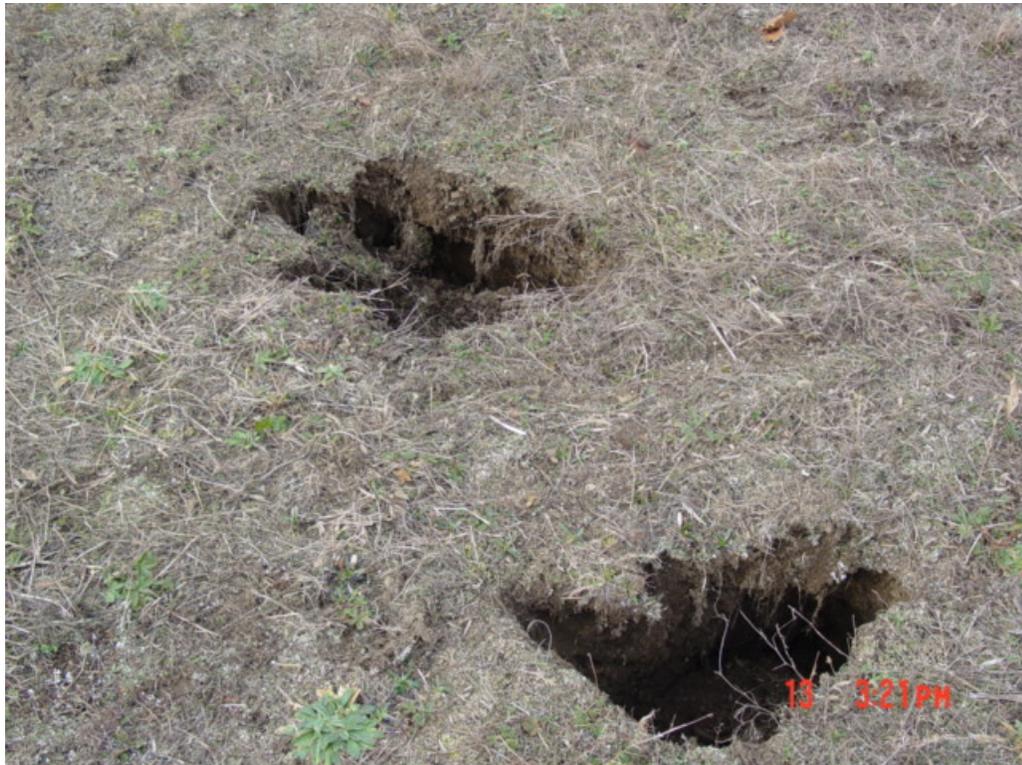
Photo No. 11 **Bolivar Dam, Ohio** **January 2005**
Sinkholes observed in downstream seepage blanket just beyond the rock toe.
Filter material was being sluiced into rock toe due to high tailwater elevation.

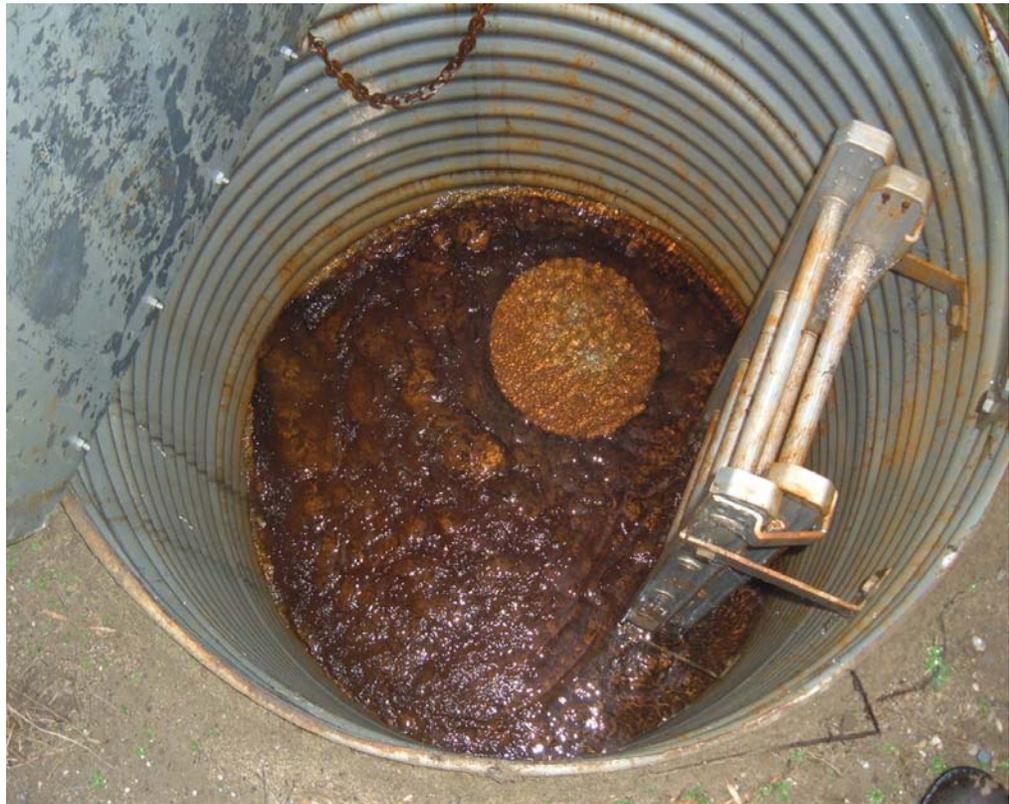
Photo No. 12 **Bolivar Dam, Ohio** **January 2005**
Typical view of relief wells flowing during pool of record.

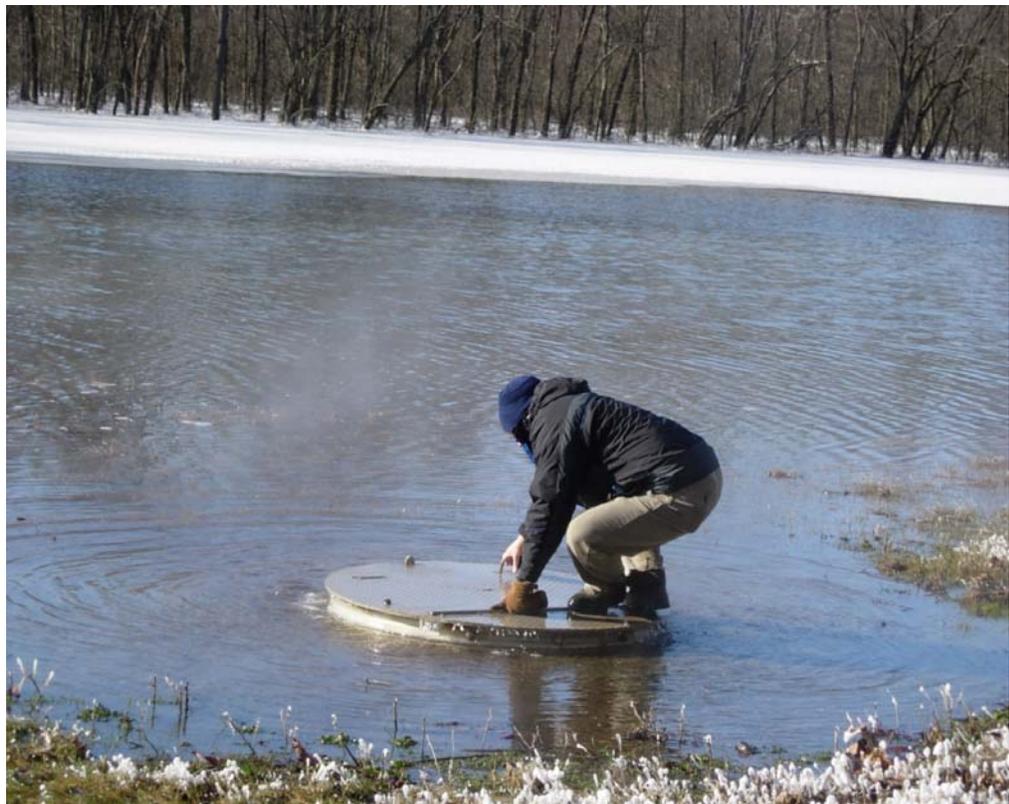
Photo No. 13 **Bolivar Dam, Ohio** **January 2005**
Relief wells in downstream toe area inundated by Dover Dam's pool.

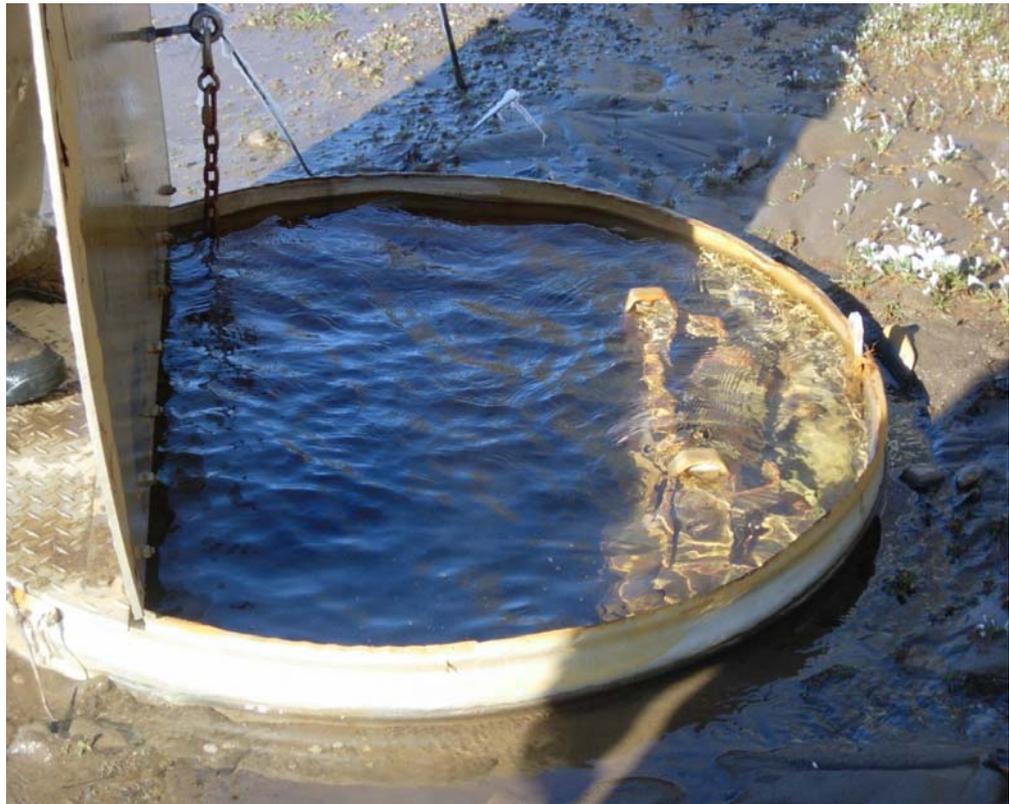
Photo No. 14 **Bolivar Dam, Ohio** **January 2005**
Inside view of a relief well in the downstream toe area.

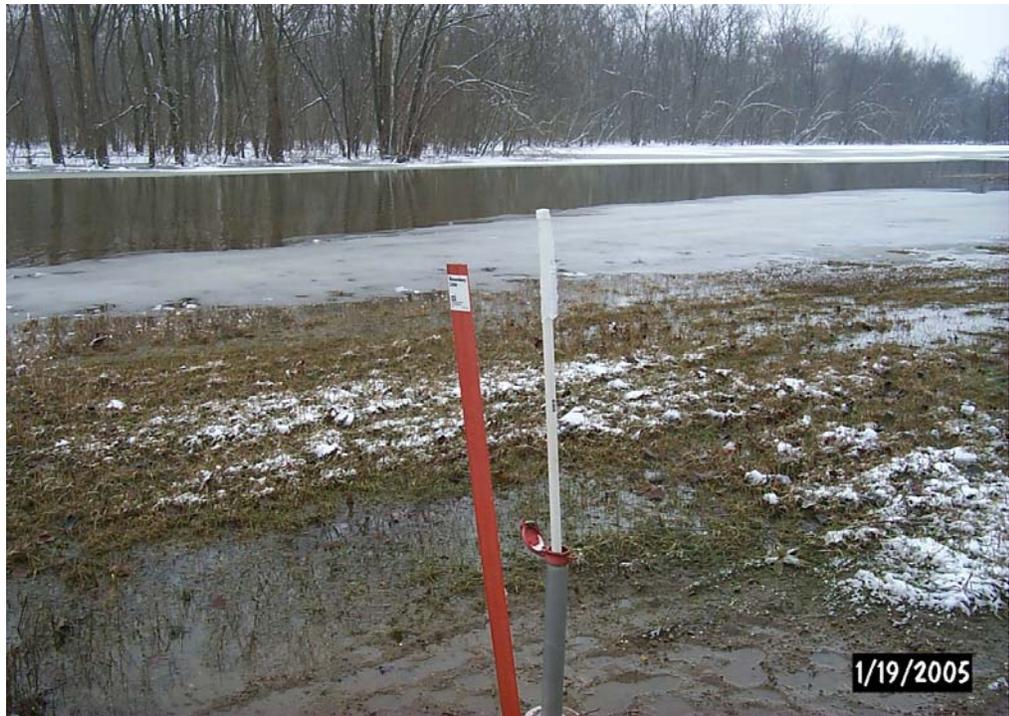
Photo No.15 **Bolivar Dam, Ohio** **January 2005**
Piezometers with extensions, in the downstream toe area, show frozen artesian conditions. Readings could not be taken during this time due to freezing.

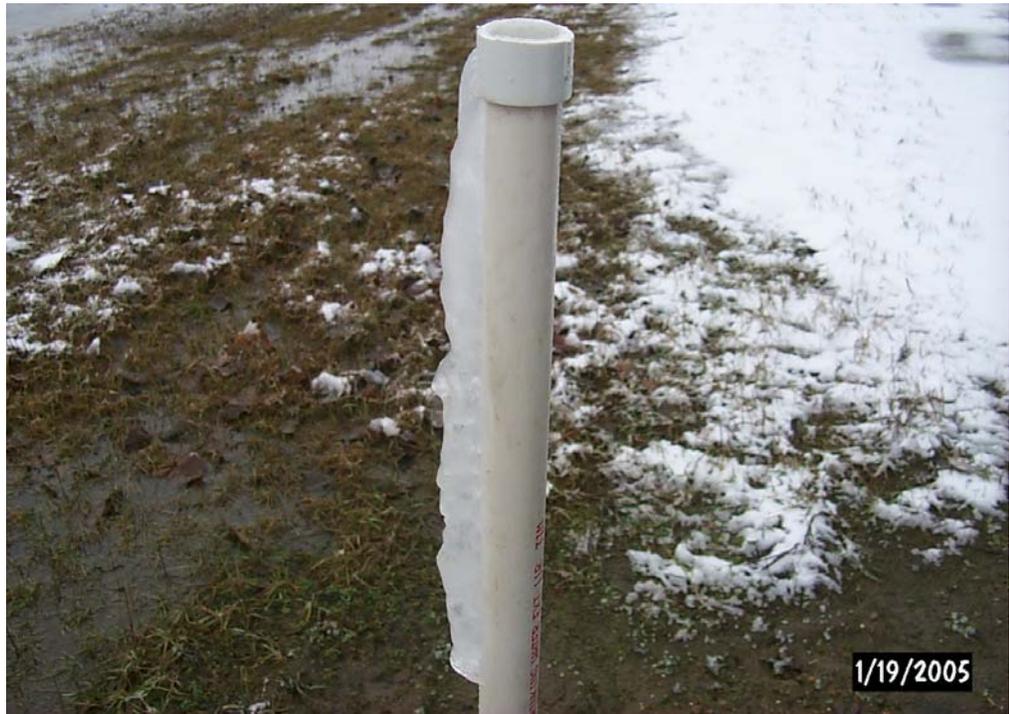
Photo No. 16 **Bolivar Dam, Ohio** **January 2005**
Piezometer extension showing artesian condition and freezing temperatures which precluded the ability to take readings.

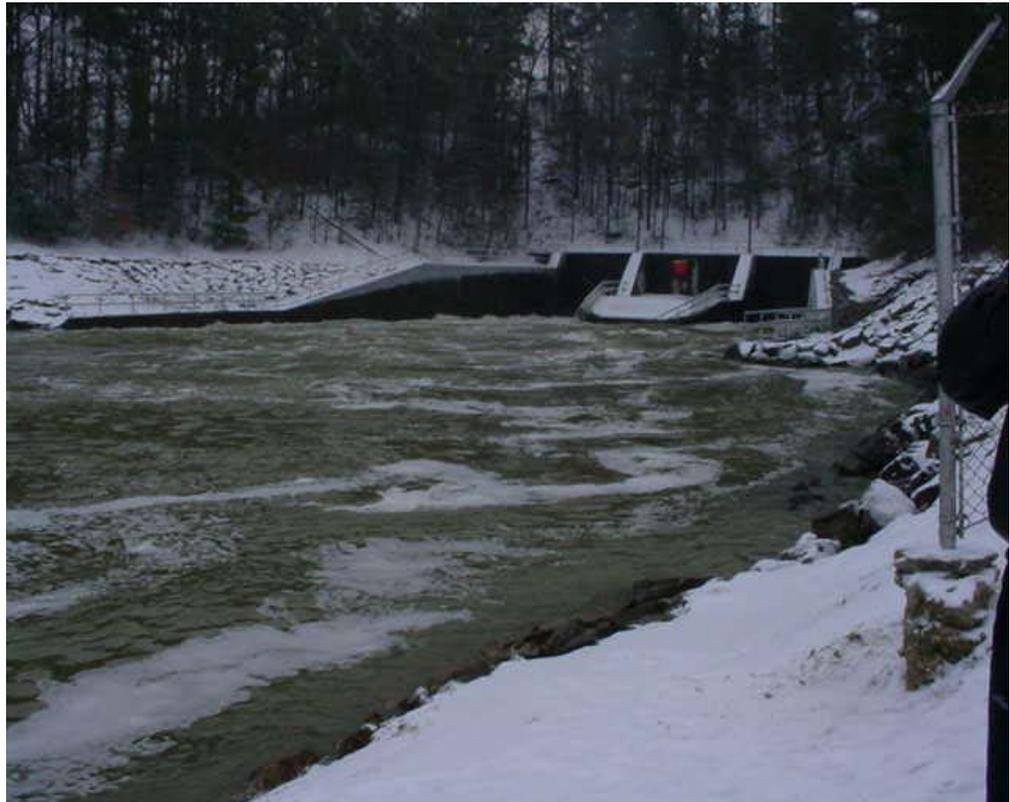
Photo No. 17 **Bolivar Dam, Ohio** **January 2005**
General view of outlet channel during pool of record.

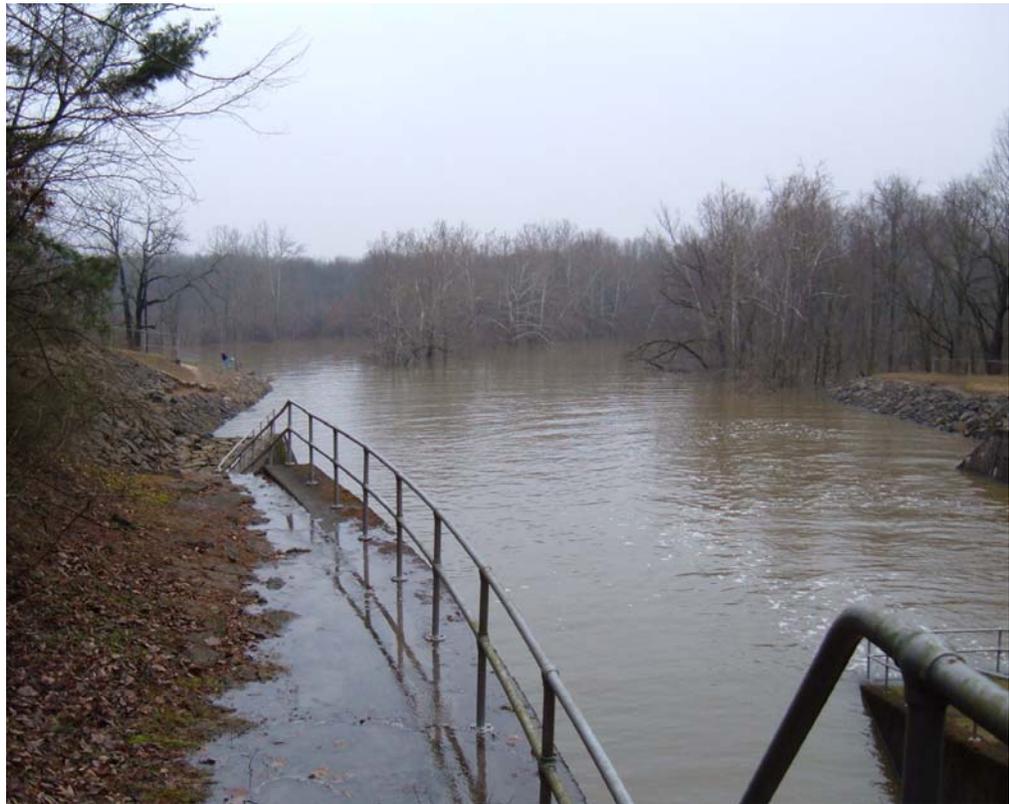
Photo No. 18 **Bolivar Dam, Ohio** **January 2005**
Downstream view of outlet channel.

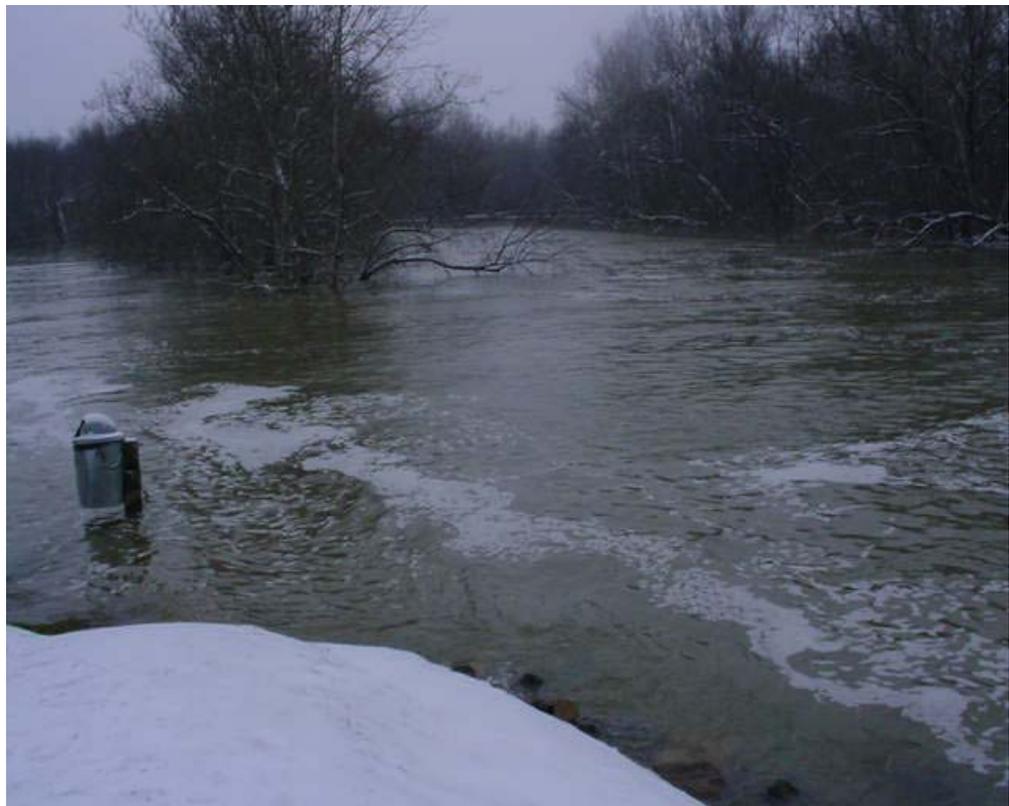
Photo No. 19 **Bolivar Dam, Ohio** **January 2005**
Submerged fishing area, downstream of outlet channel.

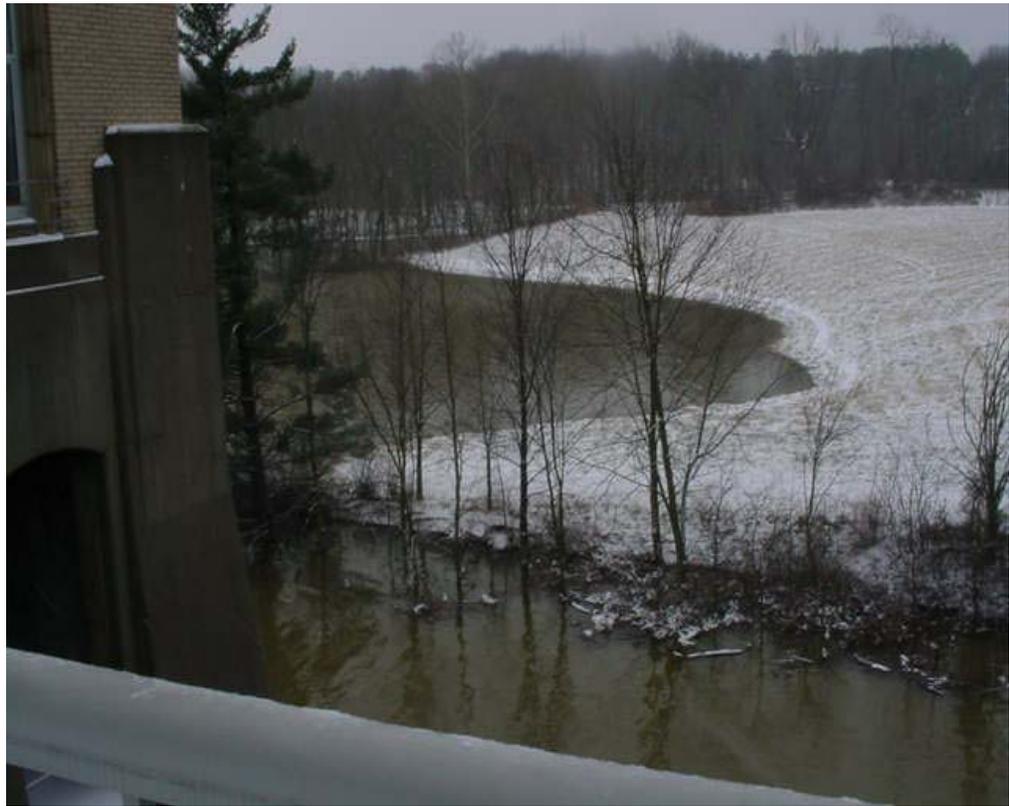
Photo No. 20

Upstream side of spillway showing pool approaching.

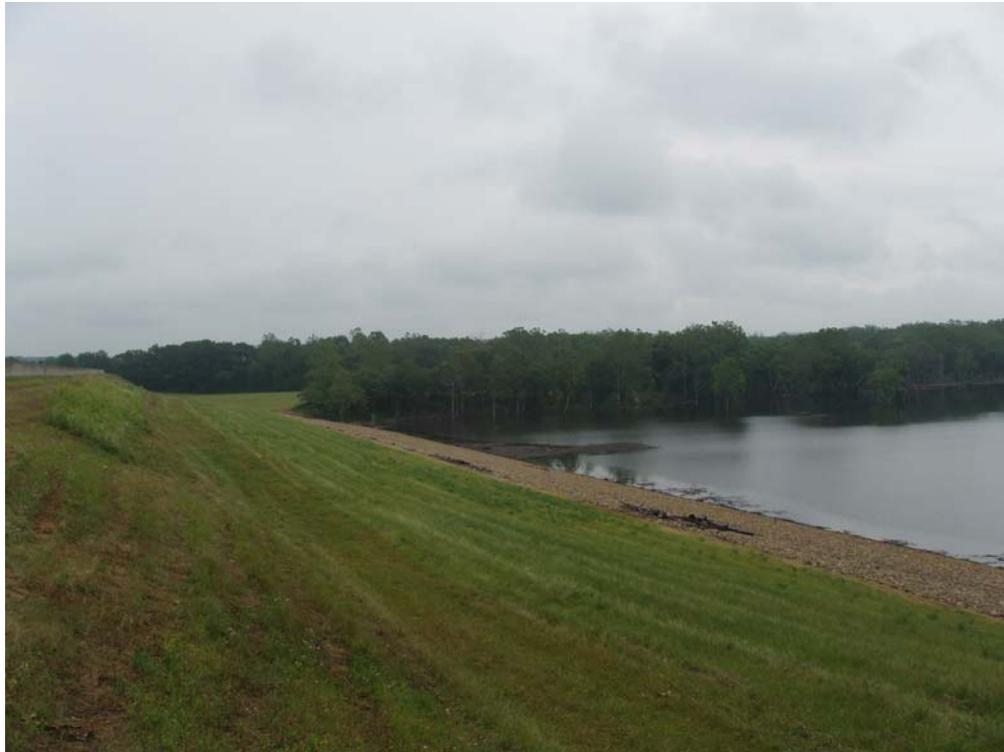
PHOTO NO. 21 **BOLIVAR DAM, OHIO** **27-28 JUNE 2006**
General view to the northeast of Bolivar Dam with a pool elevation of 921 ft retained; photograph taken from the embankment crest.

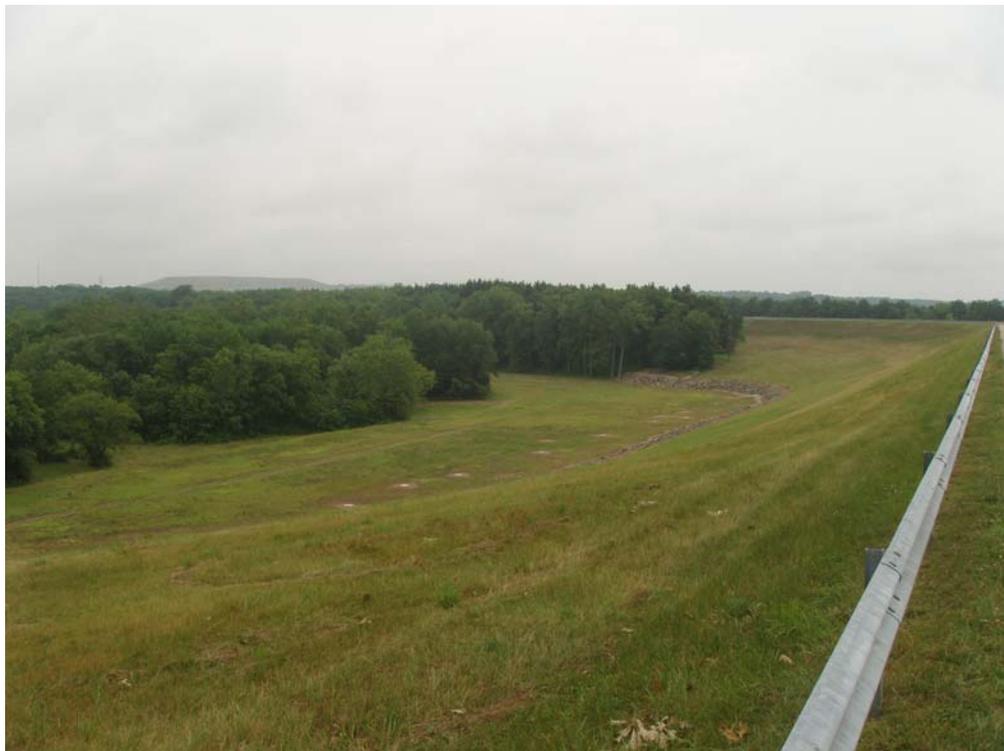
PHOTO NO. 22 **BOLIVAR DAM, OHIO** **27-28 JUNE 2006**
General view to the northwest and downstream of Bolivar Dam from the embankment crest.

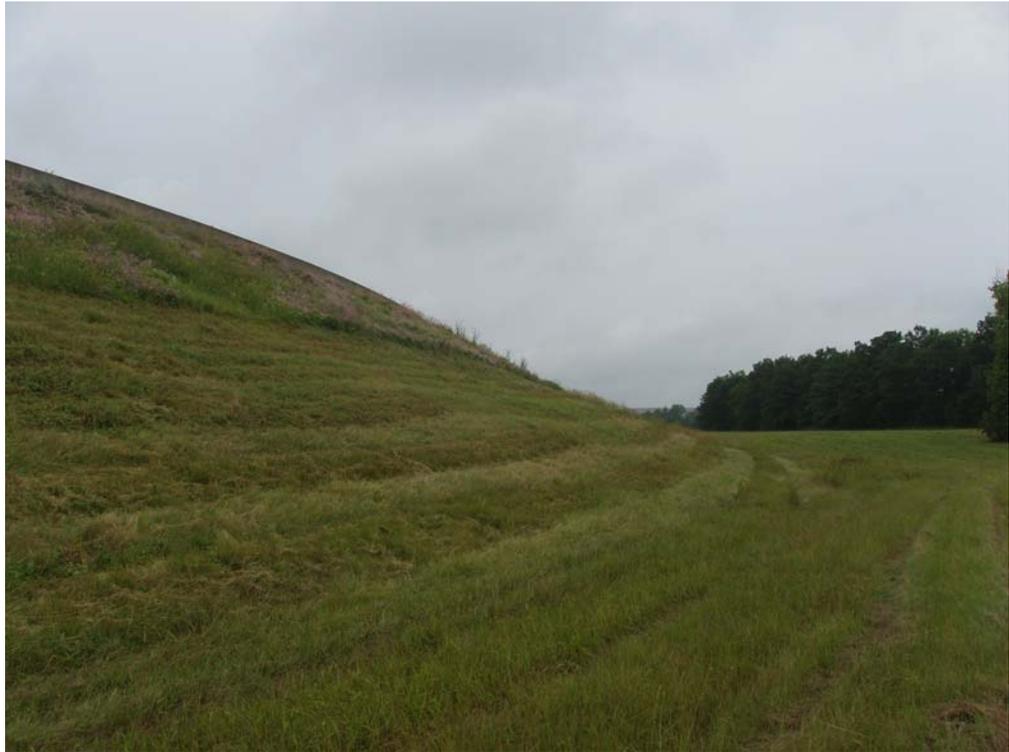
PHOTO NO. 23 **BOLIVAR DAM, OHIO** **27-28 JUNE 2006**
View of the upstream embankment taken from the upstream impervious blanket at approximately station 55+00. Note upper embankment covered with crown vetch was in the process of being mowed.

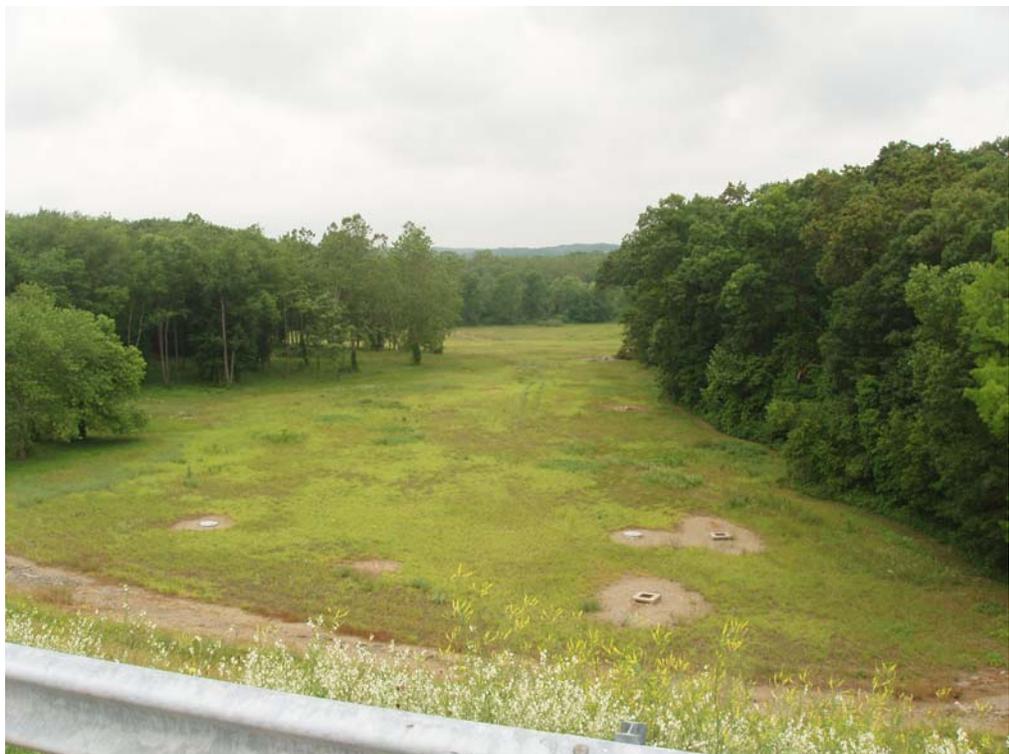
PHOTO NO. 24 **BOLIVAR DAM, OHIO** **27-28 JUNE 2006**
View to the northeast of relief wells and catch basins (bare spots) from the embankment crest at approximate station 26+00.

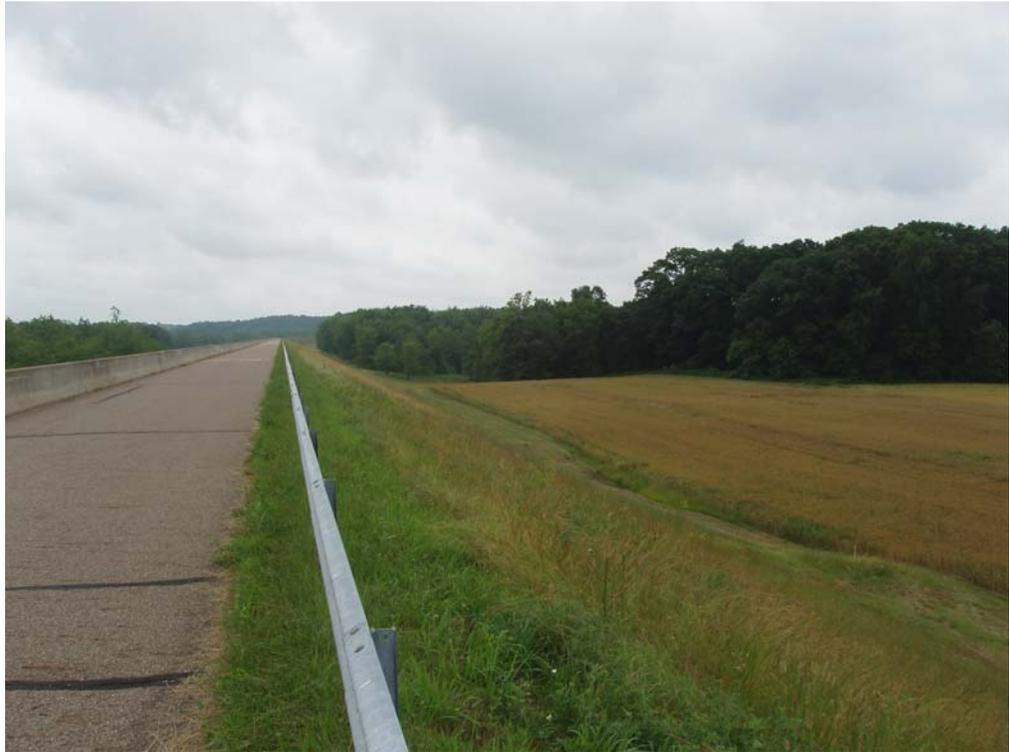
PHOTO NO. 25 **BOLIVAR DAM, OHIO** **27-28 JUNE 2006**
View southward of the embankment crest taken from approximately station 10+00.

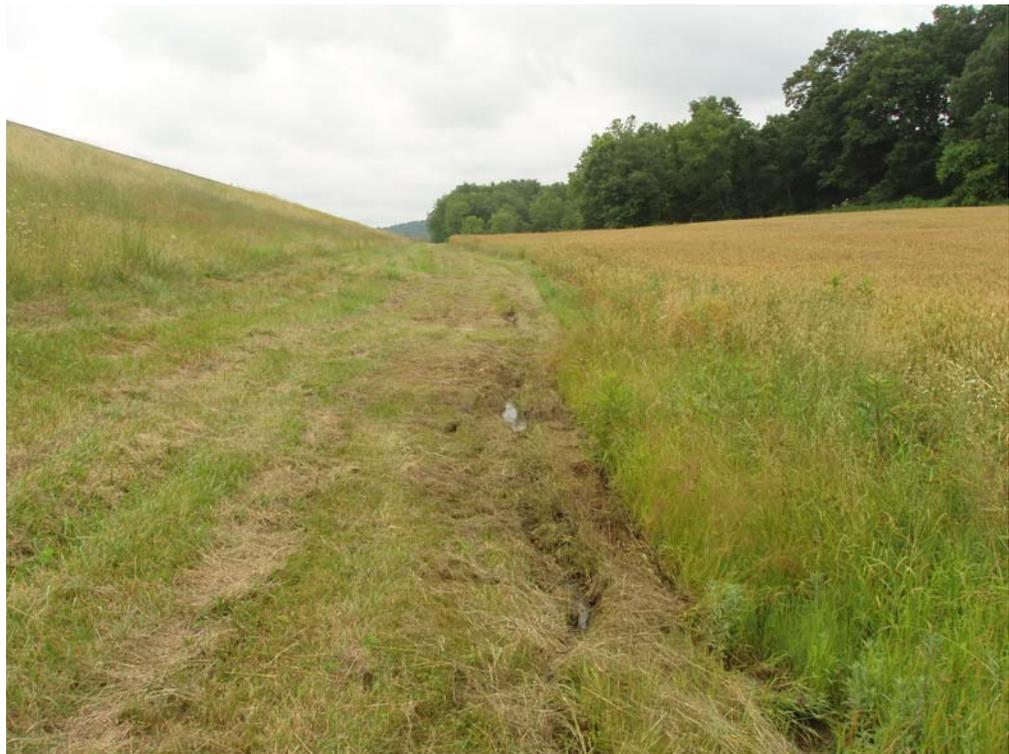
PHOTO NO. 26 **BOLIVAR DAM, OHIO** **27-28 JUNE 2006**
View of upstream toe of dam wet spot (surface and groundwater related) in the area of stations 8+00 and 10+00 as noted in previous inspections.

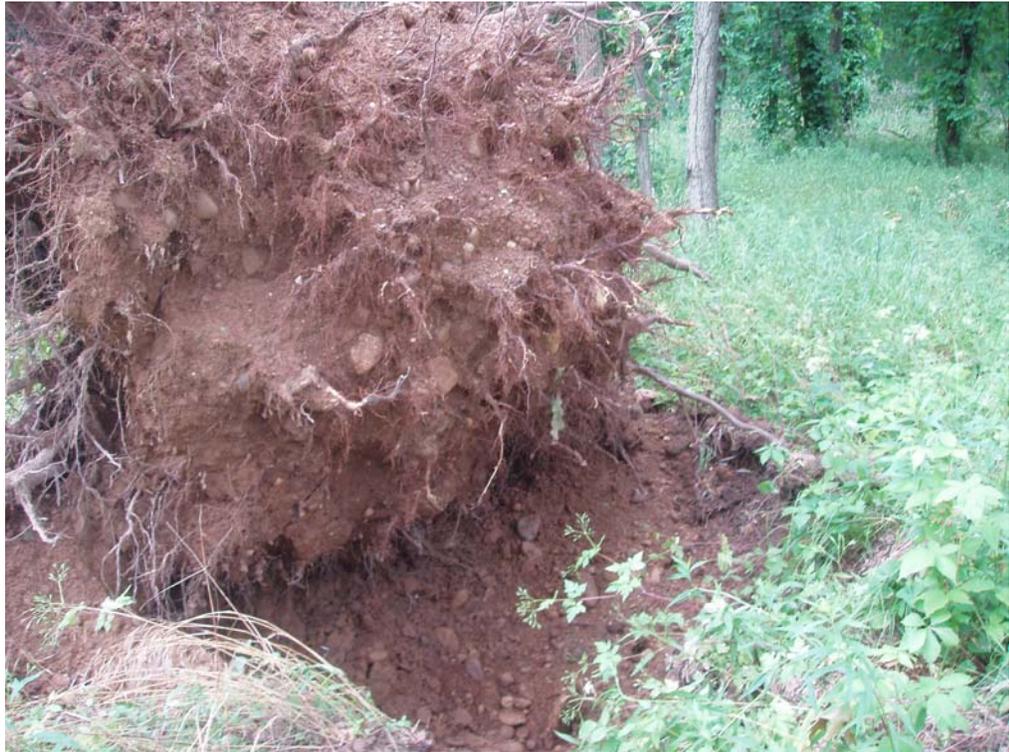
PHOTO NO. 27 **BOLIVAR DAM, OHIO** **27-28 JUNE 2006**
Uprooted tree (one of many) in the gravel terrace section of the embankment resulting from a recent storm.
