BOLIVAR DAM PROJECT PHOTOGRAPHS

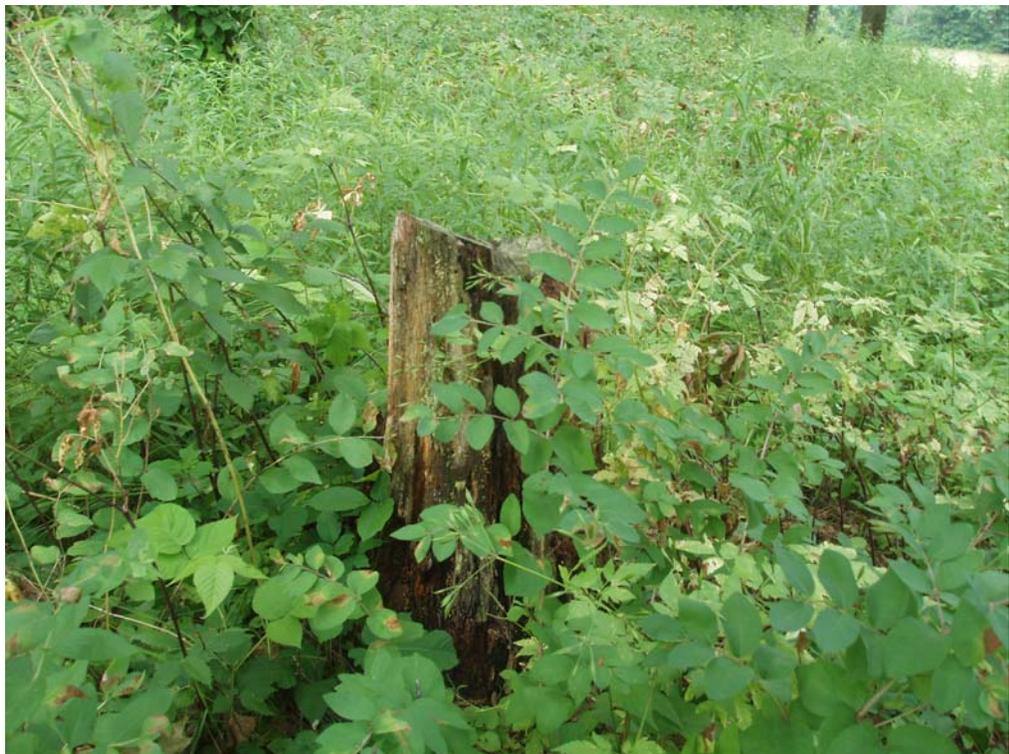
PHOTO NO. 28 **BOLIVAR DAM, OHIO** **27-28 JUNE 2006**
One of several rotted tree stumps observed in the gravel terrace section of the embankment. Note thick vegetation.

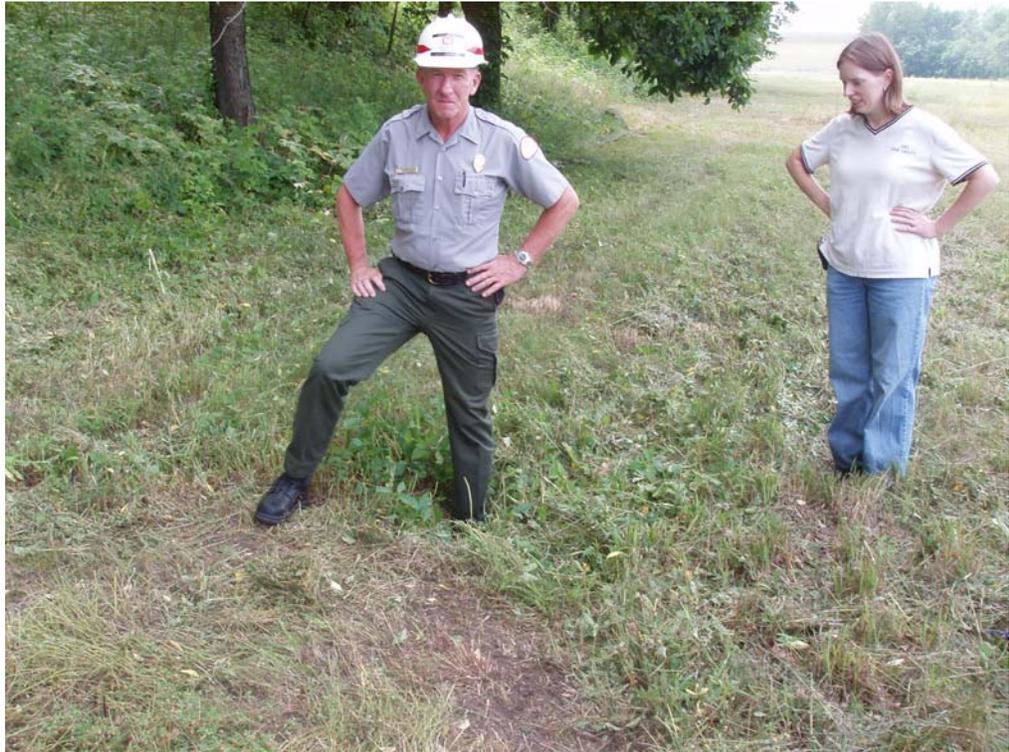
PHOTO NO. 29 **BOLIVAR DAM, OHIO** **27-28 JUNE 2006**
One of many sinkholes (1 to 2 feet deep) observed in the downstream seepage blanket near station 35+00; sinkholes occurred during the January 2005 POR.

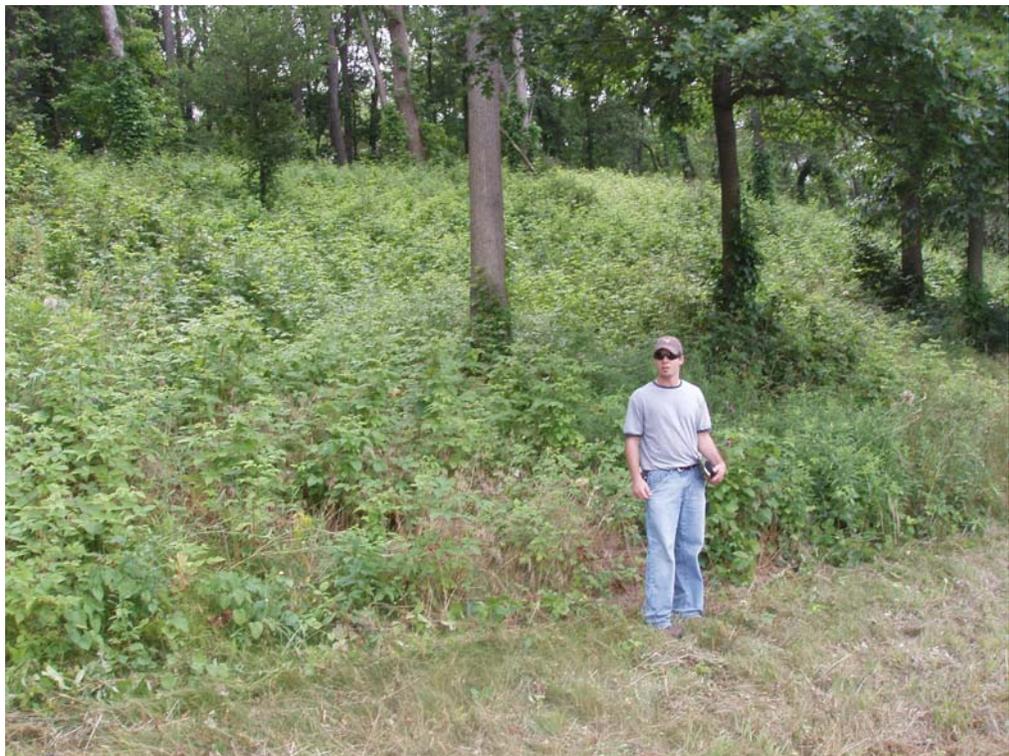
PHOTO NO. 30 **BOLIVAR DAM, OHIO** **27-28 JUNE 2006**
Vegetative growth (3-5 ft high) preventing observation of terrace gravel embankment section of project.

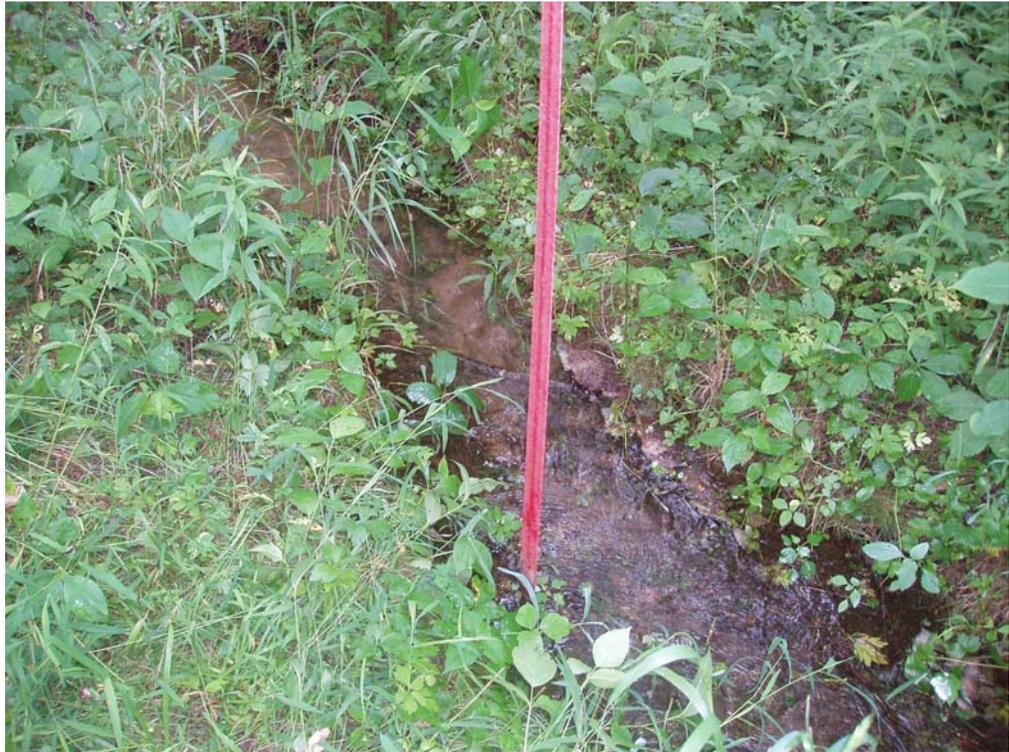
PHOTO NO. 31 **BOLIVAR DAM, OHIO** **27-28 JUNE 2006**
Seepage observed downstream of the seepage blanket at approximate station 43+00.

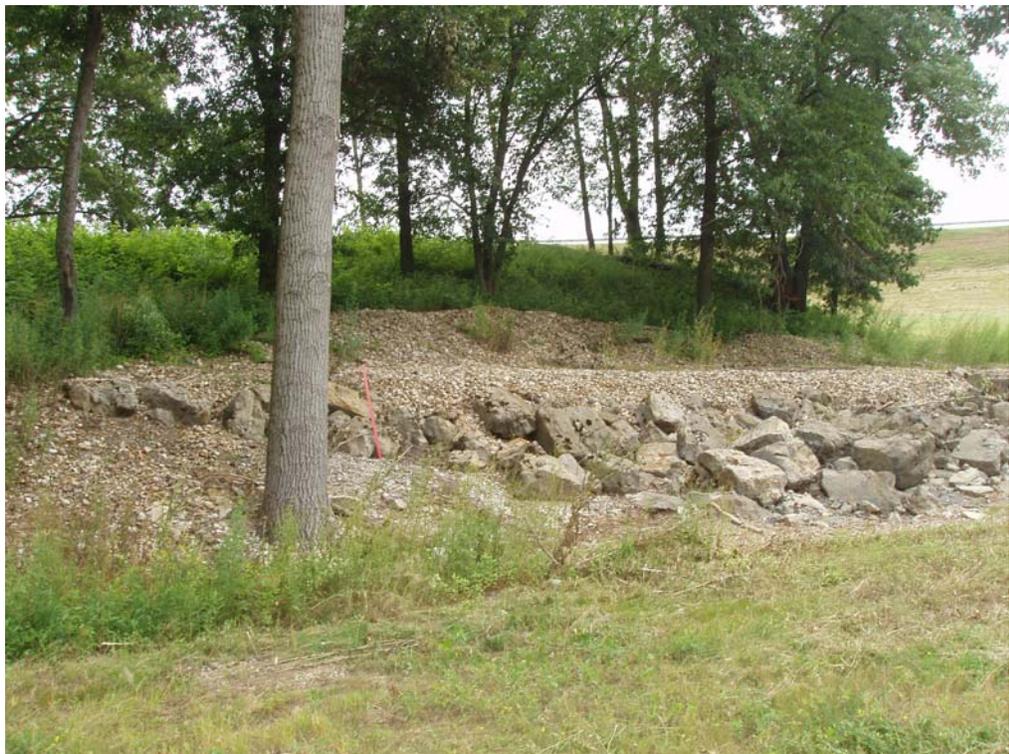
PHOTO NO. 32 **BOLIVAR DAM, OHIO** **27-28 JUNE 2006**
General view of emergency blanket that was constructed at station 50+00 during the January 2005 pool of record.

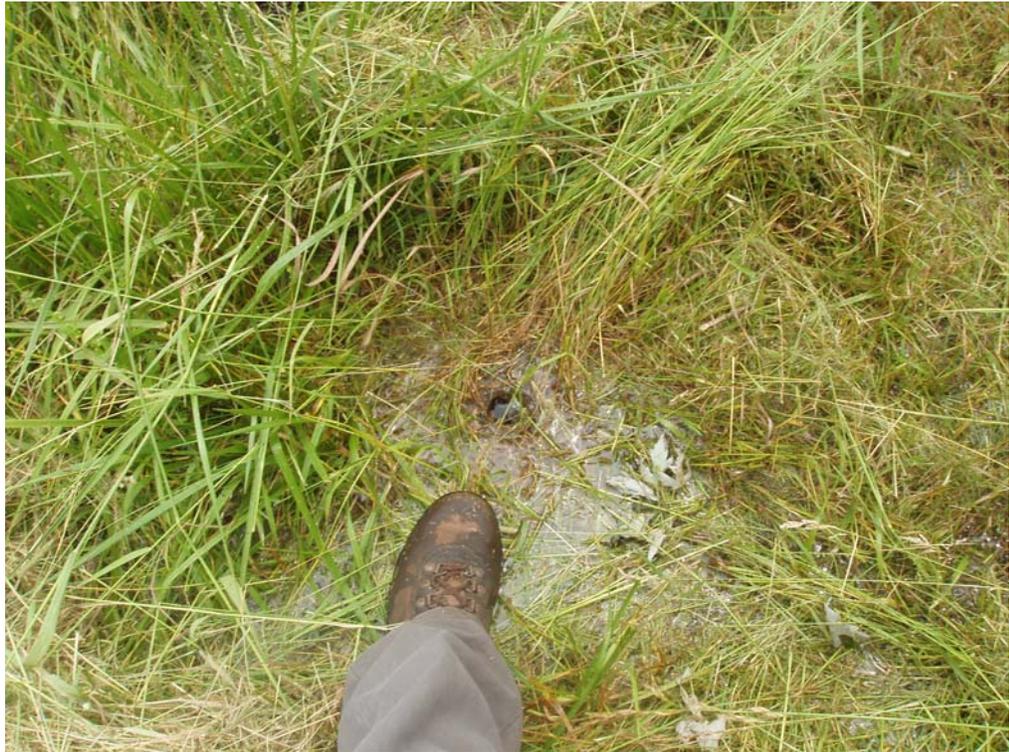
PHOTO NO. 33 **BOLIVAR DAM, OHIO** **27-28 JUNE 2006**
Seepage downstream of the seepage blanket at approximate station 58+00 (pool was at elevation 921 ft).

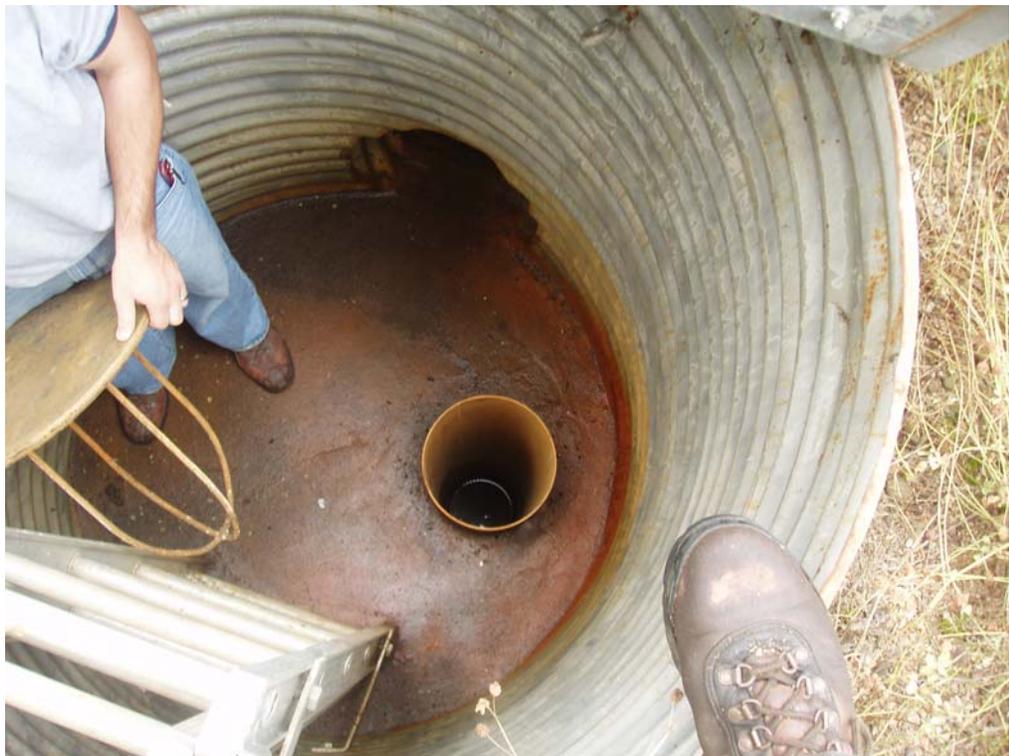
PHOTO NO. 34 **BOLIVAR DAM, OHIO** **27-28 JUNE 2006**
View inside housing of relief well No. 6. No relief wells were flowing today because the pool was less than 930 ft elevation.

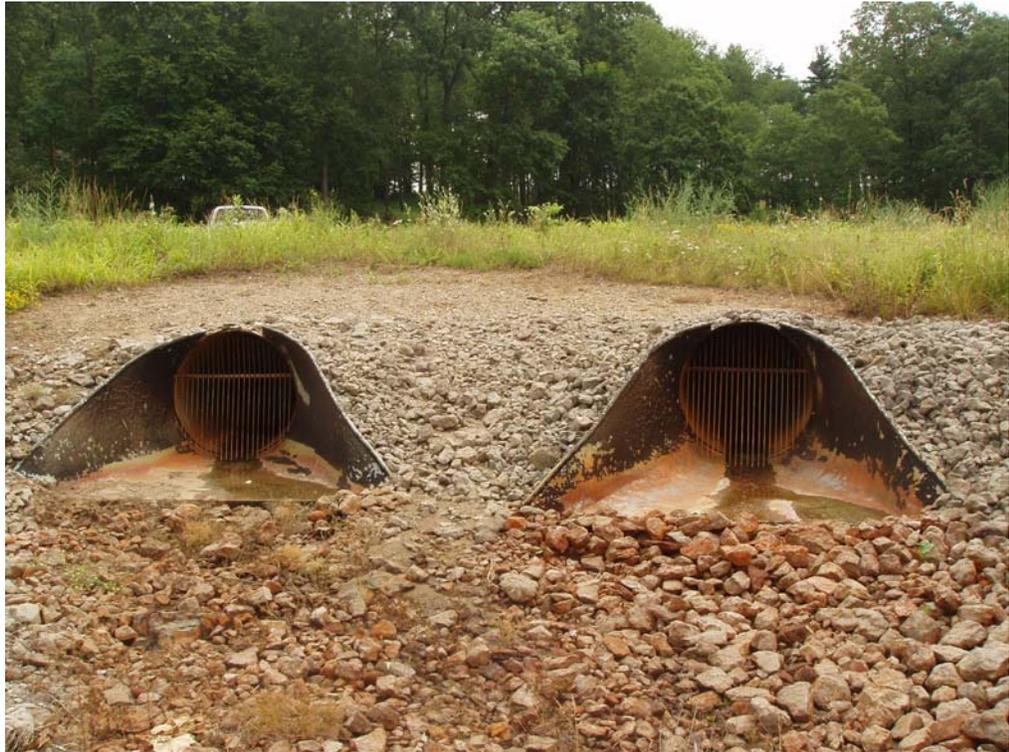
PHOTO NO. 35 **BOLIVAR DAM, OHIO** **27-28 JUNE 2006**
Screens placed over toe drain and relief well outlets since the last periodic inspection. Note iron staining on outlets indicating well biofouling potential.

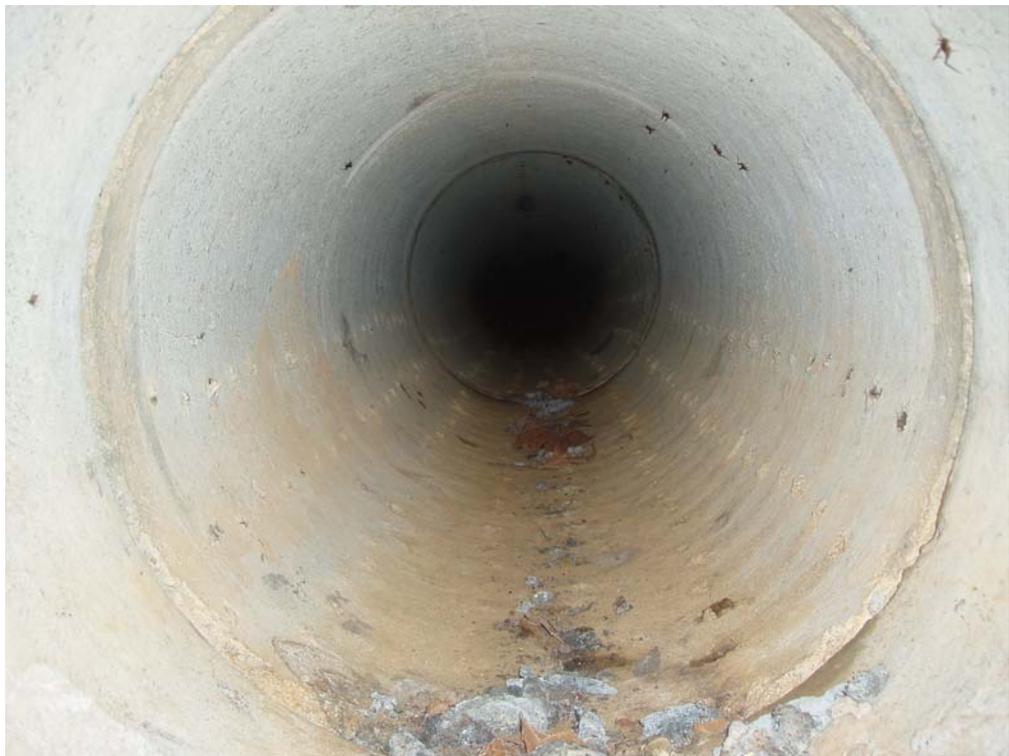
PHOTO NO. 36 **BOLIVAR DAM, OHIO** **27-28 JUNE 2006**
View inside of toe drain showing apparent open/non-clogged perforations. Note that data regarding potential positive pressure relief contribution of toe drain has not been quantified. Toe drain is 2 foot diameter.

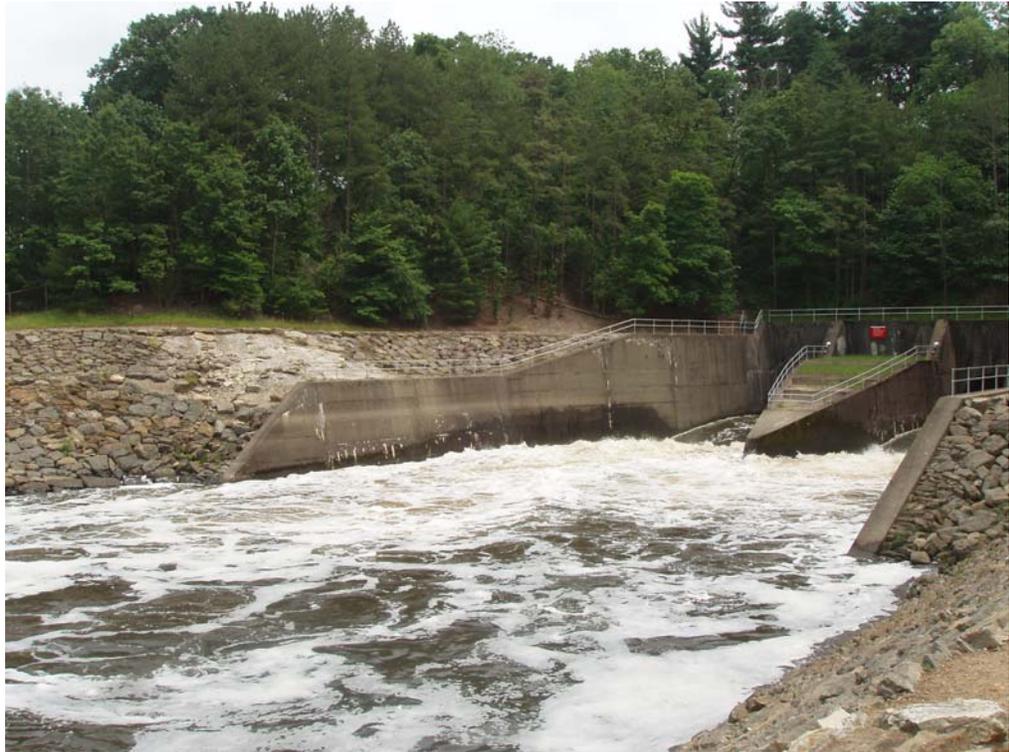
PHOTO NO. 37 **BOLIVAR DAM, OHIO** **27-28 JUNE 2006**
General view of outlet channel. Note some stone slope protection missing above the right training wall (has been previously noted).

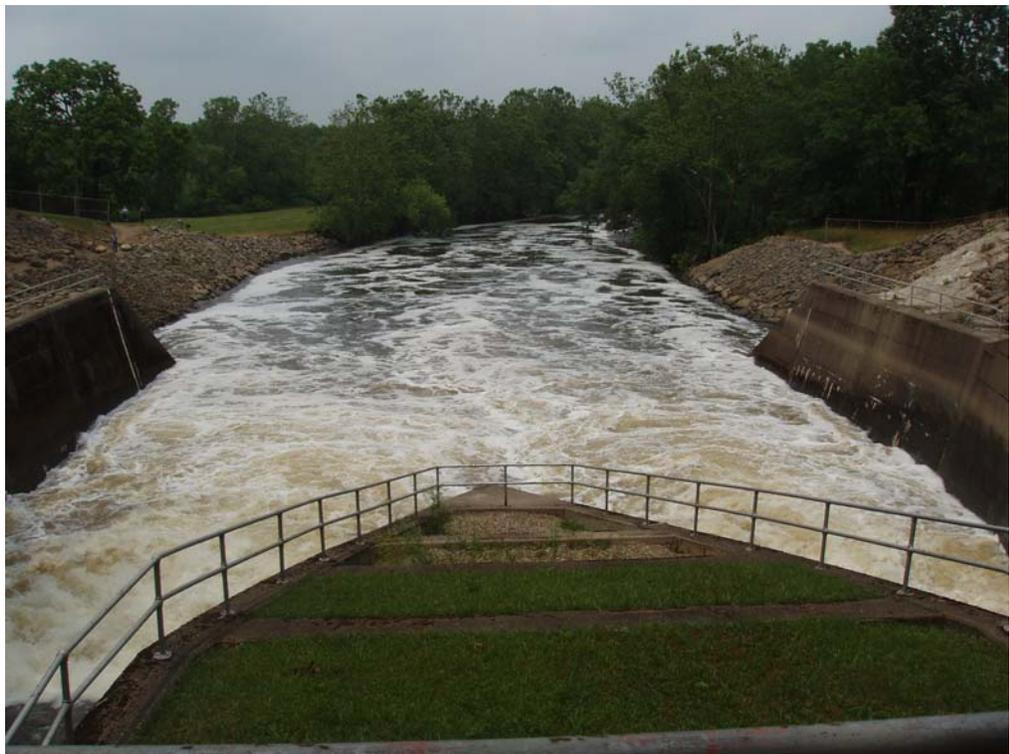
PHOTO NO. 38 **BOLIVAR DAM, OHIO** **27-28 JUNE 2006**
General downstream view of outlet channel. No hydraulic restrictions were observed.

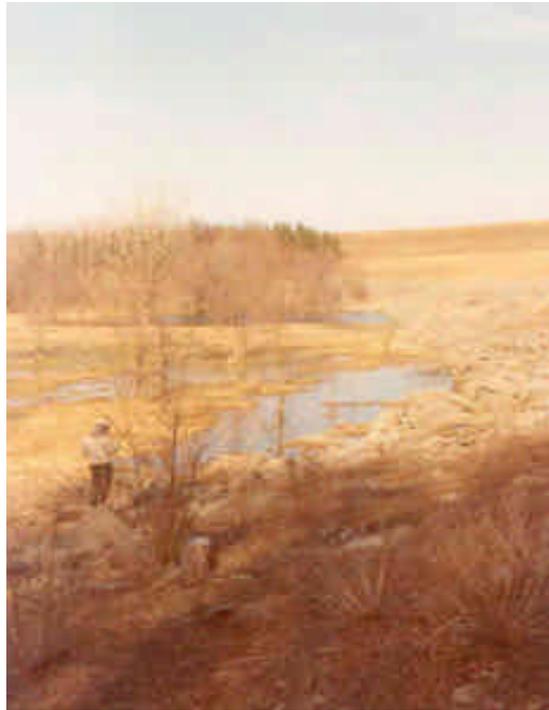
PHOTO NO. 39 **BOLIVAR DAM, OHIO** **05 MARCH 1975**
Overall view of the toe drain seepage and ponding looking from the left
downstream abutment. Pool El. 898.0

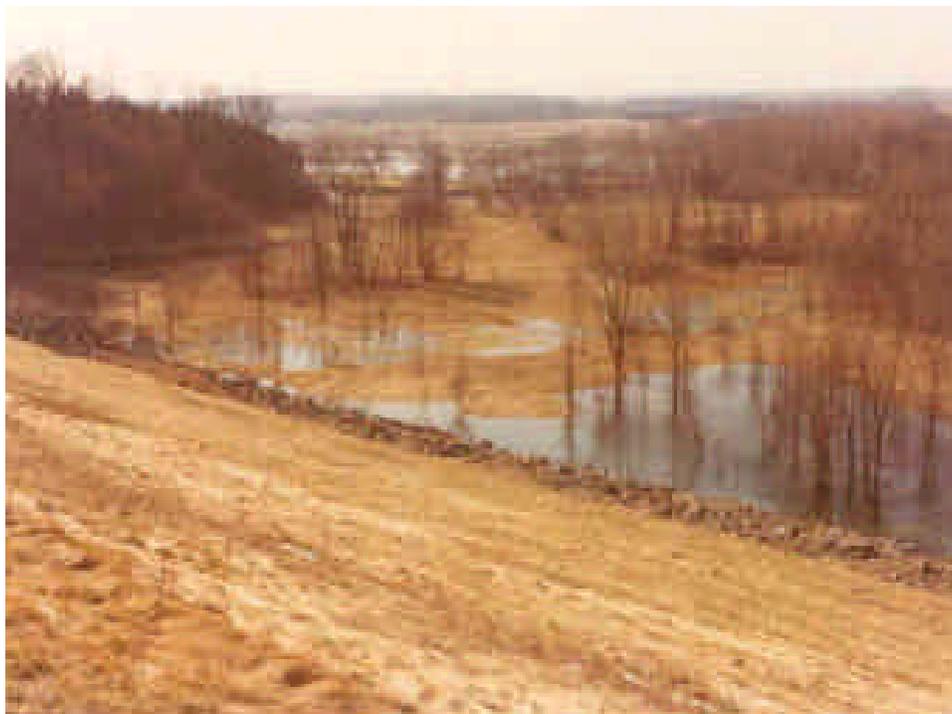
PHOTO NO. 40 **BOLIVAR DAM, OHIO** **05 MARCH 1975**
General view of the toe drain seepage and ponding looking downstream
from on top of the dam toward the left abutment. Pool El. 898.0

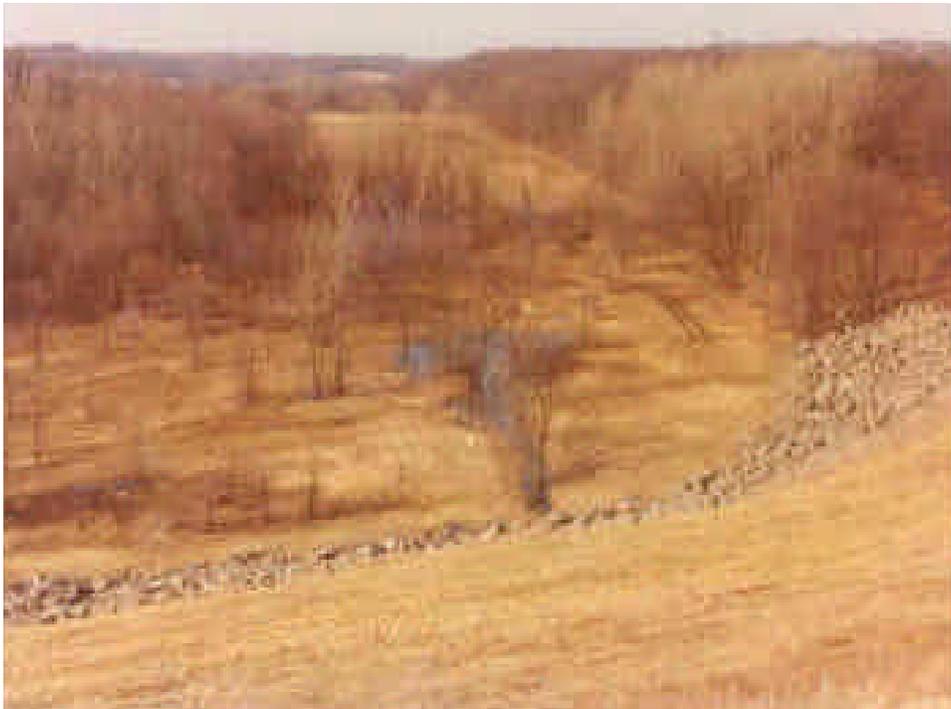
PHOTO NO. 42 **BOLIVAR DAM, OHIO** **05 MARCH 1975**
View of the toe drain seepage and ponding in the old stream channel looking downstream from on top of the dam. Pool El. 898.0

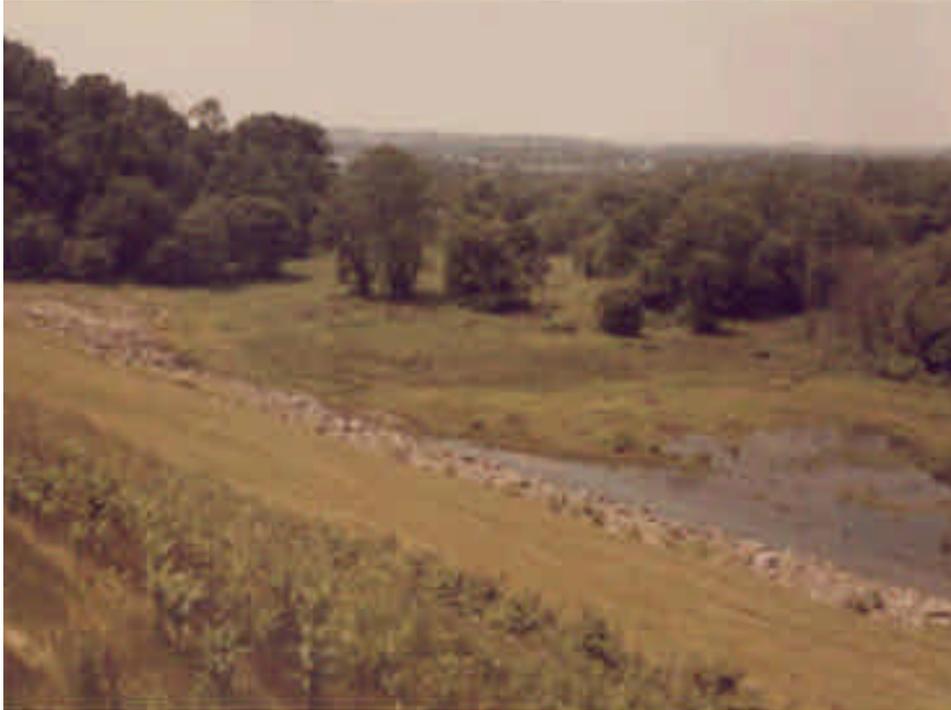
PHOTO NO. 43 **BOLIVAR DAM, OHIO** **18-19 JUNE 1981**
Downstream toe of the main embankment. Note ponded seepage.
Pool El. 928.81

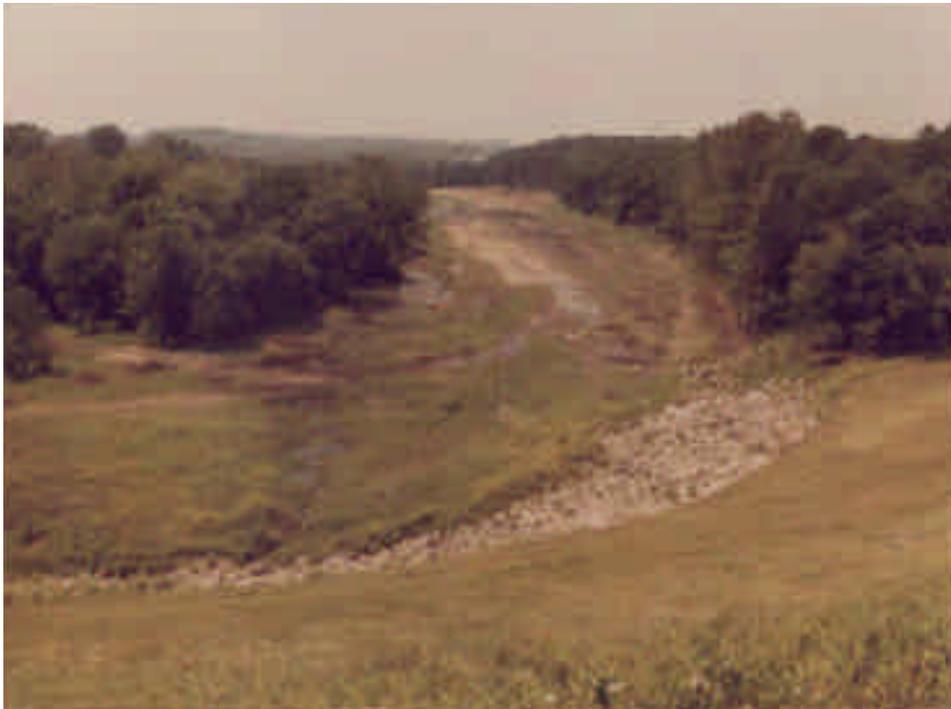
PHOTO NO. 44 **BOLIVAR DAM, OHIO** **18-19 JUNE 1981**
D/S toe of main embankment in the vicinity of the old stream channel.
Note area of clearing for sand & gravel blanket. Pool El. 928.81

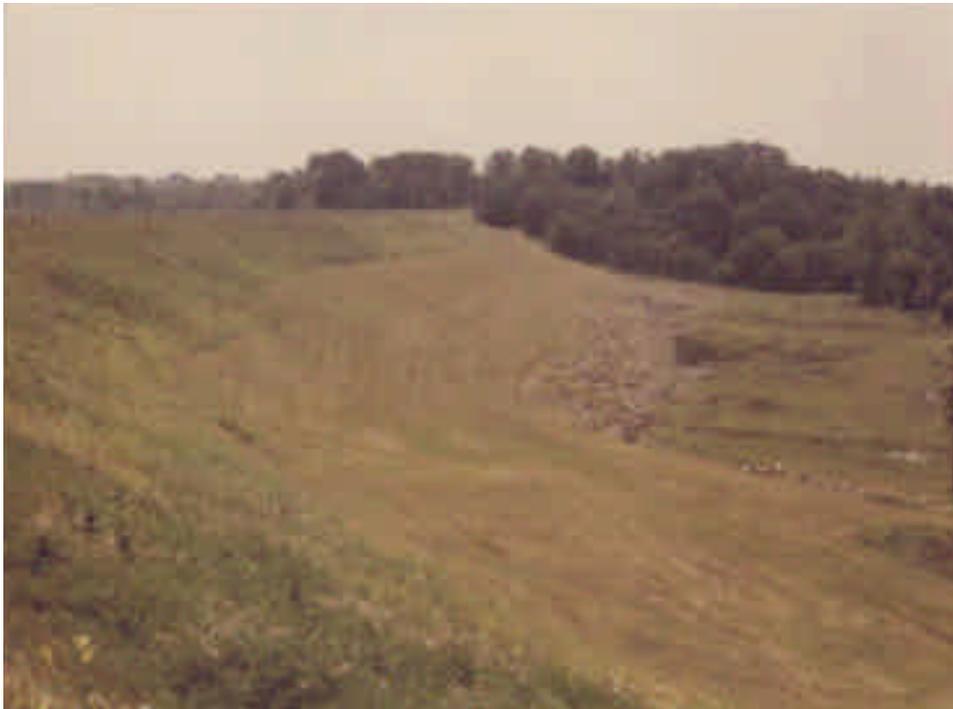
PHOTO NO. 48 **BOLIVAR DAM, OHIO** **18-19 JUNE 1981**
Downstream face of the main embankment. Note ponded seepage from the pool. Pool El. 928.81

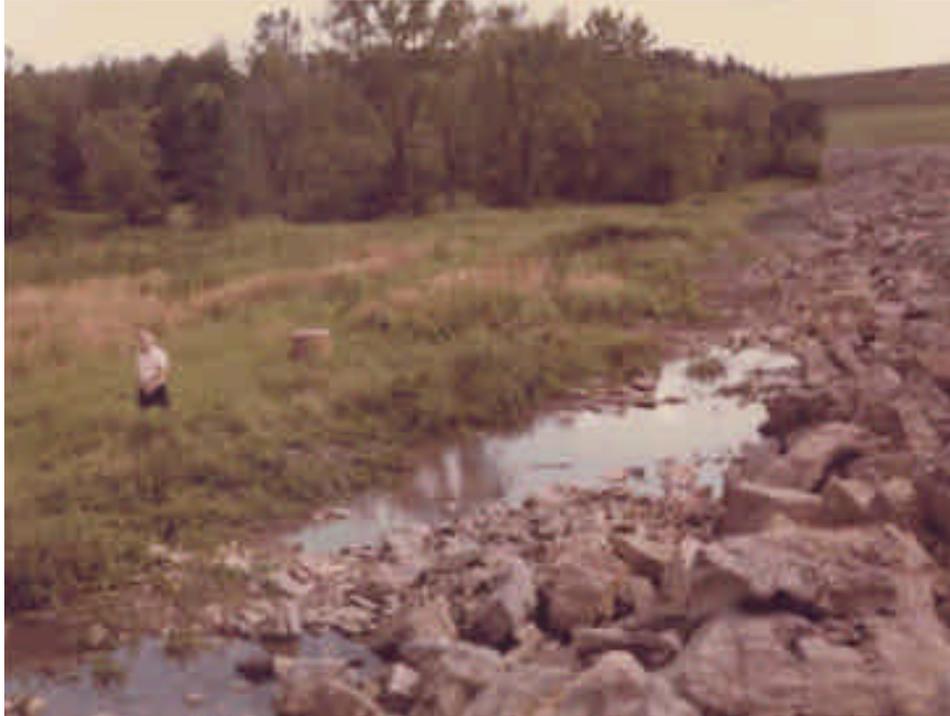
PHOTO NO. 49 **BOLIVAR DAM, OHIO** **18-19 JUNE 1981**
“Normal” seepage at downstream toe of the main embankment during a typical pool rise. Pool El. 928.81

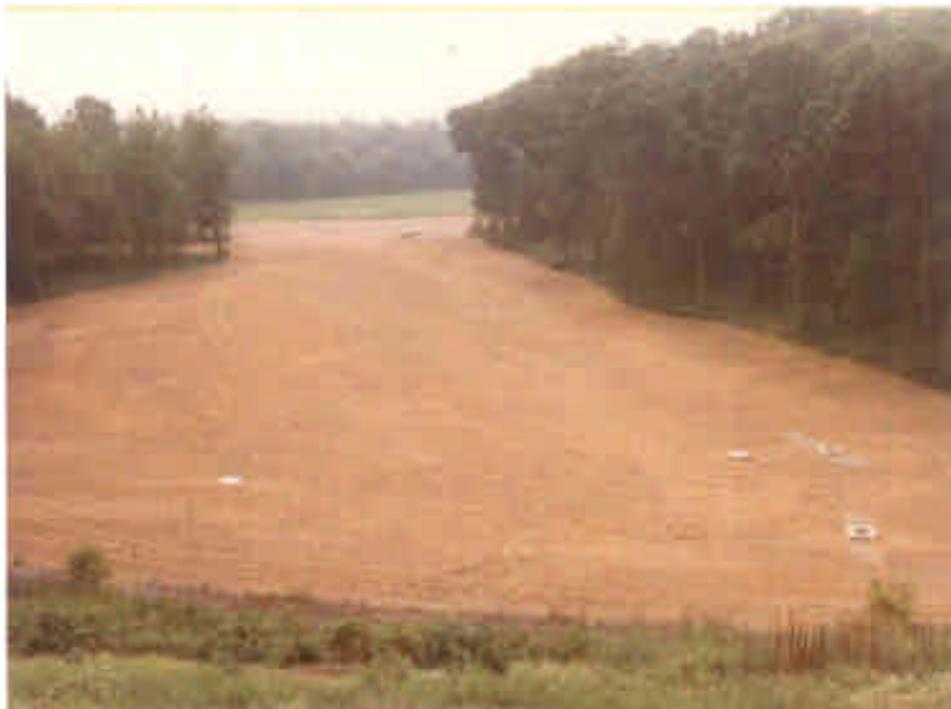
PHOTO NO. 62 **BOLIVAR DAM, OHIO** **17 MARCH 1982**
Area opposite Sta. 27+00. Old stream tributary channel (before dam
construction) was treated with perforated pipe and sand & gravel
blanket to control underseepage. Pool El. 897.51
