PERFORMANCE HISTORY

Zoar Levee

US Army Corps
of Engineers ®

Huntington District

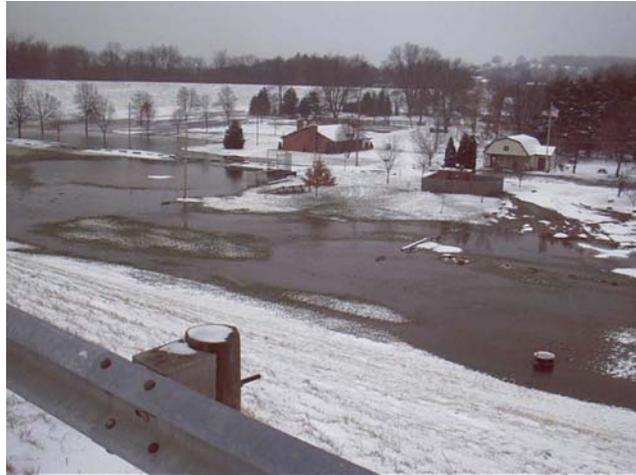
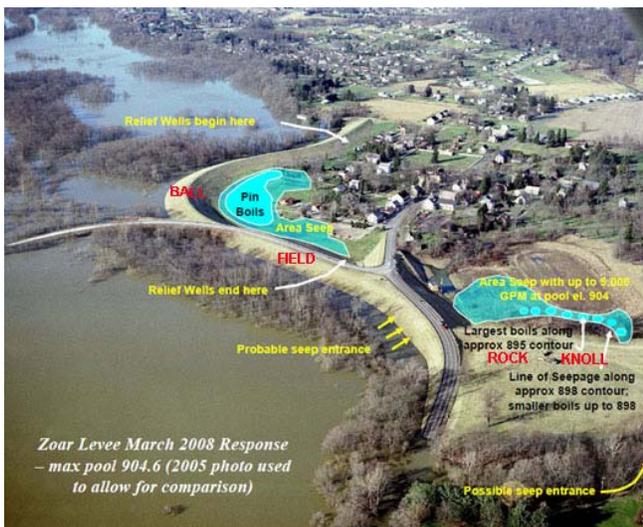
In 2005, Dover Dam retained a pool of record at elevation 907.35, which loaded water against Zoar Levee for approximately a month. Widespread small “pin” boils were noted on the Ball Field reach and more significant boils were found on the Rock Knoll reach of the levee. To remediate the piping of material exiting these boils, they were ringed with sand bags and a filter fabric was added to the landward toe of the levee. A Screening Portfolio Risk Analysis (SPRA) of Zoar Levee and Diversion Dam concluded after this event that Zoar Levee was a DSAC II, as boils and piping indicated that the project was progressing toward failure.

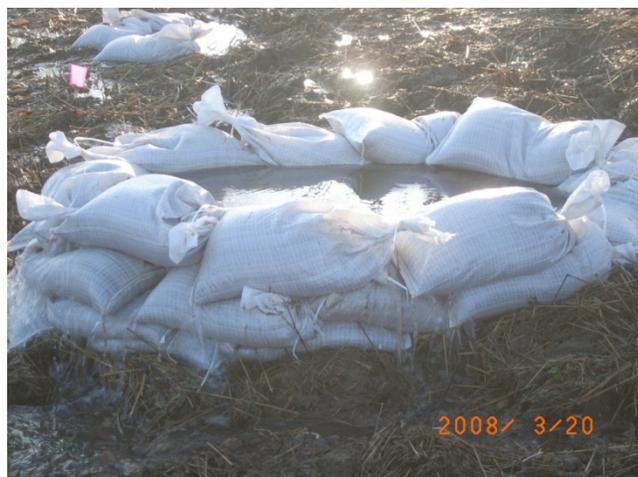
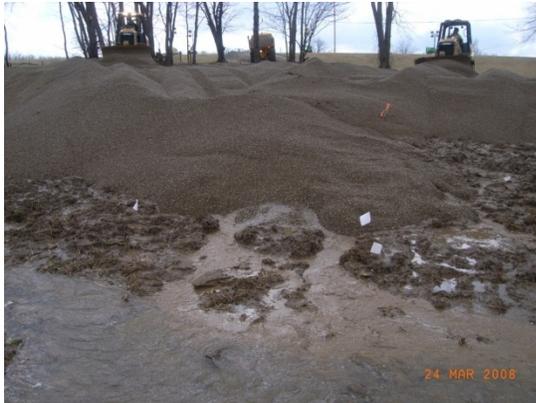
In 2008, another significant Dover Dam pool occurred loading Zoar Levee for a month and peaking three feet below the 2005 pool, at 904.6 ft. The levee’s performance near the Rock Knoll reach worsened significantly, with large boils flowing along the interior of the levee.

Early during the 2008 event, each boil on the Rock Knoll reach was sand-bagged and channelized flow of seepage developed. As the pool elevation increased during the next two weeks the number of boils, the size of the boils, and the total quantity of seepage across

the area increased significantly. Boils repeatedly expanded beyond and collapsed sandbag rings, and coalesced at multiple project locations into large unstable regions.

The area seepage and boils extended along a line approximately 550 ft. long, parallel with the levee centerline, for a total of around 5,000 gpm of flow at its peak. Flood fighting with sandbag rings was employed for two and a half weeks, while Dover Dam’s pool rose from approximately el. 894 to 904.6. Several boils grew to 1.5 ft. in diameter and produced up to 300 gpm each moving a significant amount of foundation soils. As smaller boils began to

coalesce into larger boils capable of moving foundation material faster and large unstable regions were developing, the decision was made to install a \$1.26 million seepage berm with 37,000 tons of granular material.

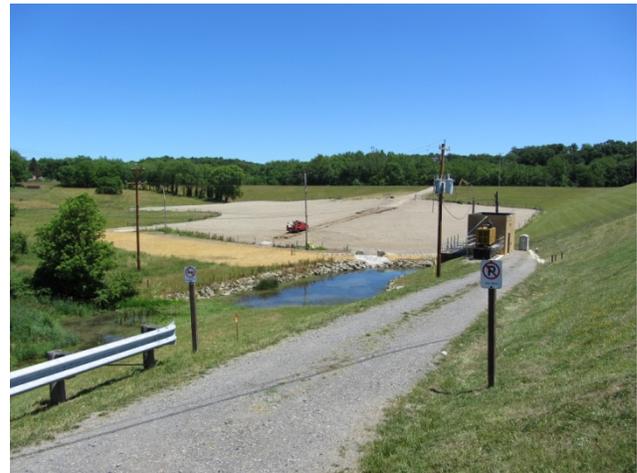
At the same time, widespread small boils and pervasive area seepage were again observed on the Ball Field reach of the levee, but no immediate flood fighting actions were taken. The boils were

generally observed from within 150 ft. of the levee toe. This scenario was very similar to what occurred in 2005. The boils were monitored for about three and a half weeks, but did not expand to the point they were carrying large amounts of soil.

This event resulted in Zoar Levee and Diversion Dam being reclassified as a DSAC 1 project, as progression toward failure had been confirmed. The DSAC I rating was subject to an Independent External Peer Review (IEPR) and confirmed (Battelle 2010).

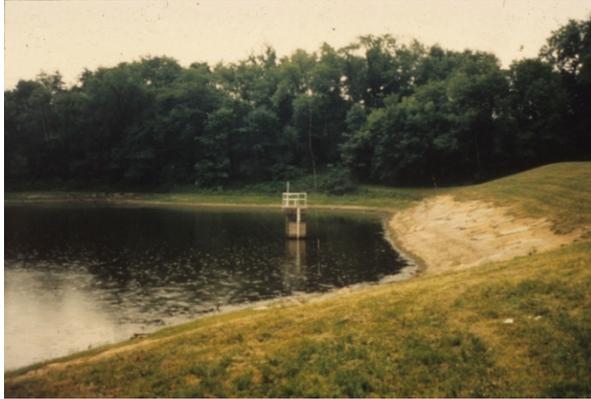
In 1989, seepage of 50-100 gpm was reported 300 ft downstream of the conduit outlet on the right side, exiting at several points. By 1990, flow had increased to 150-200 gpm. During the spring and summer of 1991 the seepage caused the lake level to drop significantly before leveling off at el. 906. The flow had peaked at 500 gpm and a large vertical piping cavity had developed. Studies were begun, including a seepage tracing study that confirmed a connection between pool and seepage.
