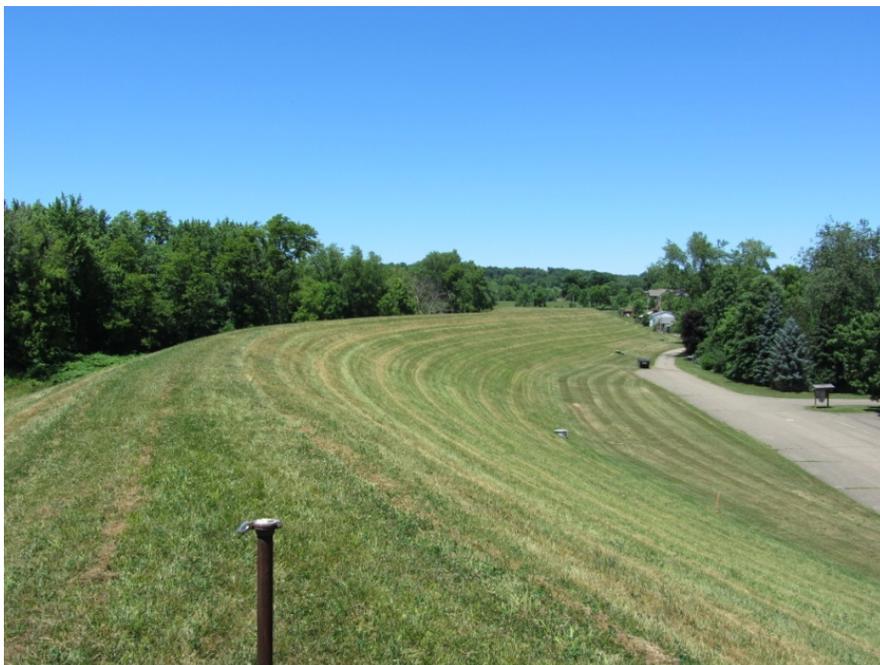
This is a 2012 photograph of the crest of Ball Field side of Zoar Levee. When it was originally built, the crest of the levee was at elevation 919'. In the 1950s, Zoar Levee was raised to its current crest height of elevation 928.5'. At its highest point, Zoar Levee is approximately 45 feet high. The levee is approximately 3,893 feet long, or nearly 12 football fields.

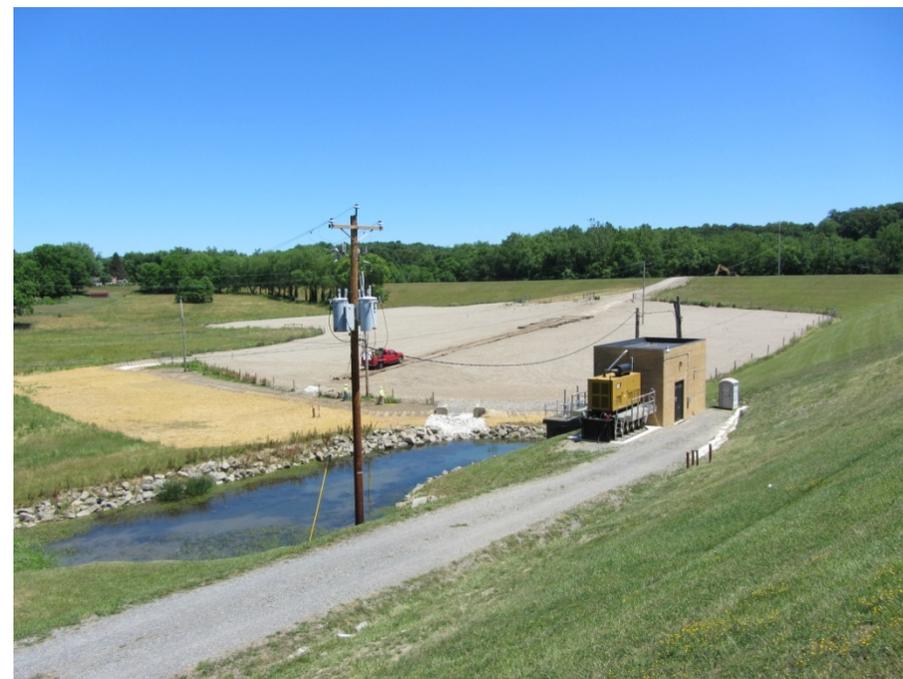
This is a 2012 photograph of the Rock Knoll side of Zoar Levee. When it was originally built, the Rock Knoll had two levees as a piece of high ground bisected it. However, following raising the levee in the 1950's, the embankment was merged. Also visible is the pump station in the foreground. It was also added in the 1950s. Recently the U.S. Army Corps of Engineers upgraded the pump so it can pump 45,000 gallons per minute. It also has a new diesel generator. A \$1.26 million dollar seepage blanket lines the interior of the Rock Knoll. It was placed in 2008 in response to significant under seepage that occurred.

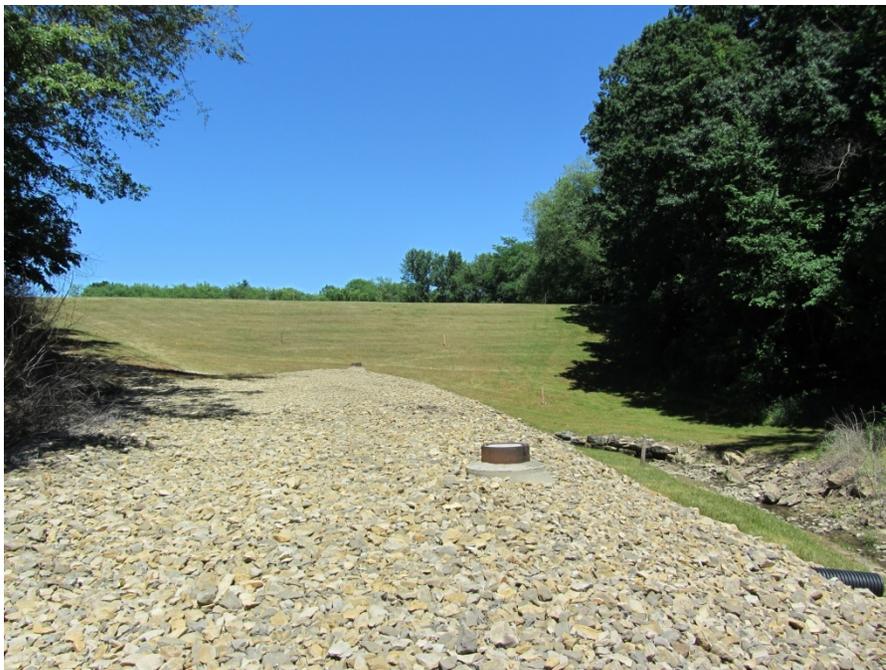
This is a 2012 photograph of the downstream face of Zoar Diversion Dam. Zoar Diversion Dam is located on Goose Run, about 1000 feet upstream from Zoar Levee. It is approximately 500 feet long and 35 feet wide. Its crest is at elevation 936'. In the foreground is a 1992 Seepage Blanket placed to help capture and control seepage that occurred through the abutment of the dam.

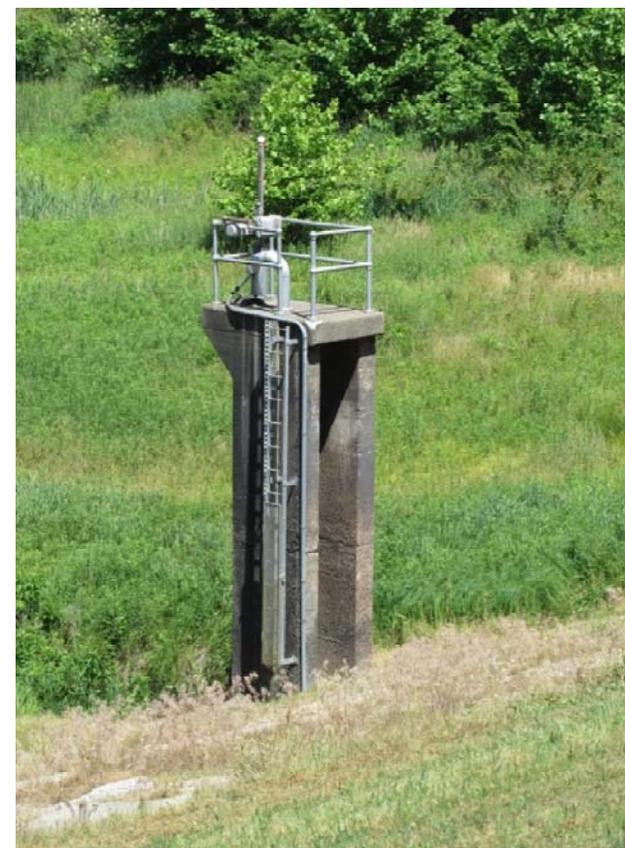
This is a 2012 photograph of the control tower for Zoar Diversion Dam. It is located on the upstream toe of the dam and it has a single sluice gate that can cover the 3-x-3 foot tunnel that carries Goose Run through the dam. Until the early 1990's, a permanent lake was impounded behind Zoar Diversion Dam. This lake partially drained itself through seepage on one of the abutments. Following some remedial actions, including the installation of the gravel blanket pictured above, it was recommended that the lake be permanently drained.

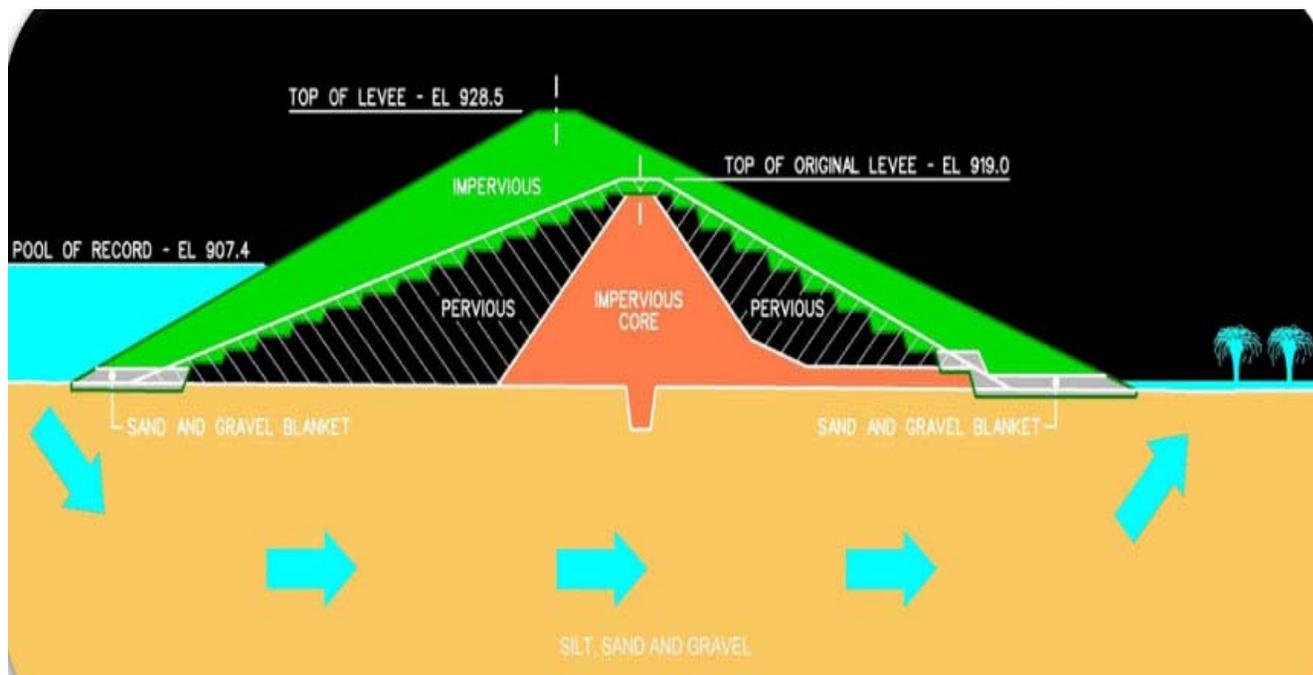
Below is a cross section of Zoar Levee demonstrating how water being impounded on the outside of the levee (left side) moves underneath the levee. This is called “under seepage”. Because Zoar Levee is founded on sands, gravels and fractured bedrock, this under seepage tends

to channelize or “pipe” which can result in holes opening up on the interior side (right side) of the levee. The holes are called “boils”. Water and sands underneath the levee can then exit through these boils, undermining the foundation of the levee and ultimately its stability.

The level of water displayed above (elevation 907.4) corresponds to the highest amount of water Zoar Levee has had to hold back to date. This was the “Pool of Record”

for Dover Dam. This event occurred in January of 2005 and caused under seepage which led to piping and boils. The U.S. Army Corps of Engineers, Huntington District was able to manage this seepage using geo-textile fabric and sandbags.

In March of 2008, Dover Dam held a pool of water to elevation 904.6 which caused under seepage at Zoar Levee that led to much larger boils opening up. The largest boils occurred on the Rock Knoll, which continued to grow in size despite placing sandbags around them. In response to this event, the U.S. Army Corps of Engineers, Huntington District took emergency action by adding a large stone blanket to prevent the levee from catastrophically failing.

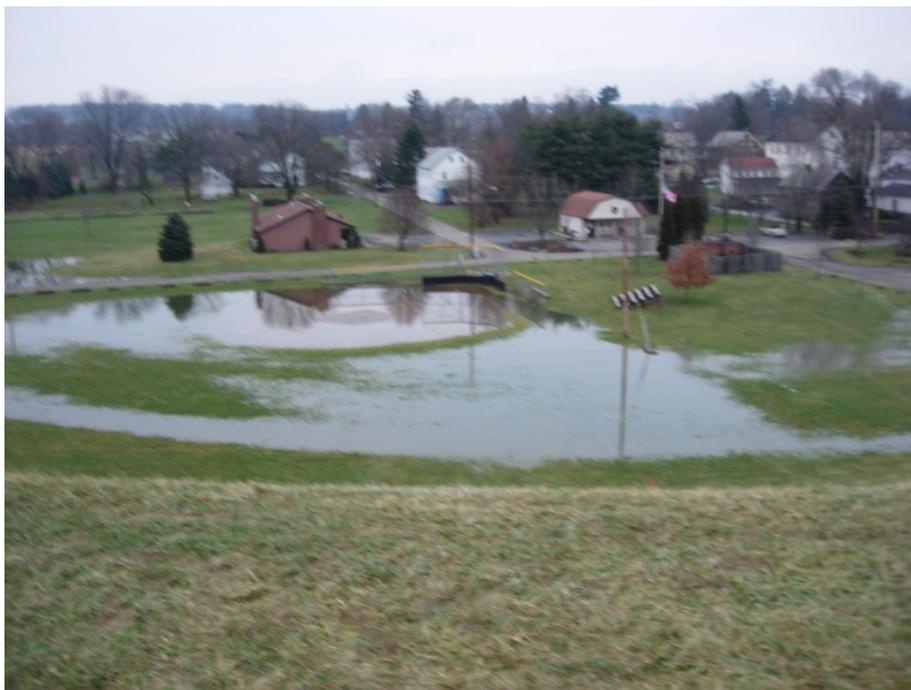
This a photograph of standing water on interior side of the Ball Field at Zoar Levee January 2005. This is evidence of under seepage occurring.

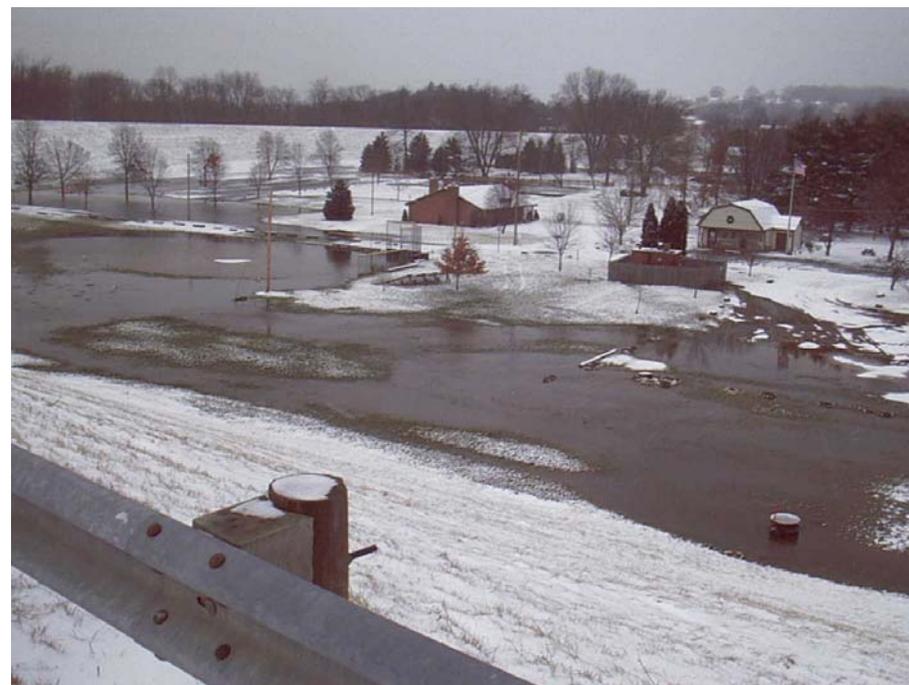
This is a photograph of standing water on interior side of the Ball Field at Zoar Levee January 2005. This is evidence of under seepage occurring.

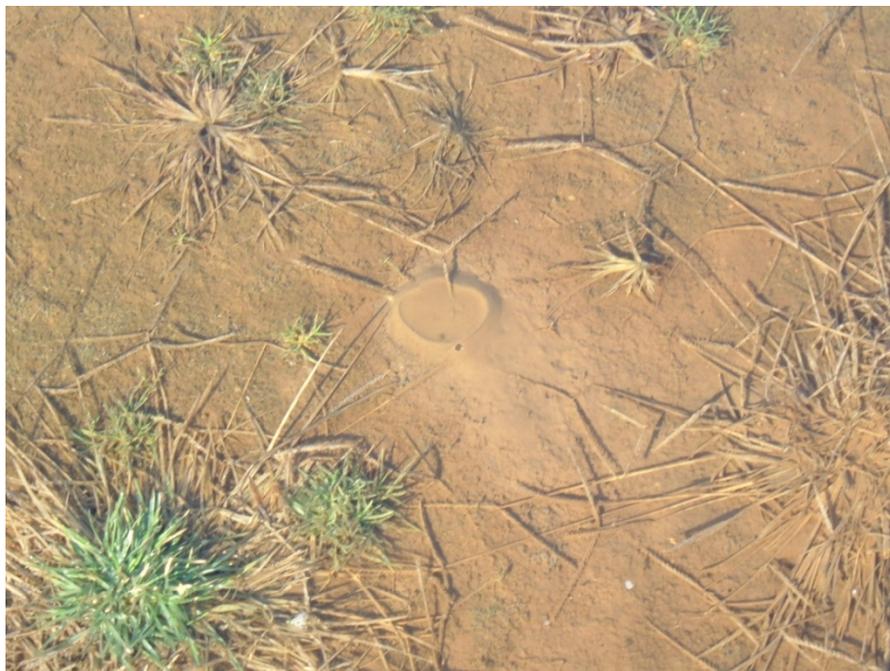
This is a picture of a small boil forming on the interior side of Zoar Levee in January of 2005. This is called a "pin boil". These small boils were evidence that seeping water is piping underneath the levee.

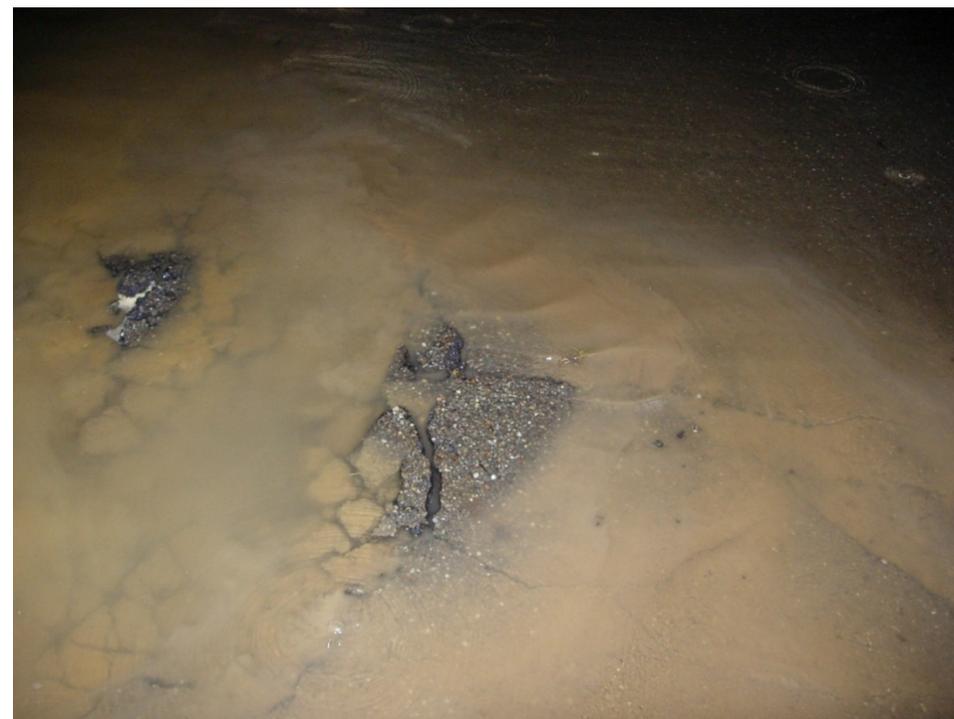
Portions of the Ball Field side at Zoar Levee are paved with asphalt for parking. This is a picture of that pavement failing due to pressure from water seeping underneath the levee and exiting on the interior side as boils in January of 2005. These boils were evidence that seeping water was piping underneath the levee.

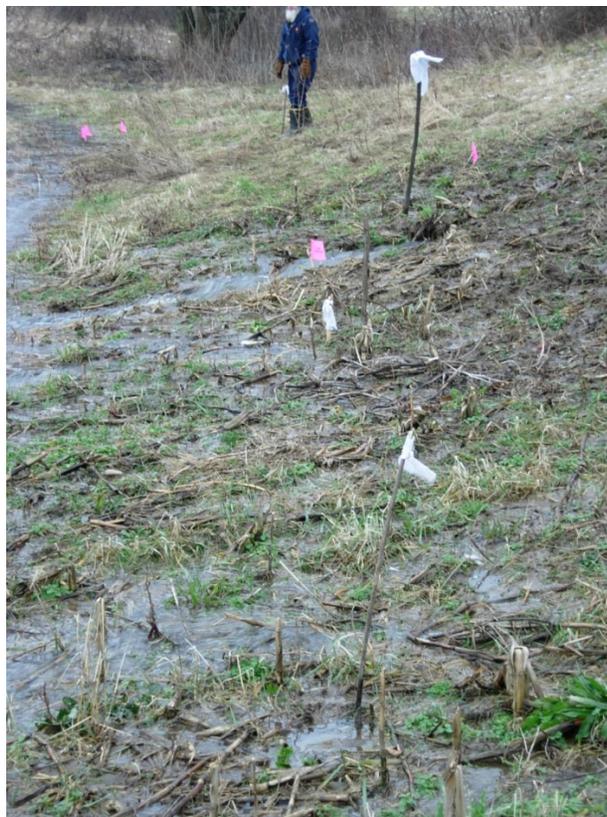
This is a photograph of water seeping on the interior side of the Rock Knoll at Zoar Levee in January 2005. At this location water exited directly from the ground in large volumes. This volume of water indicated that seeping water was beginning to pipe underneath the levee.

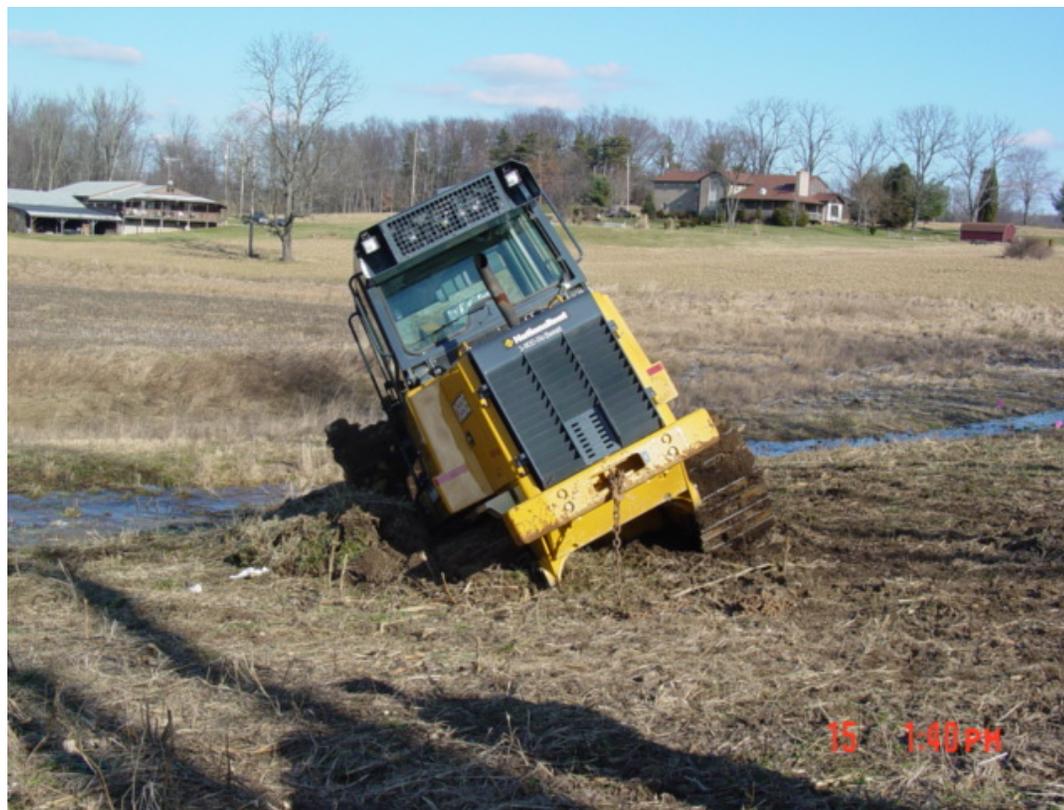
This is a photograph of mechanical equipment stuck in the saturated ground on the interior side of the Rock Knoll at Zoar Levee in January 2005.

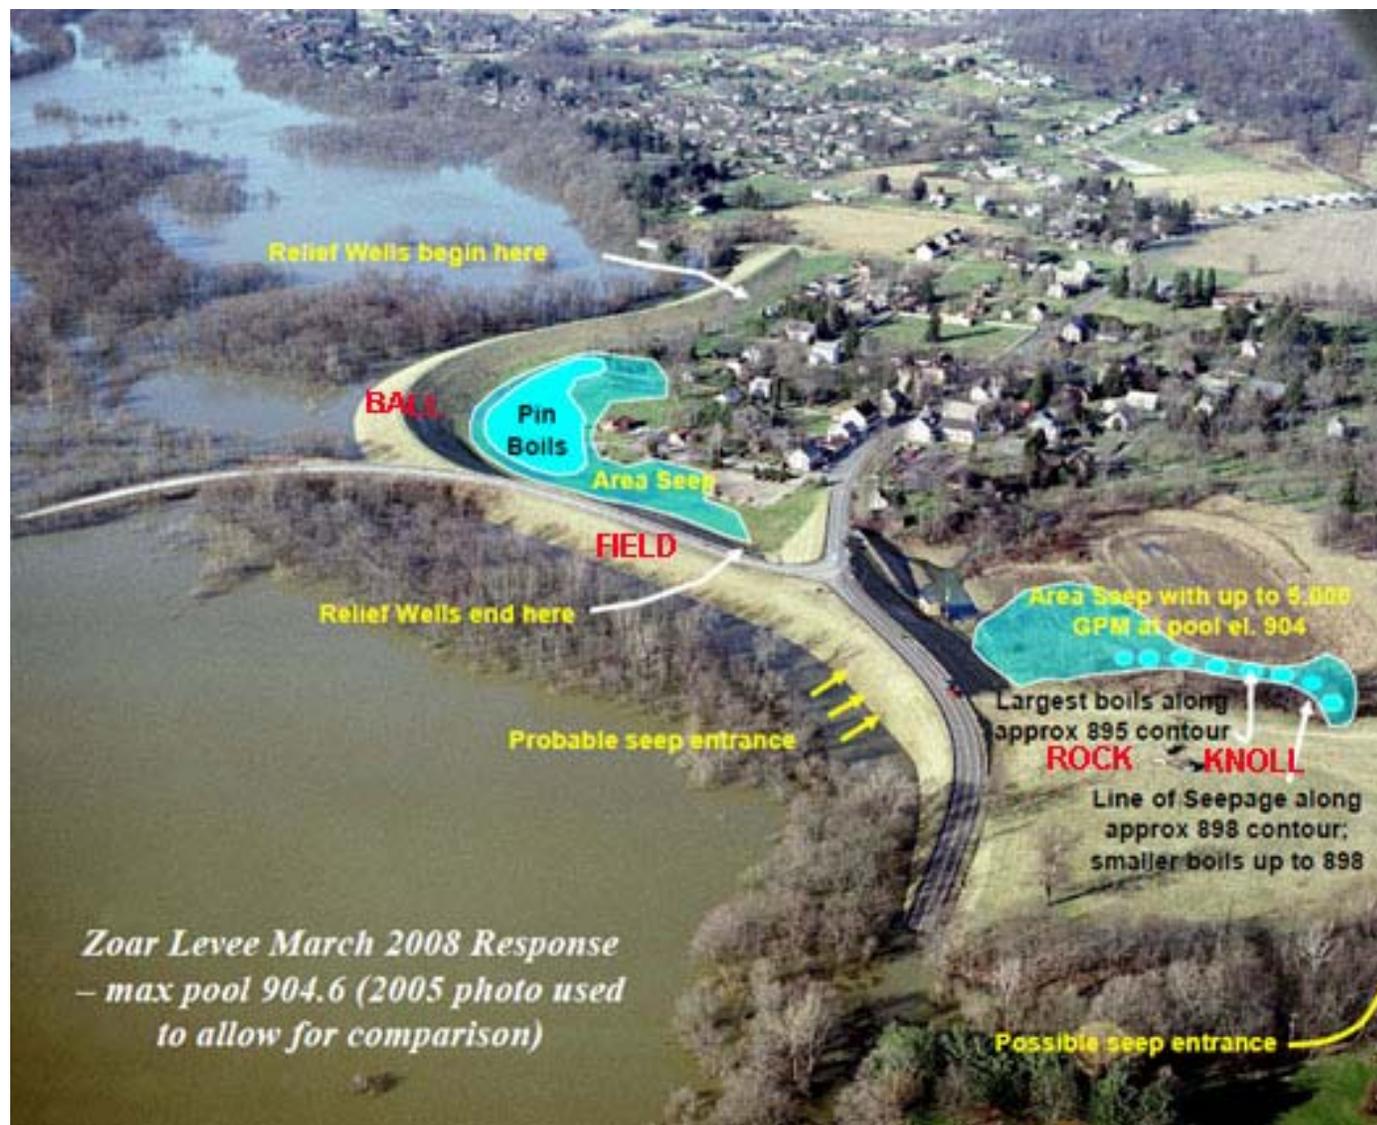
*Zoar Levee March 2008 Response
– max pool 904.6 (2005 photo used
to allow for comparison)*

This is an oblique view of Zoar Levee graphically demonstrating the locations of area seepage, pin boils, and large boils on the interior of Zoar Levee in March of 2008. Possible seepage entrances are also speculated. For comparison purposes, this photograph dates from the January 2005 event, but the performance issues reflect what was happening in March of 2008.

As noted, the most significant problems occurred along the Rock Knoll at the same location and elevation where water was seen significantly seeping in January 2005.

The March 2008 event resulted in a pool of water that was approximately 3 feet lower than what occurred in January of 2005. Despite that, the

performance of Zoar Levee decreased significantly and required that the U.S. Army Corps of Engineers, Huntington District take emergency action to prevent the levee from catastrophically failing.

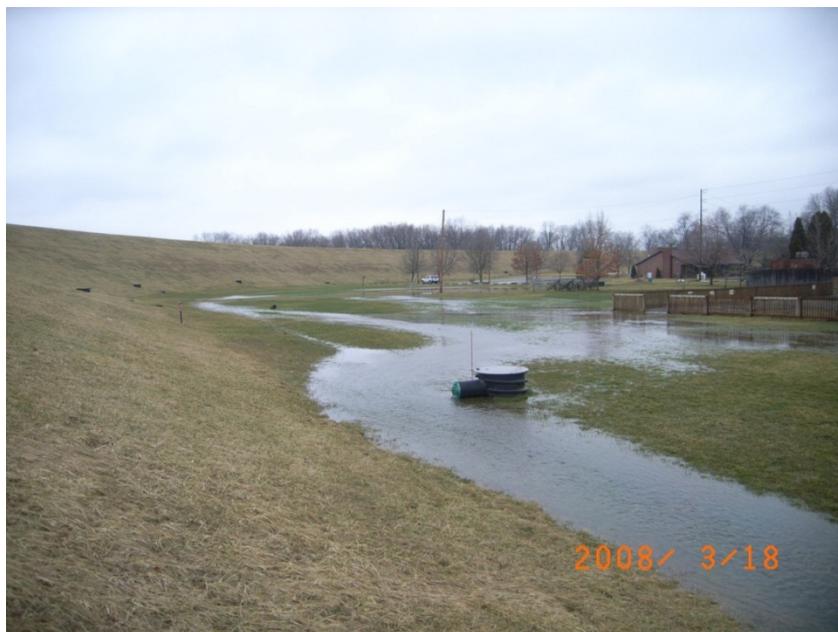
This is a photograph of standing water on interior side of the Ball Field at Zoar Levee March 2008. This is evidence of under seepage occurring. This condition was very similar to that observed in January of 2005.

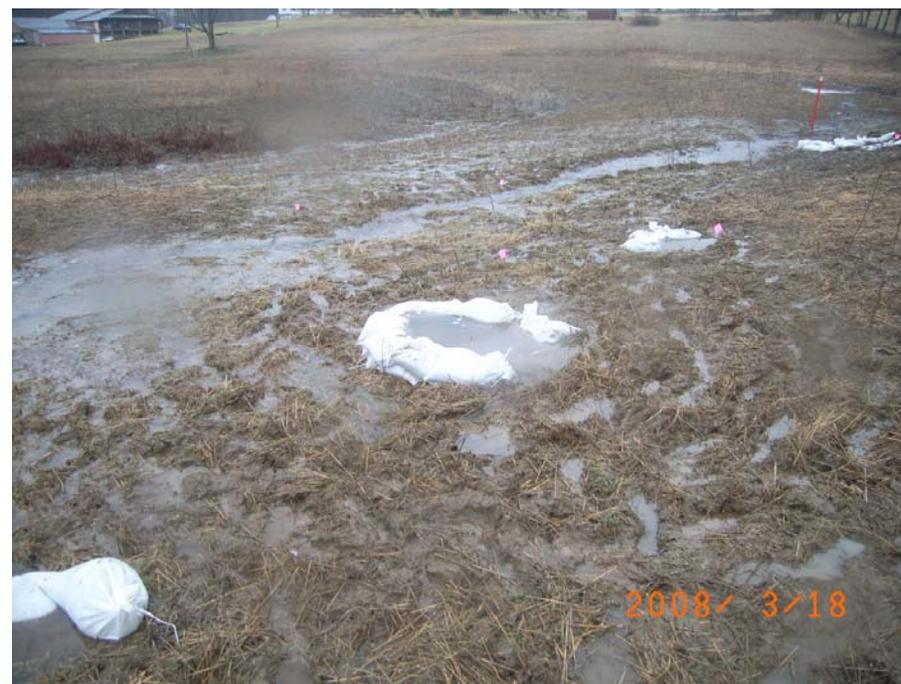
This is a photograph of water seeping on the interior side of the Rock Knoll at Zoar Levee in March 2008. Like in January 2005, water exited directly from the ground at this location in high volumes. Unlike January 2005, large boils formed in 2008. Above these boils are marked by the white rings of sandbags. These sandbag rings are deployed to stabilize the boils and keep them from increasing in size.

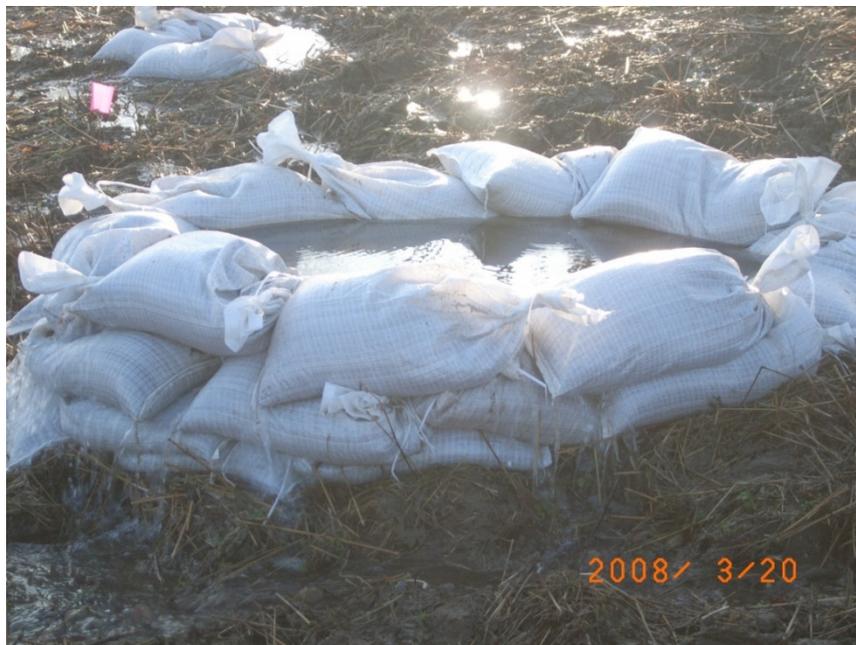
This is a photograph of another boil on the interior side of the Rock Knoll at Zoar Levee in March 2008. The amount of sandbagging employed was increased as boils continued to grow in diameter.

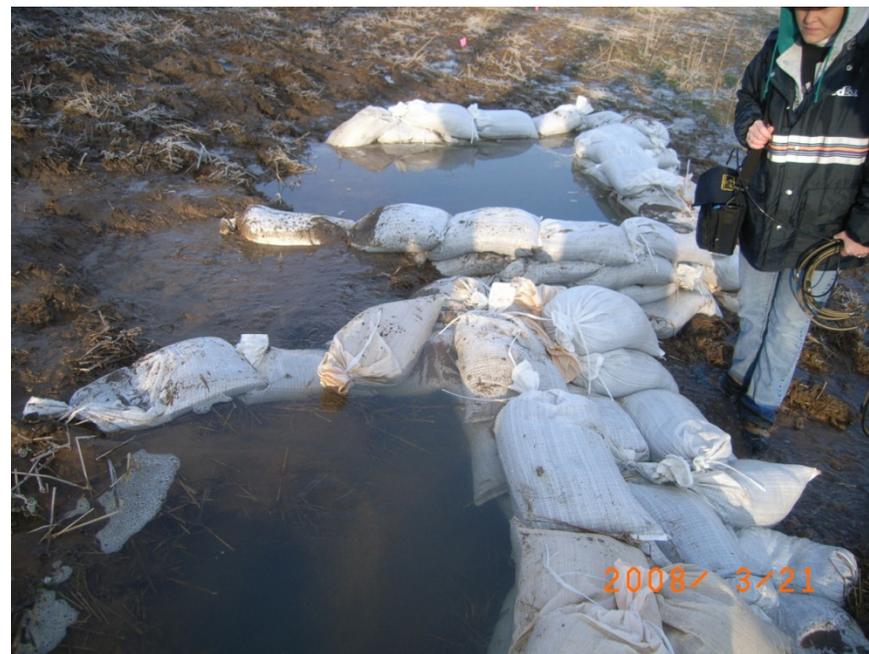
This is a photograph of boils on the interior side of the Rock Knoll at Zoar Levee in March 2008. Despite attempts to control the growing size of boils with sandbag rings, boils continued to expand rapidly, eventually coalescing into one another, forming a large seepage exit point. Approximately 5,000 gallons per minute of water and sands were flowing through these boils.

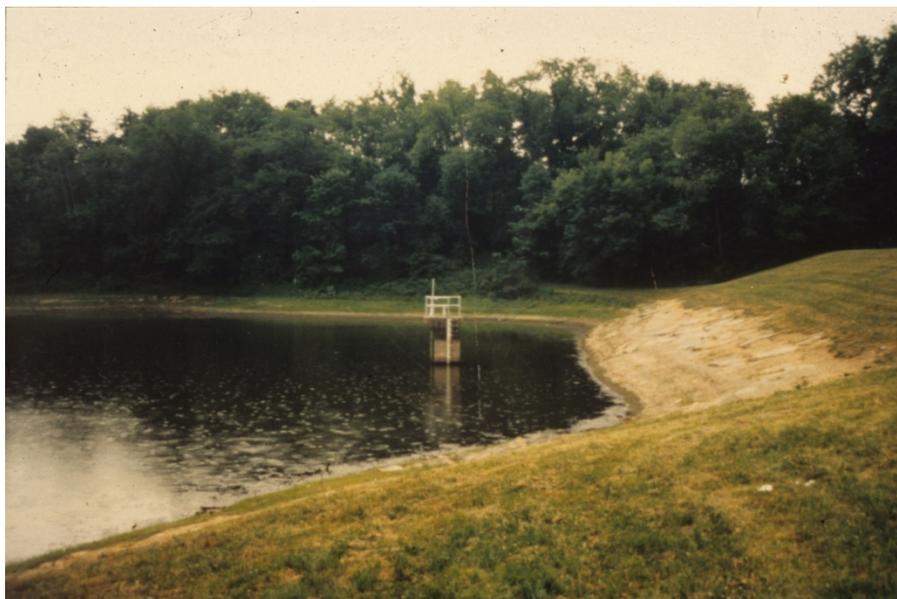
This is a photograph of Zoar Diversion Dam in 1991 when it still impounded a permanent lake.

This lake was commonly referred to as Lime Kiln or Goose Run Lake. The lake was permanently impounded to elevation 909'. The control tower can be seen in the middle ground.

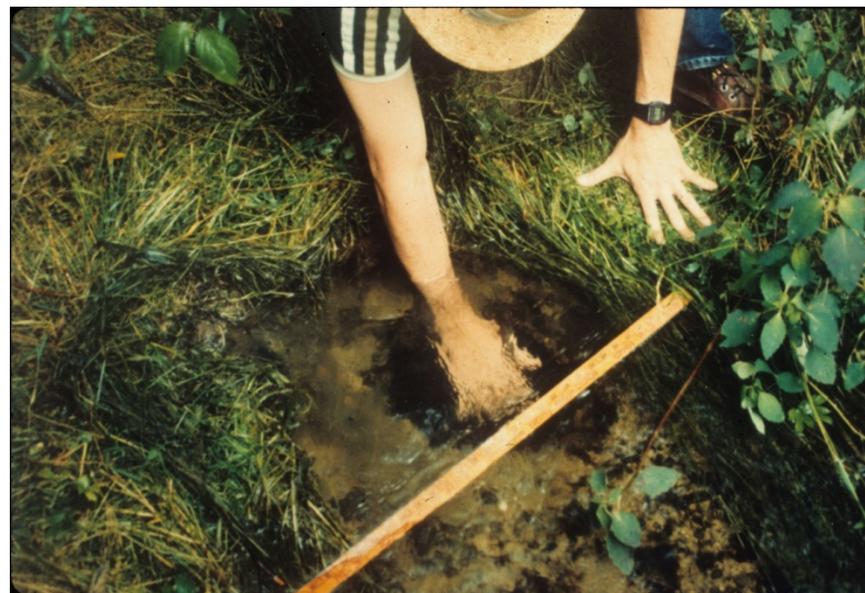
This is a photograph of a boil located downstream of Zoar Diversion Dam that was resulting from the seepage. This boil was evidence that seepage was piping. This seepage was traveling through the bedrock that the diversion dam abuts. This is referred to as “abutment seepage”. This abutment seepage partially drained the permanent impoundment from elevation 909' to elevation 906'.

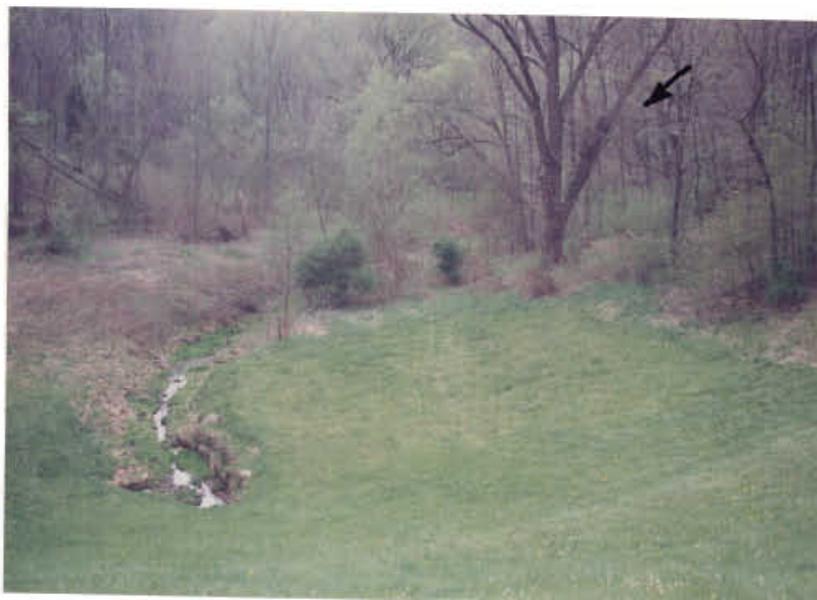
This is a photograph from the crest of the Zoar Diversion Dam looking downstream. Goose Run can be seen exiting at the toe of the dam. The black arrow is highlighting the location where seepage was occurring.

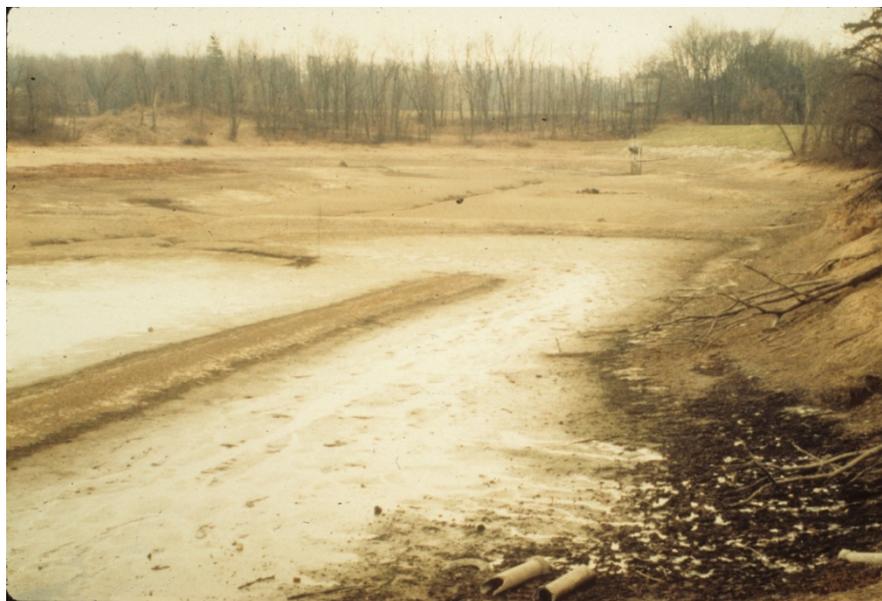
In addition to downstream treatment, in 1992 Lime Kiln or Goose Run Lake was drained to look for possible seepage entrances in the lake bed. Zoar Diversion Dam can be seen in the background.

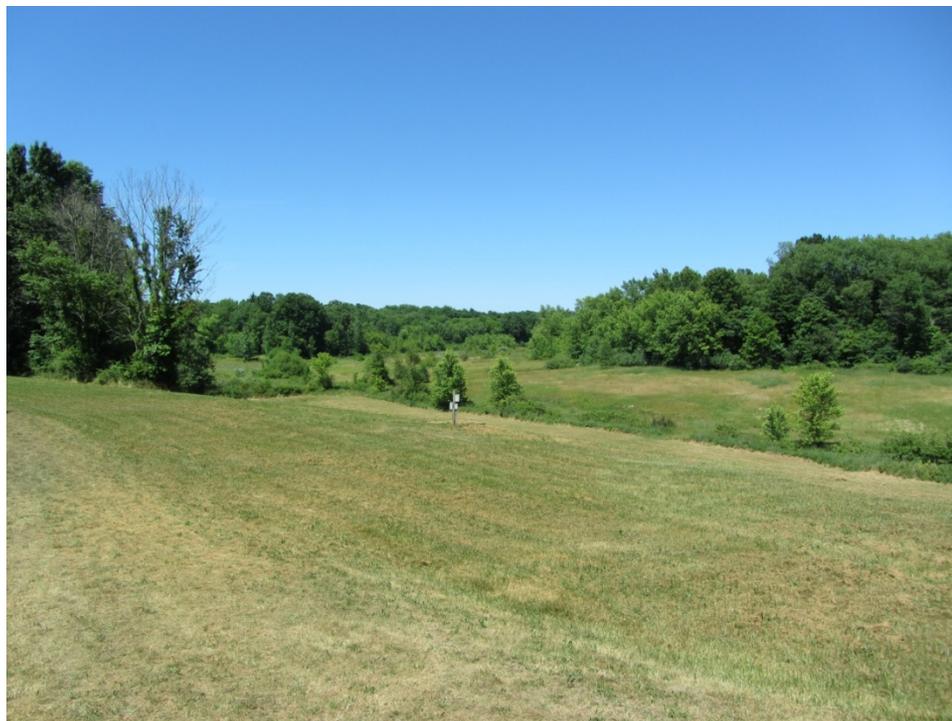
Today, Lime Kiln or Goose Run Lake remains dry. However, flashy storm events have impounded the lake without warning and with the control gate open. This is a photograph of the dry bed of Lime Kiln or Goose Run Lake in 2012. The photograph is taken from the crest of Zoar Diversion Dam.
