PERFORMANCE HISTORY

Zoar Levee

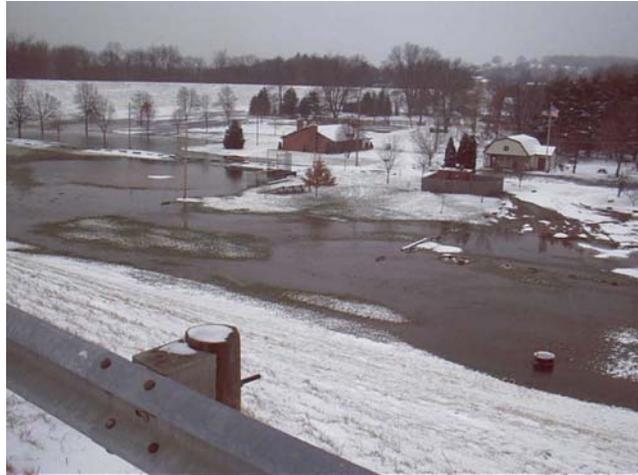
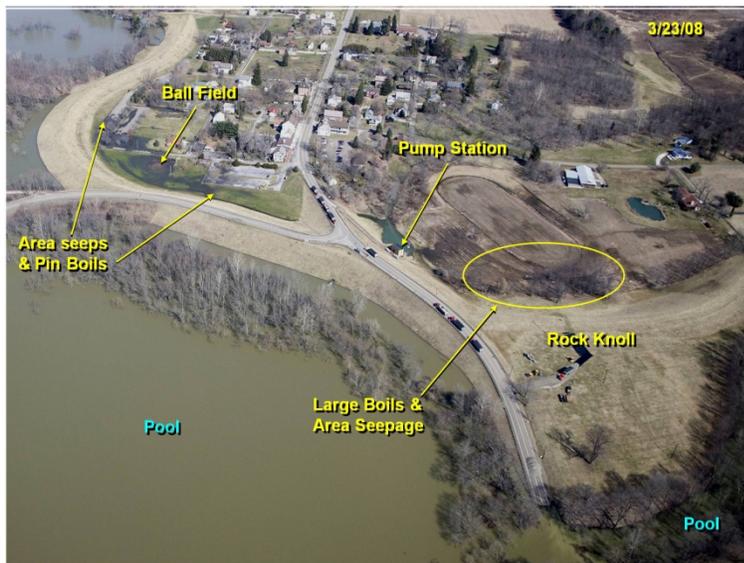
In 2005, Dover Dam retained a pool of record at elevation 907.35, which loaded water against Zoar Levee for approximately a month. Widespread small “pin” boils were noted on the Ball Field reach and more significant boils were found on the Rock Knoll reach of the levee. To remediate the piping of material exiting these boils, they were ringed with sand bags and a filter fabric was added to the landward toe of the levee. A Screening Portfolio Risk Analysis (SPRA) of Zoar Levee and Diversion Dam concluded after this event that Zoar Levee was a DSAC II, as boils and piping indicated that the project was progressing toward failure.

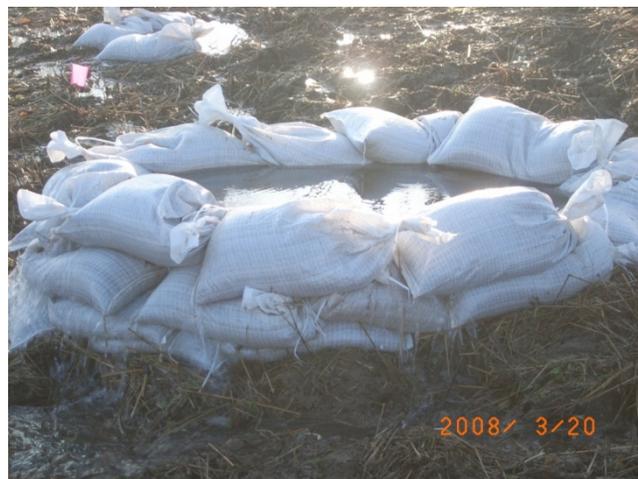
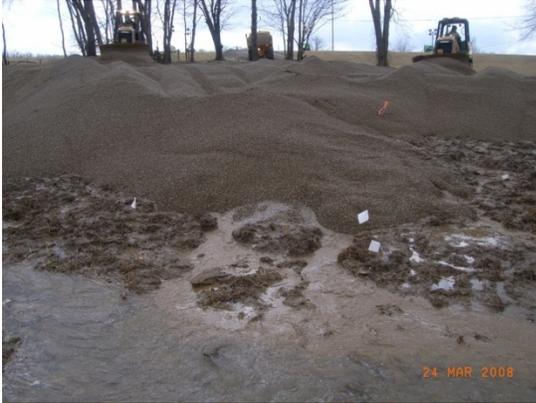
Early during the 2008 event, each boil on the Rock Knoll reach was sand-bagged and channelized flow of seepage developed. As the pool elevation increased during the next two weeks the number of boils, the

size of the boils, and the total quantity of seepage across the area increased significantly. Boils repeatedly expanded beyond and collapsed sandbag rings, and coalesced at multiple project locations into large unstable regions.

The area seepage and boils extended along a line approximately 550 ft. long, parallel with the levee centerline, for a total of around 5,000 gpm of flow at its peak. Flood fighting with sandbag rings was employed for two and a half weeks, while Dover Dam’s pool rose from approximately el. 894 to 904.6. Several boils grew to 1.5 ft. in diameter and produced up to 300 gpm each moving a significant amount of

foundation soils. As smaller boils began to coalesce into larger boils capable of moving foundation material faster and large unstable regions were developing, the decision was made to install a \$1.26 million seepage berm with 37,000 tons of granular material.

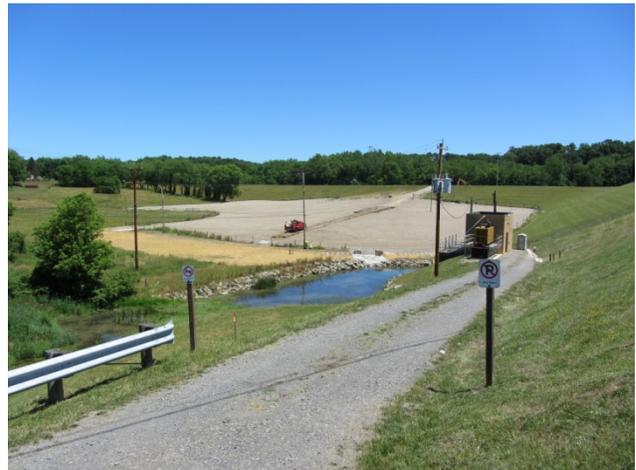
At the same time, widespread small boils and pervasive area seepage were again observed on the Ball Field reach of the levee, but no immediate flood fighting actions were taken. The boils were

generally observed from within 150 ft. of the levee toe. This scenario was very similar to what occurred in 2005. The boils were monitored for about three and a half weeks, but did not expand to the point they were carrying large amounts of soil.

This event resulted in Zoar Levee and Diversion Dam being reclassified as a DSAC 1 project, as progression toward failure had been confirmed. The DSAC I rating was subject to an Independent External Peer Review (IEPR) and confirmed (Battelle 2010).

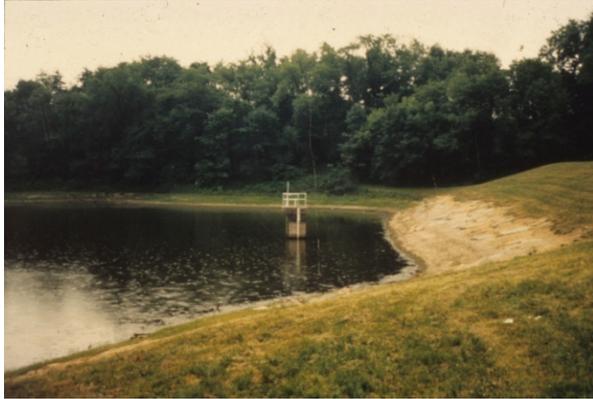
In 1970, during the first periodic inspection, clear seepage was noted exiting at the downstream toe near the outlet conduit. By 1976, the seepage exit had progressed upslope to a location 8 ft. above the toe and the toe area was described as being saturated.

In 1978, major remedial measures were undertaken which consisted of:

- Installing a toe drain system
- Lowering of the outlet channel to provide positive drainage from the outlet headwall.
- Repairing gullies on the downstream slope.
- Regrading the upstream slope and providing wave protection with large stone

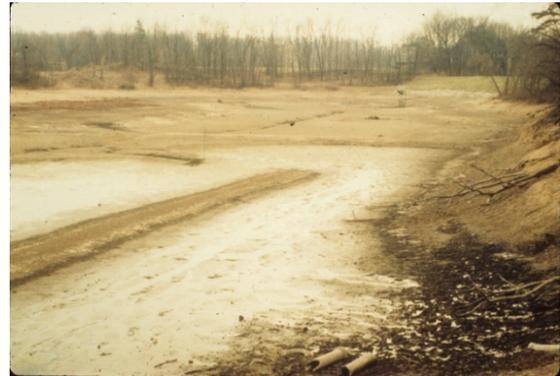
In 1989, seepage of 50-100 gpm was reported 300 ft downstream of the conduit outlet on the right side, exiting at several points. By 1990, flow had increased to 150-200 gpm. During the spring and summer of 1991 the seepage caused the lake level to drop significantly before leveling off at el. 906. The flow had peaked at 500 gpm and a large vertical piping cavity had developed. Studies were begun, including a seepage tracing study that confirmed a connection between pool and seepage.

In 1993, after an Embankment Re-Analysis was conducted to study the seepage problems, repairs were implemented which included installation of an upstream impervious geomembrane along the upstream right abutment of the dam, construction of an access road to the downstream area, and installation of a seepage berm with collection system downstream of the dam extending along the right abutment to the area of seepage.
