Huntington District

PERFORMANCE HISTORY

Zoar Levee

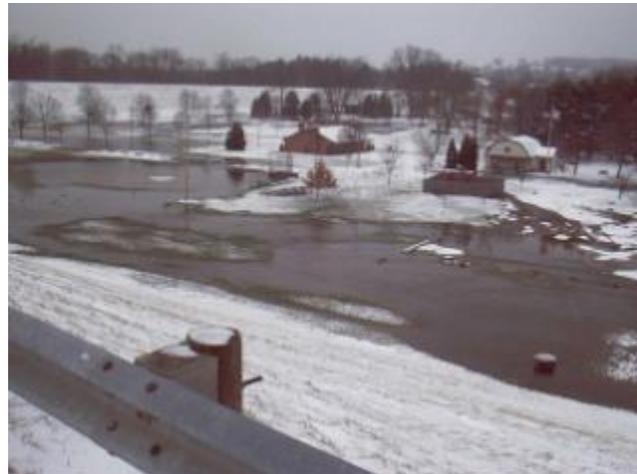
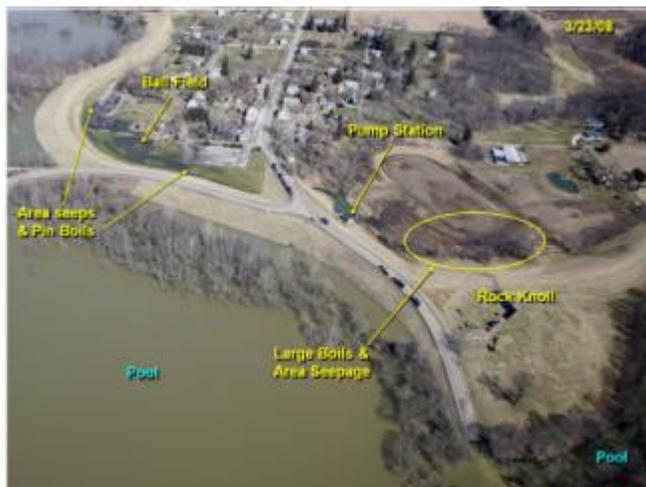
In 2005, Dover Dam retained a pool of record at elevation 907.4 feet, which loaded water against Zoar Levee for approximately a month. Widespread small “pin” boils were noted on the Ball Field reach and more concentrated seepage was found on the Rock Knoll reach of the levee. The District installed rings of sand bags around the seeps and attempted to place a small granular filter berm to reduce the movement of soil particles. A Screening Portfolio Risk Assessment (SPRA) of Zoar Levee and Diversion Dam assigned Zoar Levee a DSAC II classification, citing “extensive seepage and small boils” and rating both the levee and Diversion Dam as “Probably Inadequate” for seepage and piping under “Normal” loading conditions.

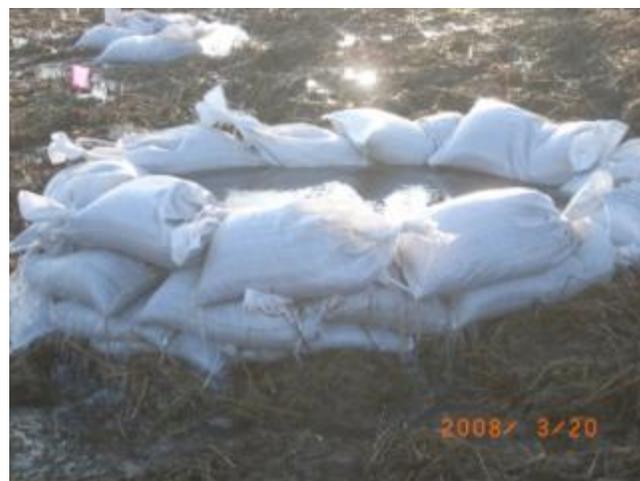
Flood fighting with sandbag rings was employed for two and a half weeks, while Dover Dam’s pool rose from approximately elevation 894 feet to elevation 904.6 feet and several boils grew to 1.5 feet in diameter. It was estimated by the Geotechnical Engineers on site that some boils produced up to 300 gallons per minute (gpm) each; moving a significant amount of foundation soils. Without having the benefit to be able to interpret whether

the seepage was flowing solely through bedrock or dangerously along the bedrock/soil contact, the changing locations and increasing seepage quantities were considered as just cause to declare an emergency. Under an emergency situation, it was decided to install a \$1.26 million seepage berm with 37,000 tons of granular material.

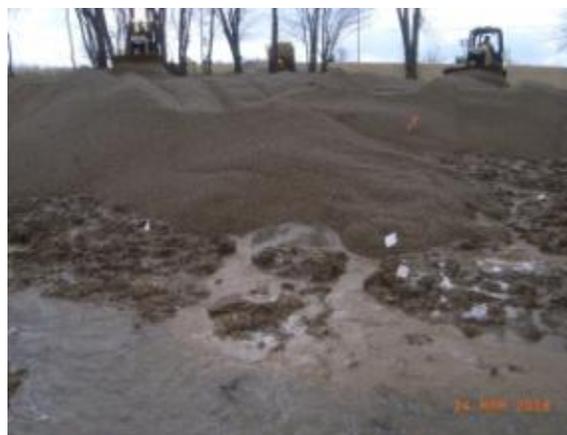
At the same time, widespread small boils and pervasive area seepage were again observed on the Ball Field reach of the levee, but no immediate flood fighting actions were taken. This scenario was very similar to what occurred in 2005. The boils were monitored for about three and a half weeks, but did not expand.

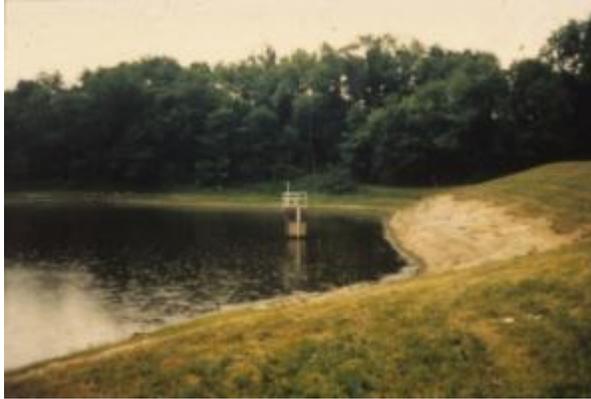
In 1989, seepage of 50-100 gallons per minute (gpm) was reported 300 feet downstream of the conduit outlet on the right side, exiting at several points. By 1990, flow had increased to 150-200 gpm. During the spring and summer of 1991 the seepage caused the lake level to drop significantly before leveling off at elevation 906 feet. The flow had peaked at 500 gpm and a large vertical piping cavity had developed. Studies were begun, including a seepage tracing study that confirmed a connection
