US Army Corps
of Engineers ®

PERFORMANCE HISTORY

Zoar Levee

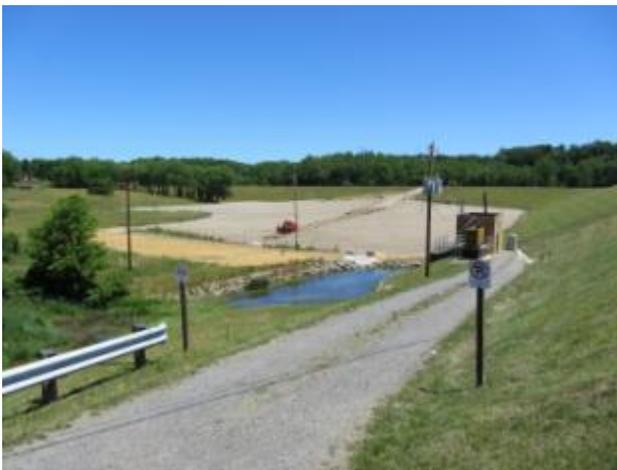
At the same time, widespread small boils and pervasive area seepage were again observed on the Ball Field reach of the levee, but no immediate flood fighting actions were taken. This scenario was very similar to what occurred in 2005. The boils were monitored for about three and a half weeks, but did not expand.

This event resulted in Zoar Levee and Diversion Dam being reclassified as a DSAC 1 project, as progression toward failure was believed to be potentially occurring.

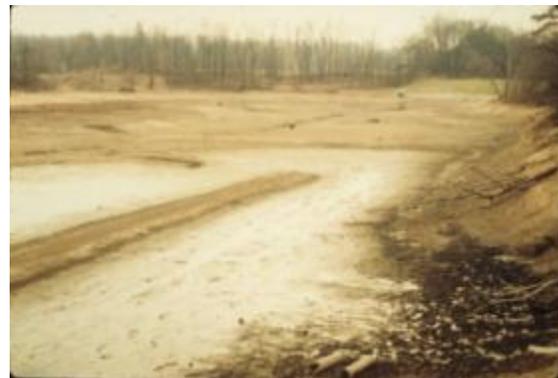
In 1989, seepage of 50-100 gallons per minute (gpm) was reported 300 feet downstream of the conduit outlet on the right side, exiting at several points. By 1990, flow had increased to 150-200 gpm. During the spring and summer of 1991 the seepage caused the lake level to drop significantly before leveling off at elevation 906 feet. The flow had peaked at 500 gpm and a large vertical piping cavity had developed. Studies were begun, including a seepage tracing study that confirmed a connection

between pool and seepage.

In 1993, after an Embankment Re-Analysis was conducted to study the seepage problems, repairs were implemented which included installation of an upstream impervious geomembrane along the upstream right abutment of the dam, construction of an access road to the downstream area, and installation of a seepage berm with collection system downstream of the dam extending along the right abutment to the area of seepage.

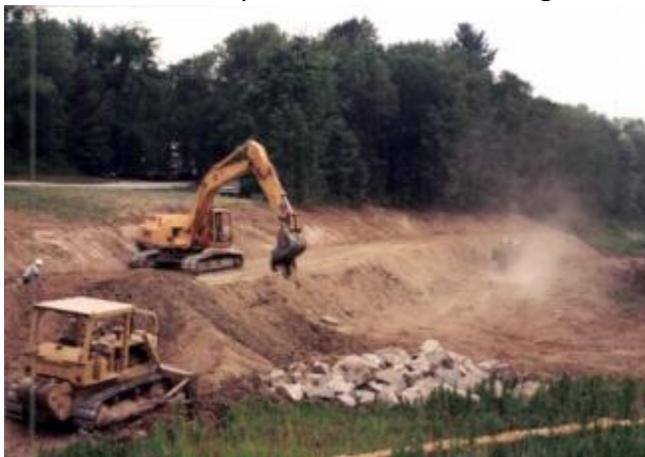
In 1997, an analysis was completed to study Zoar Diversion's flood storage capacity and potential for being overtopped. This study recommended that the impounded Goose Run Lake be drained and a permanent lake no longer retained. The gate has remained open ever since,

and the only known pools retained occurred in spring 2011 (3 very flashy pools as high as elevation 909 feet). No concerns were noted during these pools, but only limited observation was possible due to the lack of warning.
