Archaeology at Jenkins House

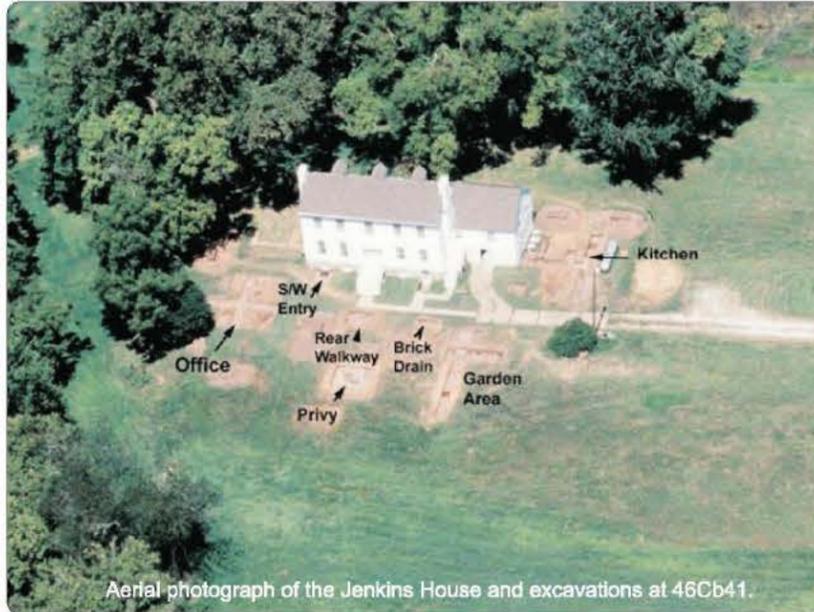
Aerial photograph of the Jenkins House and excavations at 46Cb41.

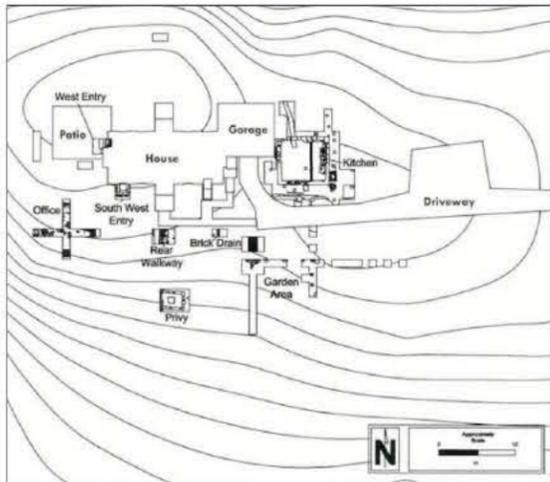
Plan drawing of historic features at 46Cb41.

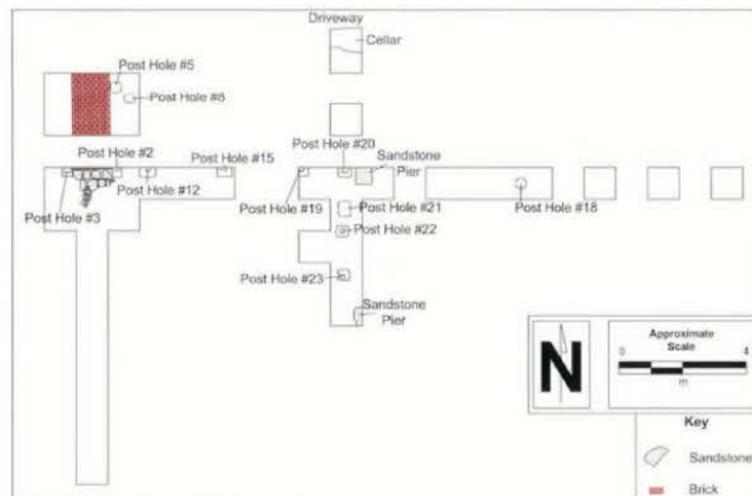
Plan drawing of brick walkway and garden area excavations.

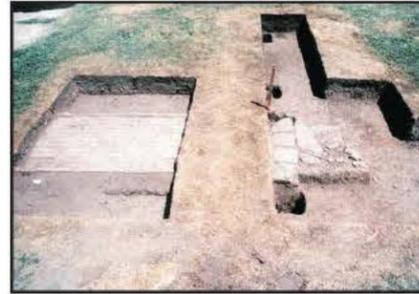
Garden walkway and postholes

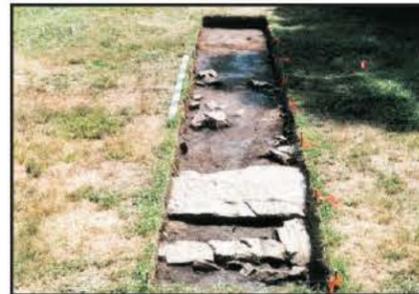
Office excavations looking south showing intact stone wall and possible step.

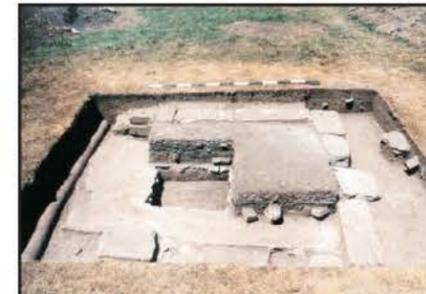
Privy structure (looking north)
