SUPPLEMENTAL DRAFT ENVIRONMENTAL IMPACT STATEMENT
BLUESTONE DAM SAFETY MODIFICATION

HINTON, WEST VIRGINIA

VOLUME III: APPENDICES H through L

**PHASE I ENVIRONMENTAL SITE ASSESSMENT
BLUESTONE DAM
CONTRACTOR WORK LIMITS (CWL)
DAM SAFETY MODIFICATION STUDY
HINTON, WEST VIRGINIA
JUNE 2016**

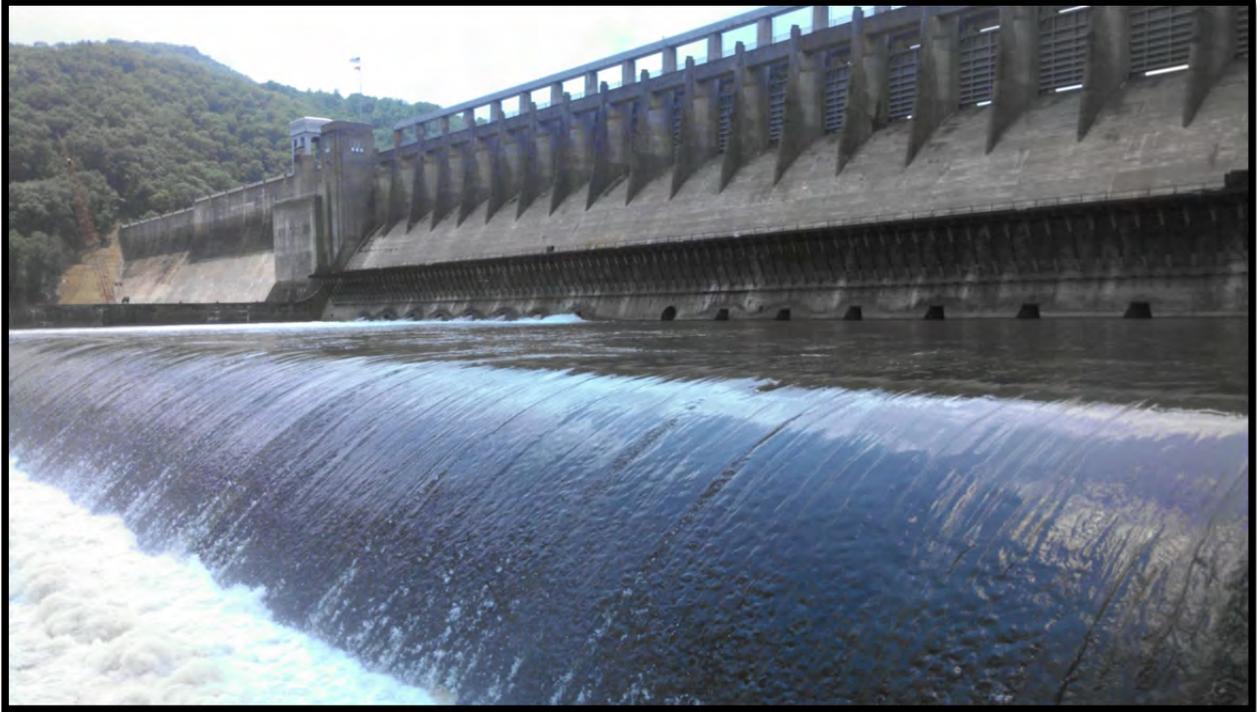
Photograph 1: Bluestone Dam (Reconnaissance Area 1).

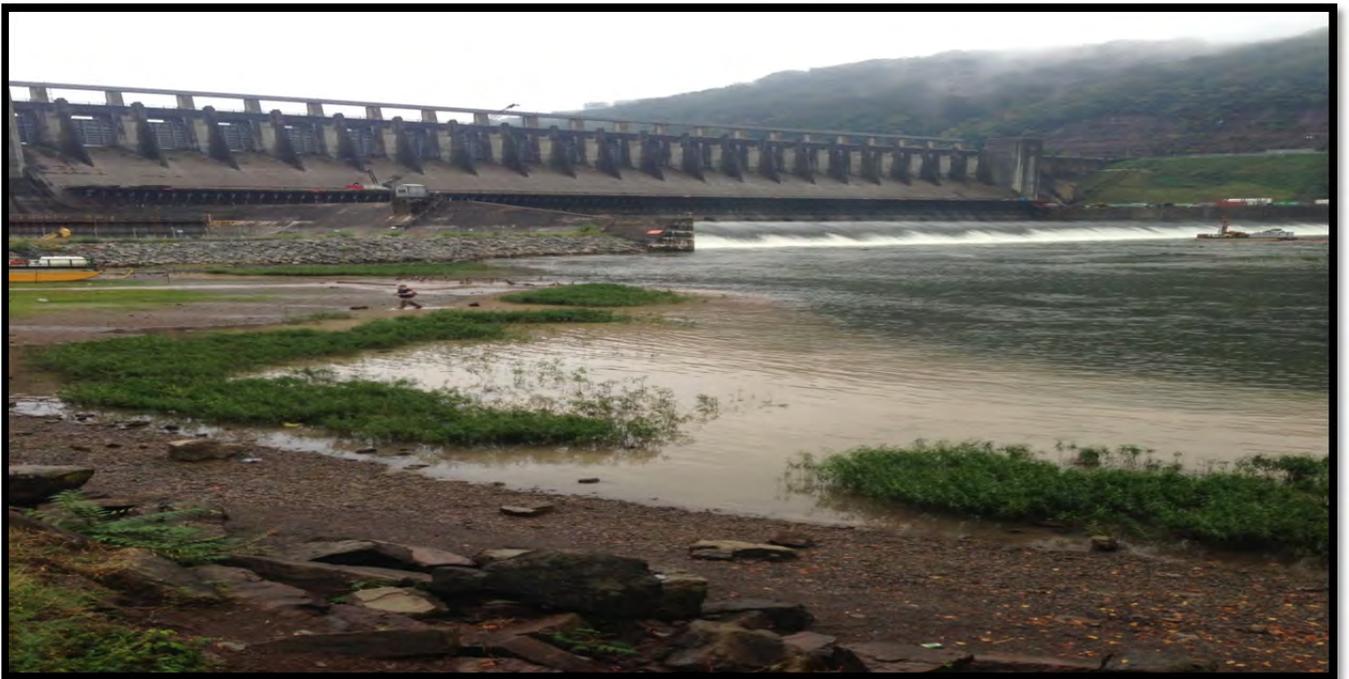
Photograph 6: Overview of Bluestone Dam (Reconnaissance Area 1).

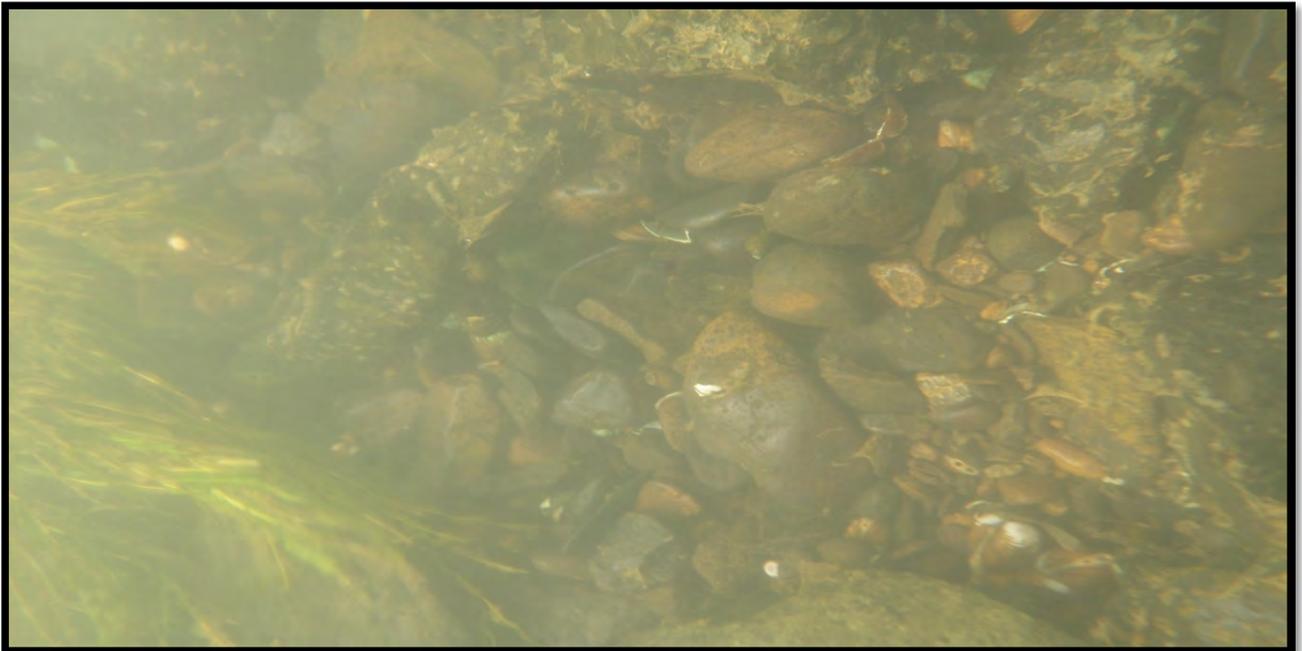
Photograph 12: Gravel and rubble substrate from the tailwaters (Reconnaissance Area 1).

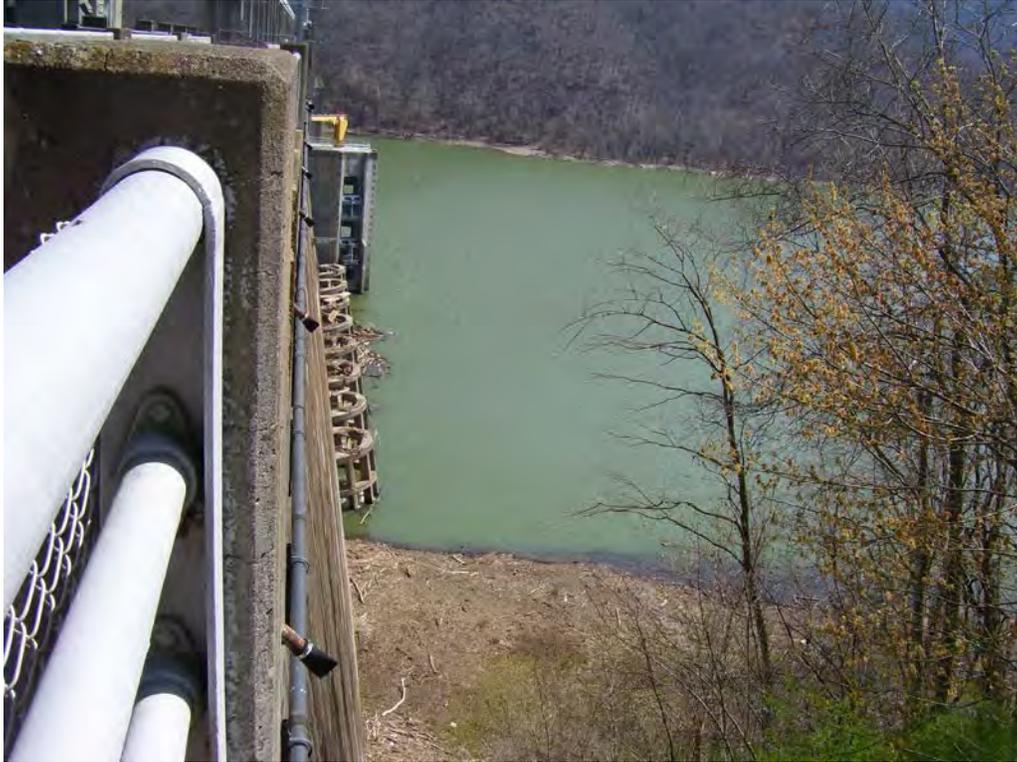
**Photo BLN01 – CWL Behind Dam
24 March 2016**

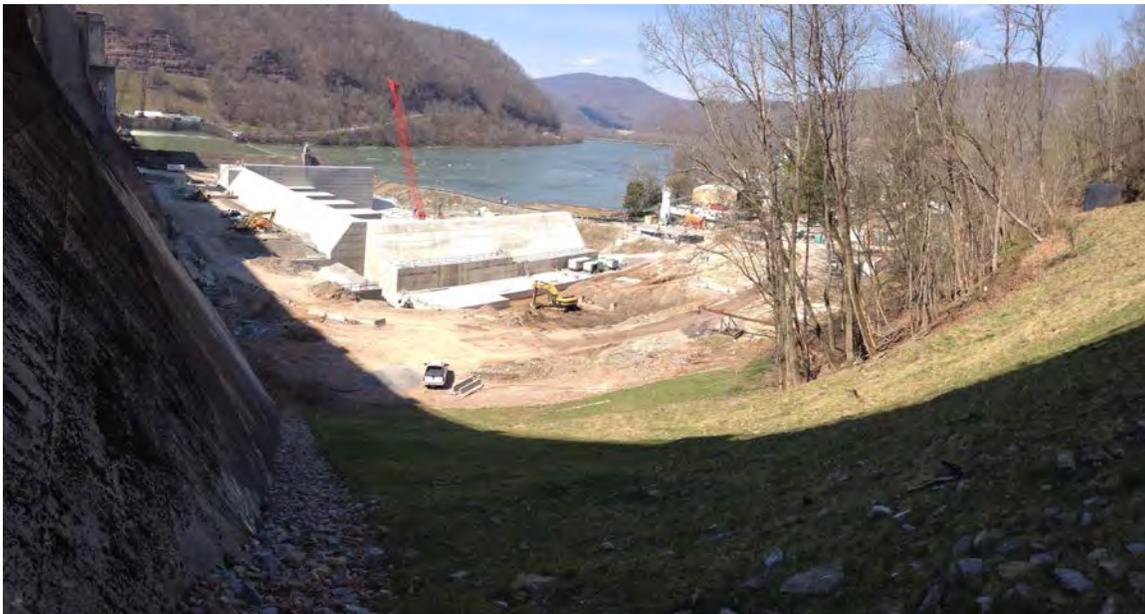
**Photo BLN08 – Phase 3 CWL Adjacent to Dam and Emergency Stilling Basin
Downstream Right Bank
24 March 2016**

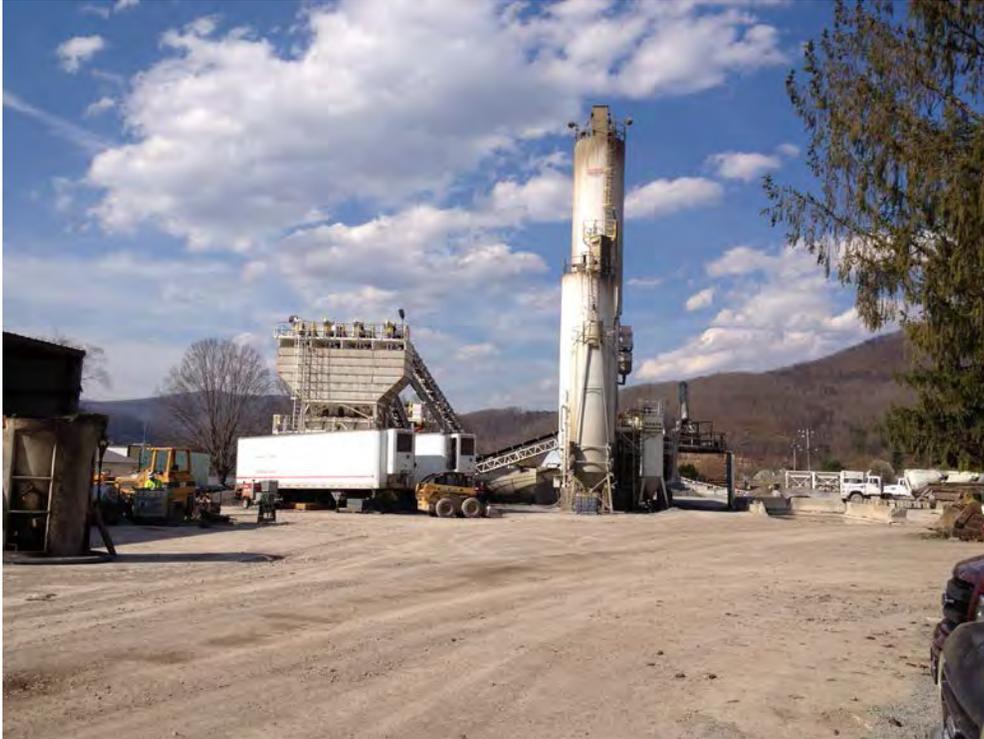
**Photo BLN11 – Phase 3 Contractor’s Concrete Plant Downstream Right Bank
24 March 2016**

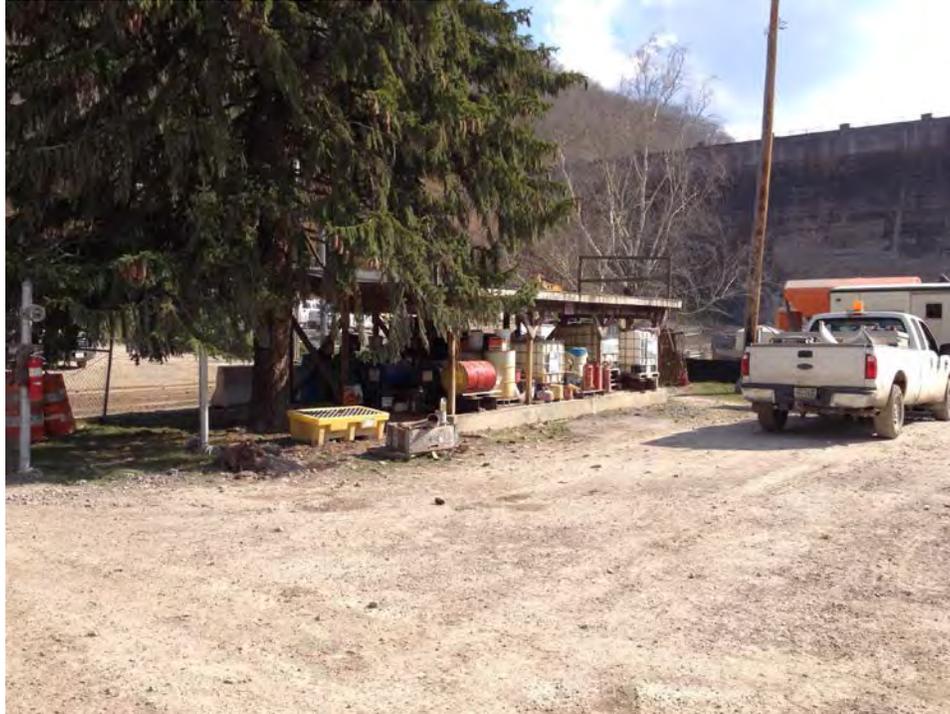
**Photo BLN13 – Phase 3 Contractor’s Petroleum Containment Area
Downstream Right Bank
24 March 2016**

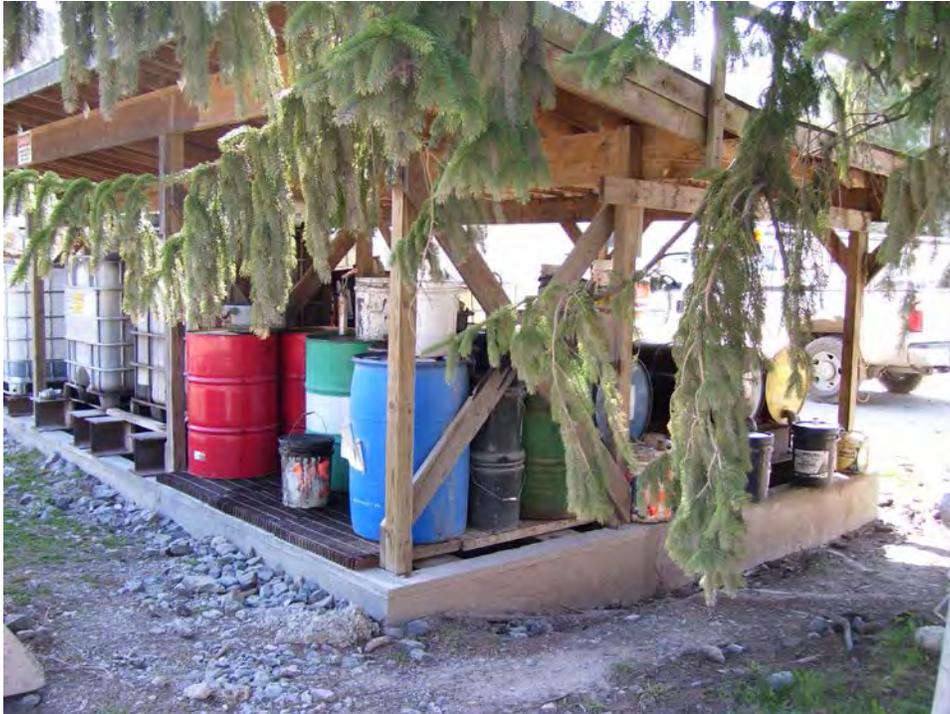
**Photo BLN14 – Phase 3 Contractor’s Petroleum Containment Area
Downstream Right Bank
24 March 2016**

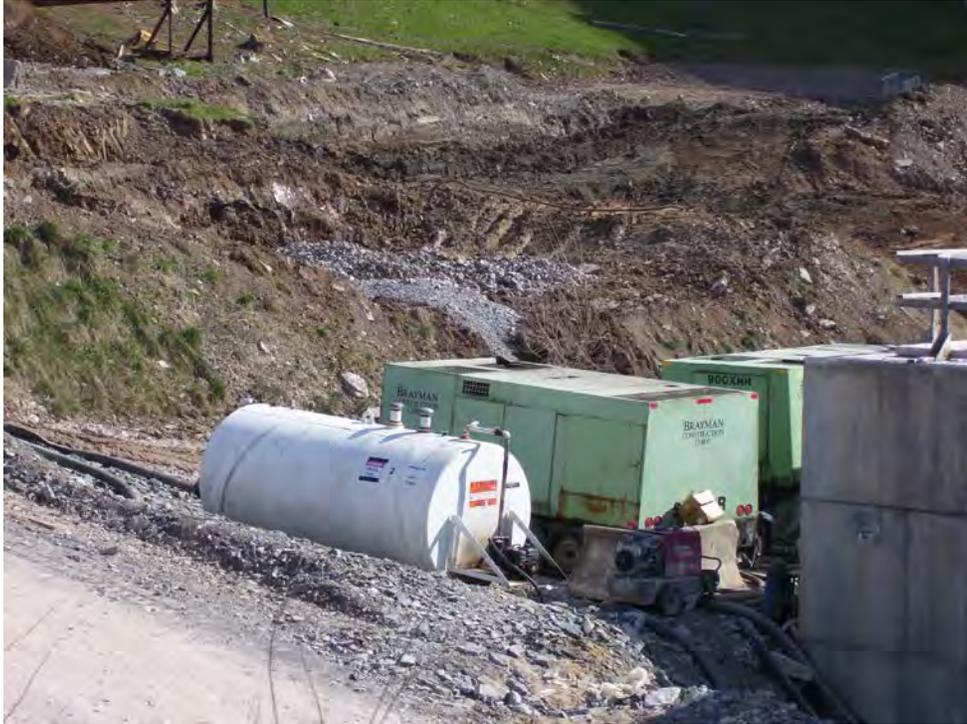
**Photo BLN15 – Phase 3 Contractor Diesel AST Adjacent to Emergency Stilling Basin Downstream Right Bank
24 March 2016**

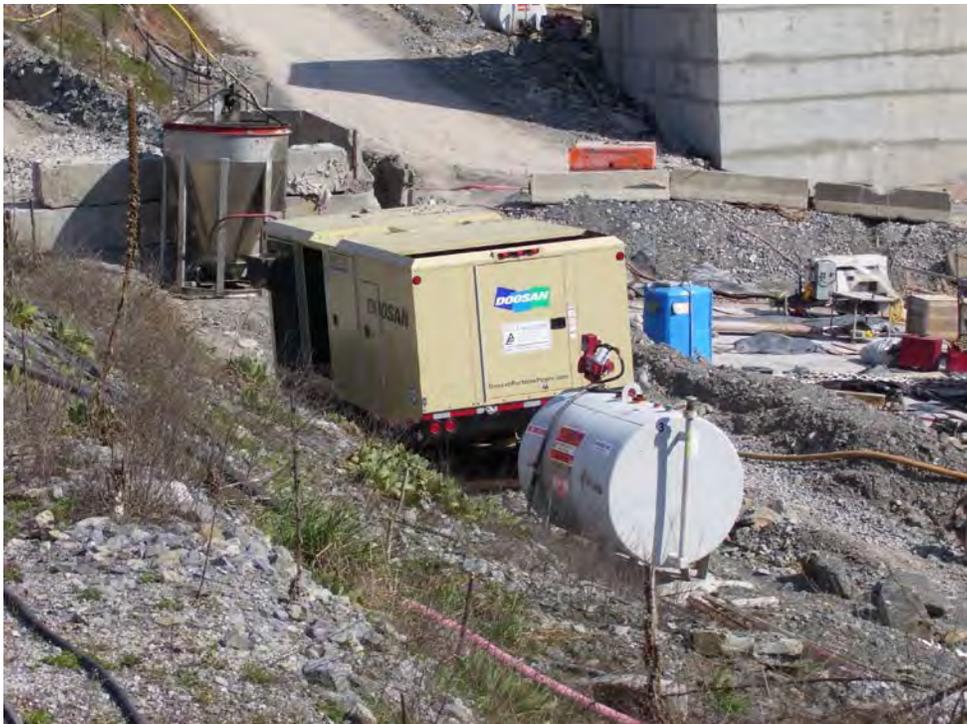
**Photo BLN16 – Phase 3 Contractor Diesel AST Adjacent to Emergency Stilling Basin Downstream Right Bank
24 March 2016**

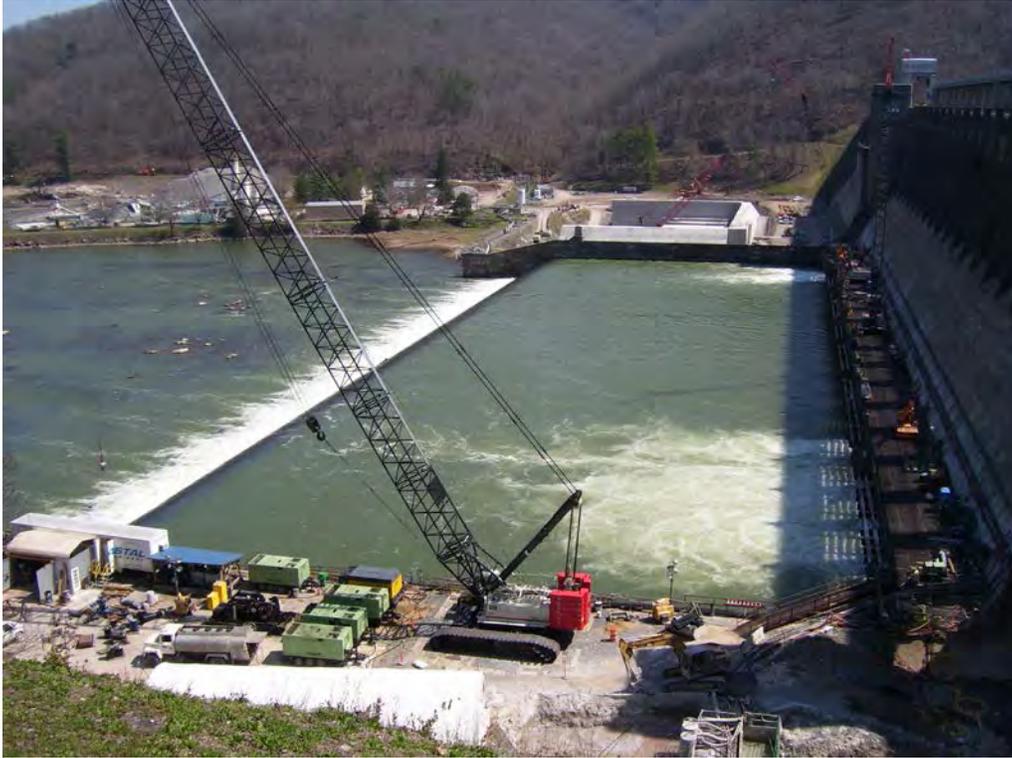
**Photo BLN17 – Phase 4 CWL Adjacent to Dam Left Bank and Stilling Basin
24 March 2016**
