# 2008-2012 PRESERVATION ACTIVITIES AT THE JENKINS HOUSE GREEN BOTTOM, WEST VIRGINIA

JENKINS  
PLANTATION  
MUSEUM  
for  
U.S. ARMY  
CORPS OF  
ENGINEERS  
GREEN BOTTOM  
WEST VIRGINIA

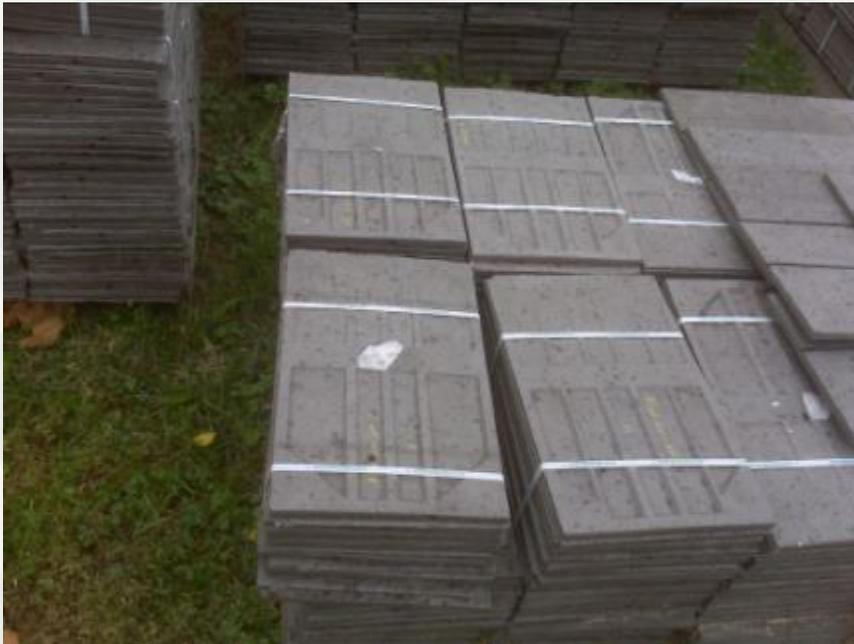
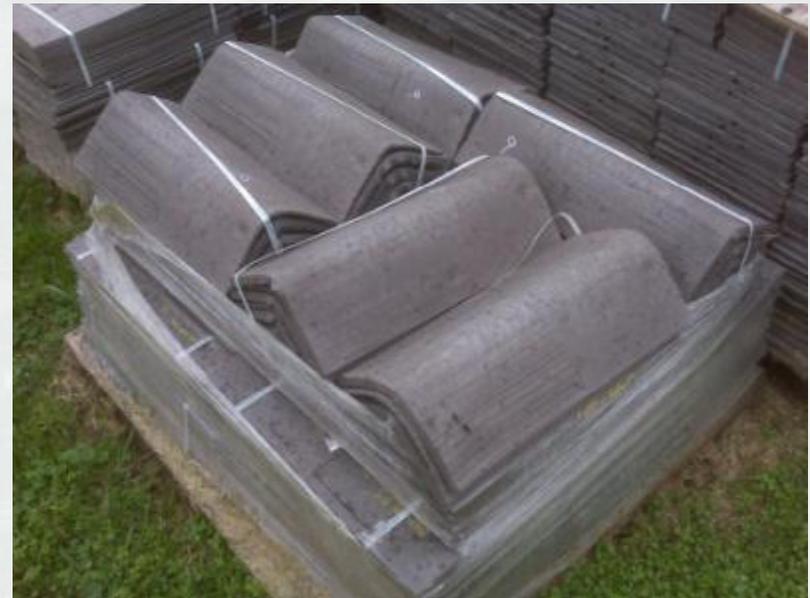
# NEW ROOF

REPLACEMENT OF ROOF WITH A PERIOD-APPROPRIATE COMPOSITE SHINGLE

Weathering Protection

Long-life material

Mimics color, texture, and dimension to original wood shingles

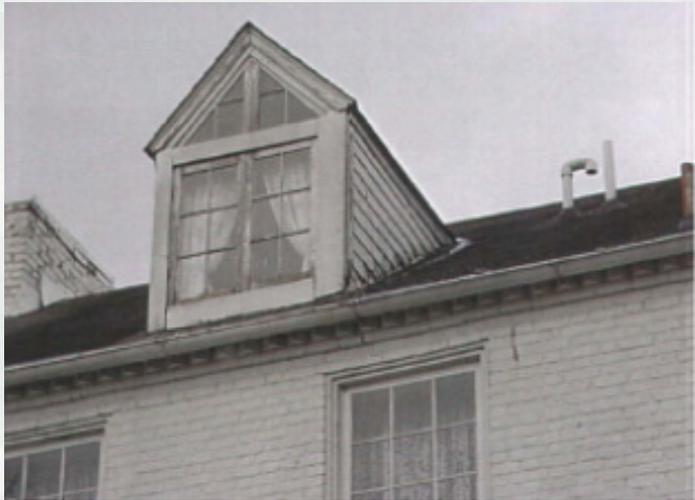
# REMOVE DORMERS

Point of moisture infiltration

Dormers were not from historical period of significance

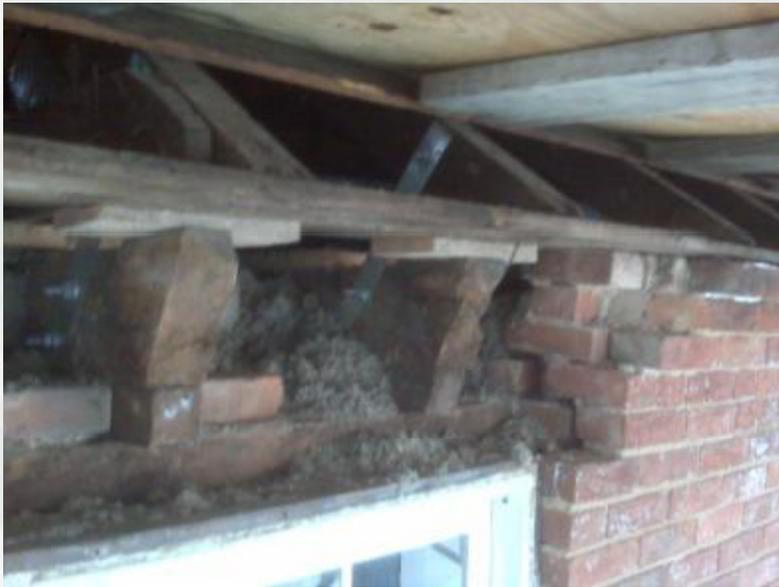
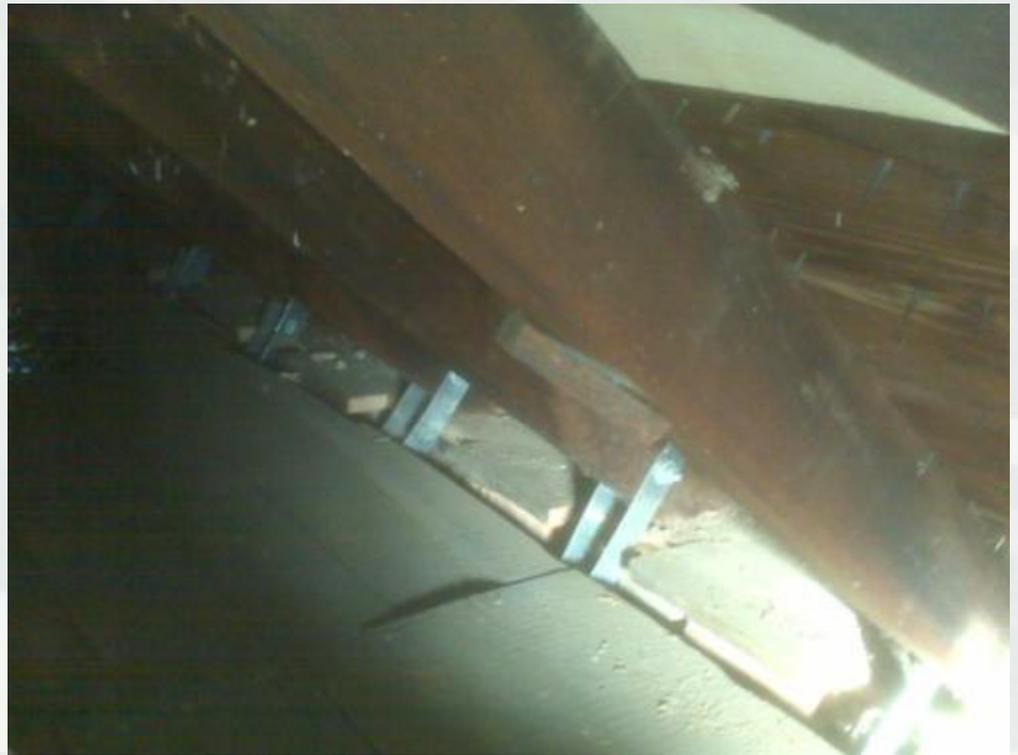
# REMOVE GARAGE

REMOVAL OF N GARAGE TO ACCESS TO EAST-SIDE OF BUILDING TO COMPLETE RE-POINTING OF BRICK AND FOUNDATION STONES.

ALSO REMOVED 1935 ADDITION FROM THE HOUSE – ACTS AS RESTORATION ACTIVITY

ALSO ALLOWED FOR CAREFUL REMOVAL AND SAFE STORAGE OF STONE BASE FOR RE-USE DURING RECONSTRUCTION

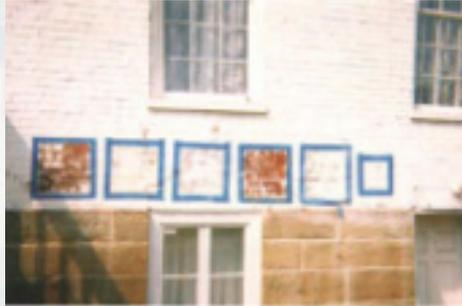
# PAINT REMOVAL

REMOVAL OF PAINT TO REPOINT  
ALSO PREVENTS MOISTURE ENTRAPMENT

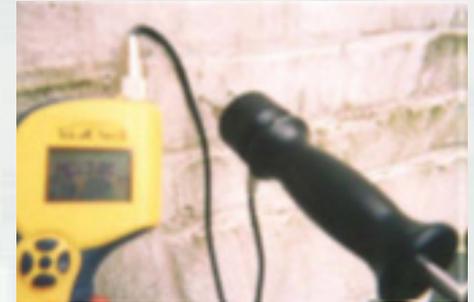
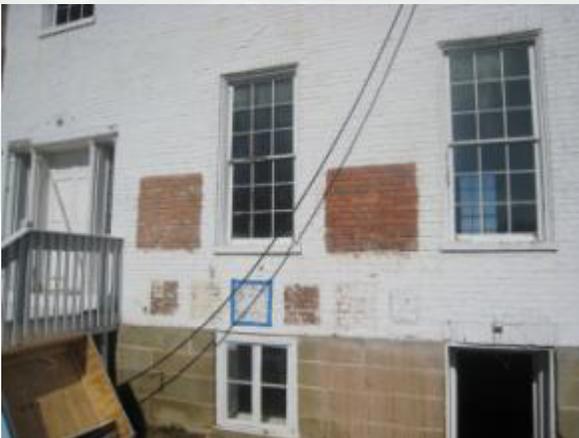
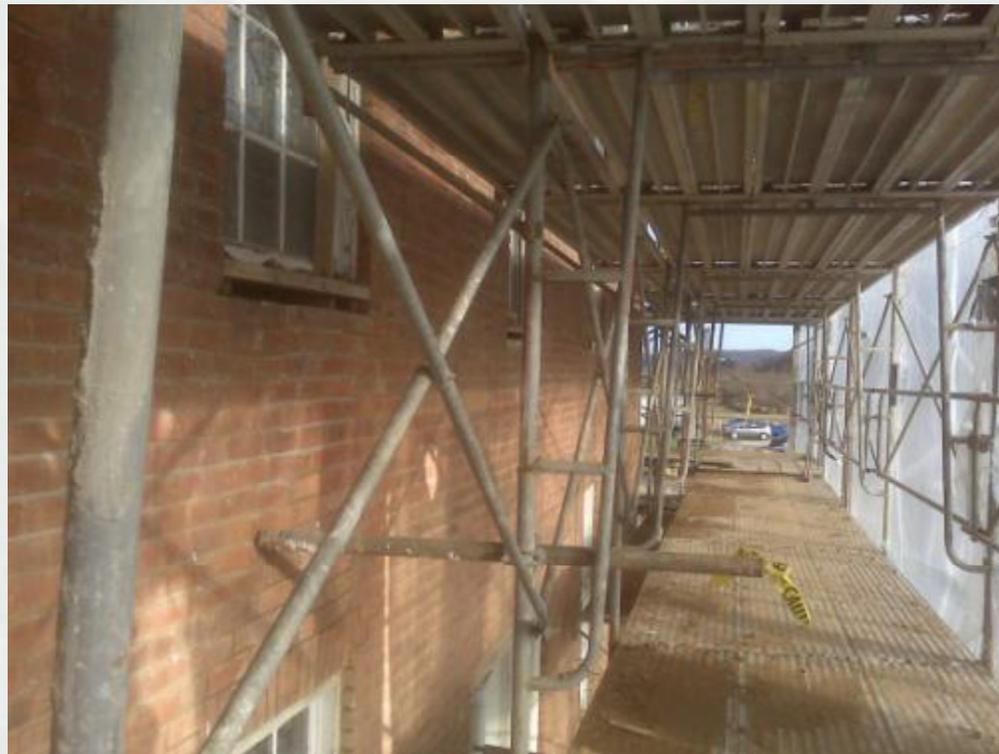
ACTS AS RESTORATION ACTIVITY

AS MANY AS SIX TREATMENTS USED

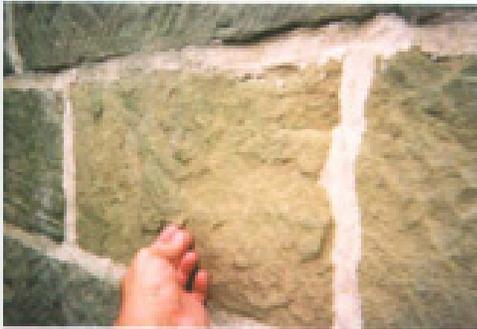
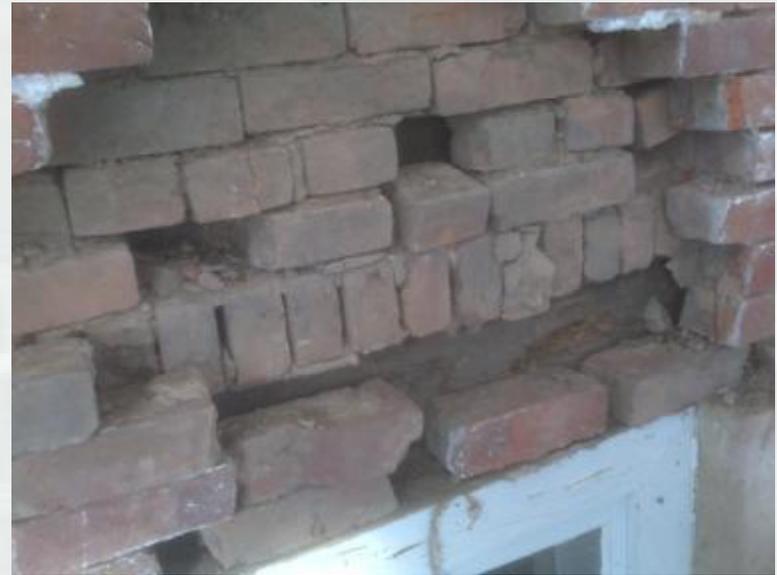
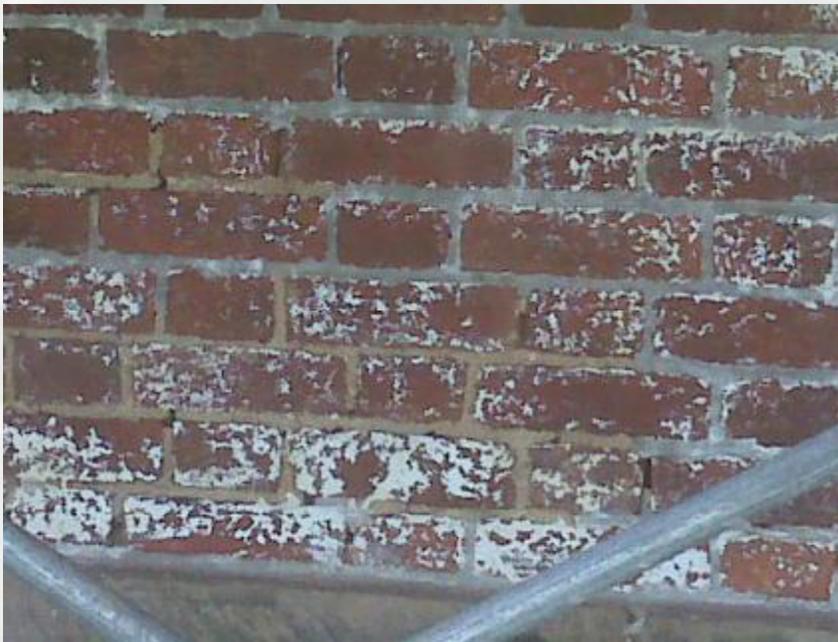
# TOTAL REPOINTING

USE LIME-BASED MORTAR TO STABILIZE AND STEM ONGOING DAMAGE FROM PAST INTERVENTIONS WITH INAPPROPRIATE MATERIAL

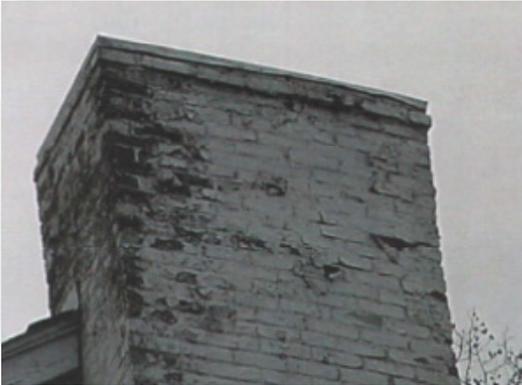
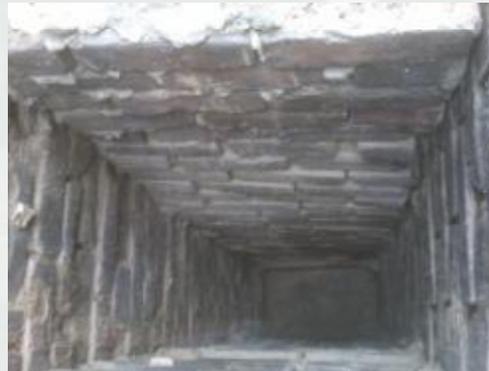
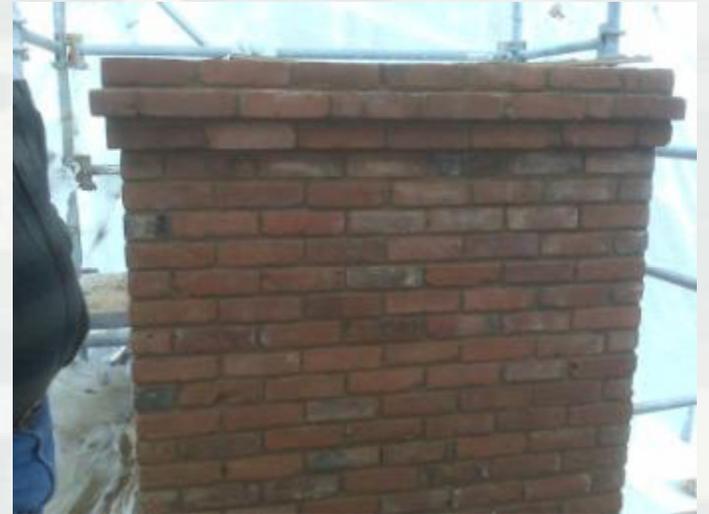
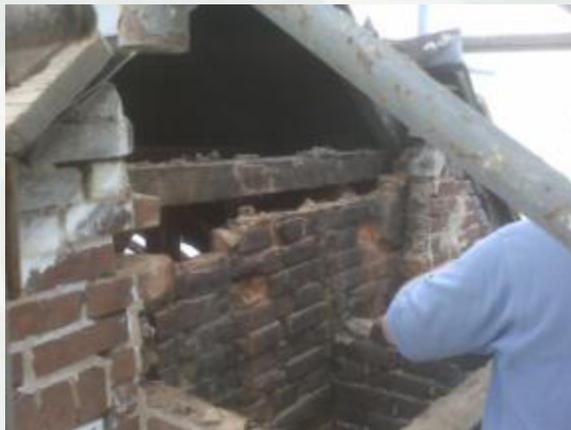
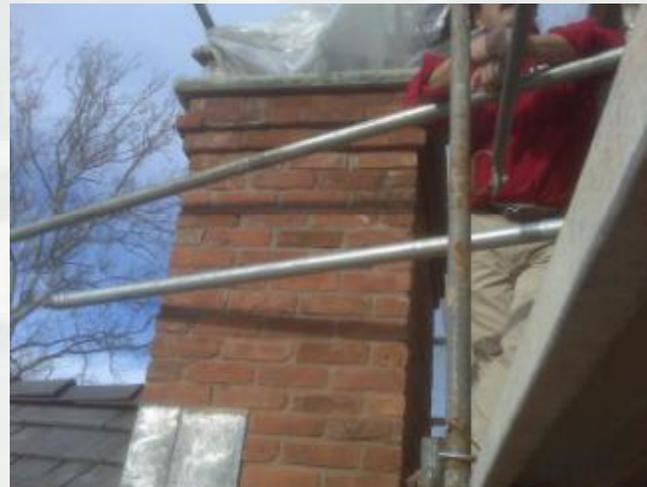
# RECONSTRUCT CHIMNEYS

REBUILD TOP CHIMNEYS FROM SHOULDER UP  
THEY WERE STRUCTURALLY UNSOUND  
PREVENT FUTURE MOISTURE PENETRATION

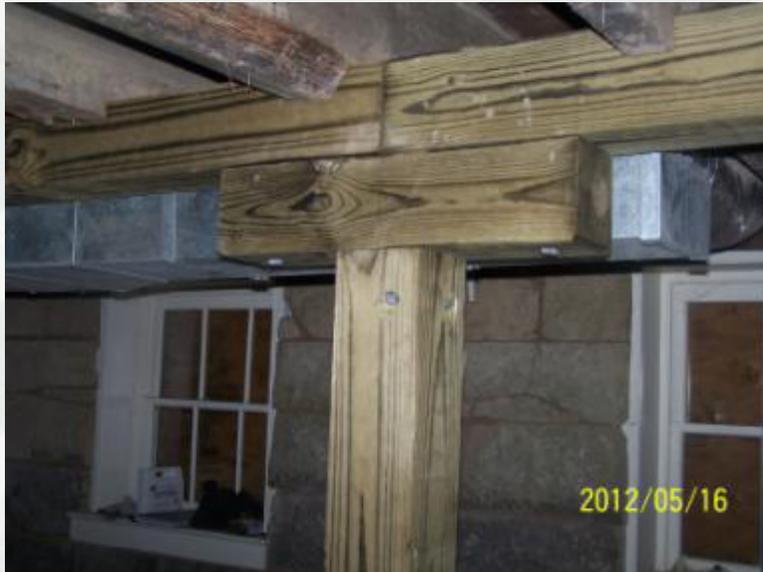
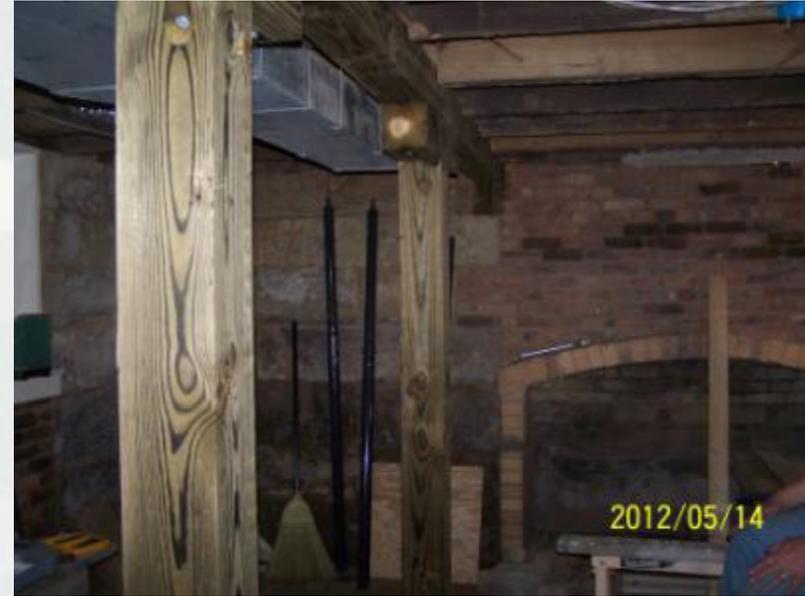
# INCREASED STRUCTURAL LOADING

INSTALLED TIMBER SHORING FOR FIRST FLOOR,  
SISTERED JOISTS

REPLACED DISTRESSED FLOOR BOARDS
