Formerly Used Defense Sites Newsletter

Summer 2015 Edition

USACE HUNTINGTON DISTRICT BEGINS REMEDIATION IN RESERVOIR NO. 2 BURNING GROUND AT THE FORMER PBOW IN SANDUSKY, OHIO

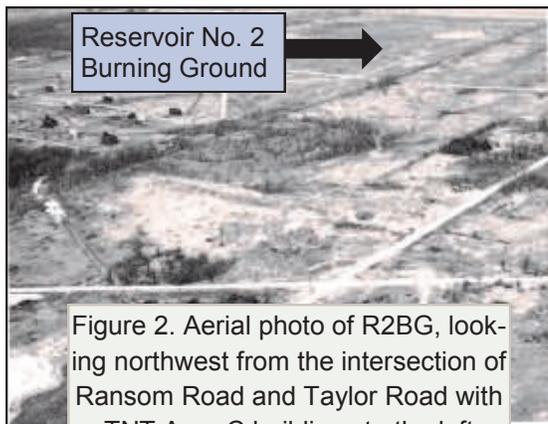
Figure 2. Aerial photo of R2BG, looking northwest from the intersection of Ransom Road and Taylor Road with TNT Area C buildings to the left

During the production years at PBOW, there were buildings in the manufacturing areas (Figure 2), but there were no buildings associated with R2BG. At the start of the remediation activities, R2BG site was a grass-covered open field bordered with young hardwood trees and brush with mature cottonwood trees surrounding the area (Figure 3).

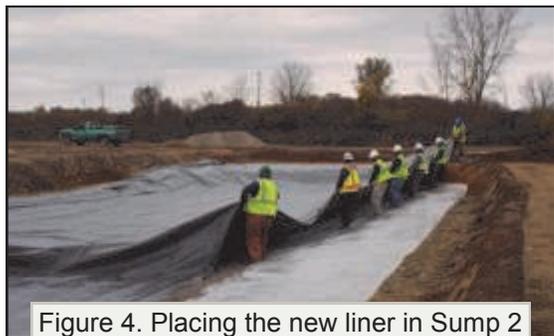
Figure 4. Placing the new liner in Sump 2

Before starting any of the remediation activities, preparation of the on-site remediation pad had to be completed before the onset of extreme temperatures. Additional stone was placed in low-lying areas, the sump liners were replaced (Figures 4 & 5), silt fence

was erected, and straw bales were placed around the sumps. The sumps are used to collect the run-off water from the pad during remediation activities. The sump water can then be used to maintain the moisture in the windrows during remediation.

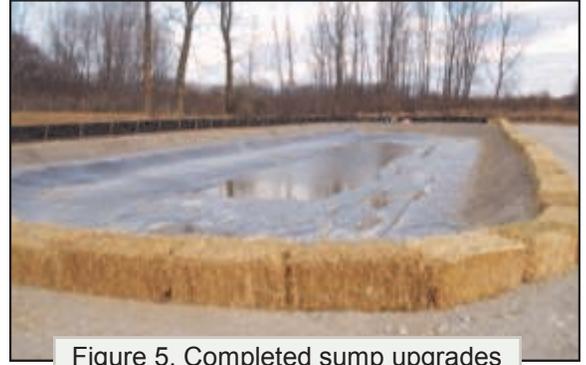
Figure 5. Completed sump upgrades

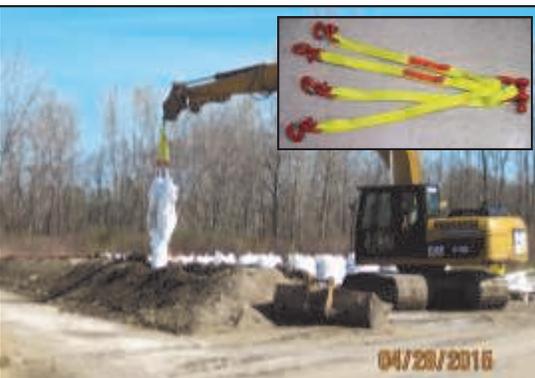
Figure 6. Adding the alkaline hydrolysis reagent to the soil (strapping shown in inset)

ics were reduced using AH (Figures 6 & 7). After AH remediation, approximately 1,000 cy of soil exceeded the Toxicity Characteristic Leaching Procedure (TCLP) for lead. The lead was stabilized by applying Severson Environmental Services' Maectite® reagent to the soil. The soil was analyzed to confirm that it was below the TCLP for lead (5.0 mg/kg) prior to disposing of the non-hazardous soil at the ECL for use as daily cover.

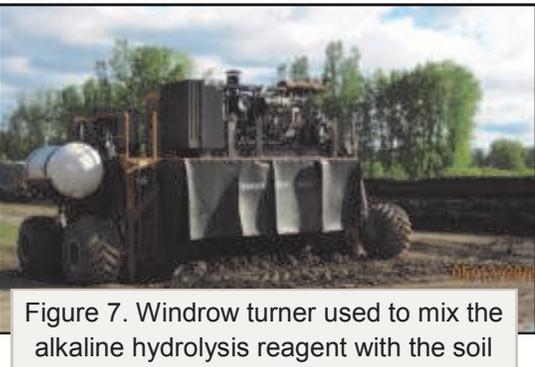
Figure 7. Windrow turner used to mix the alkaline hydrolysis reagent with the soil

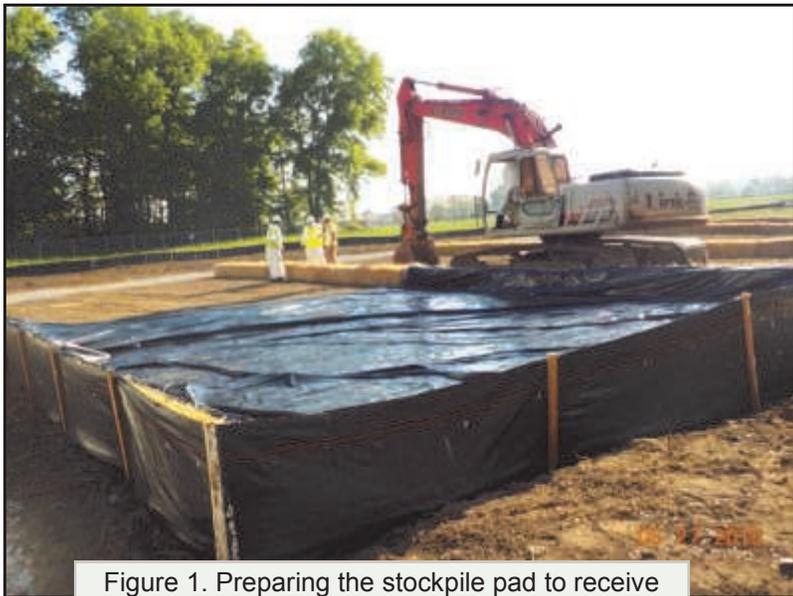
Figure 1. Preparing the stockpile pad to receive contaminated soil

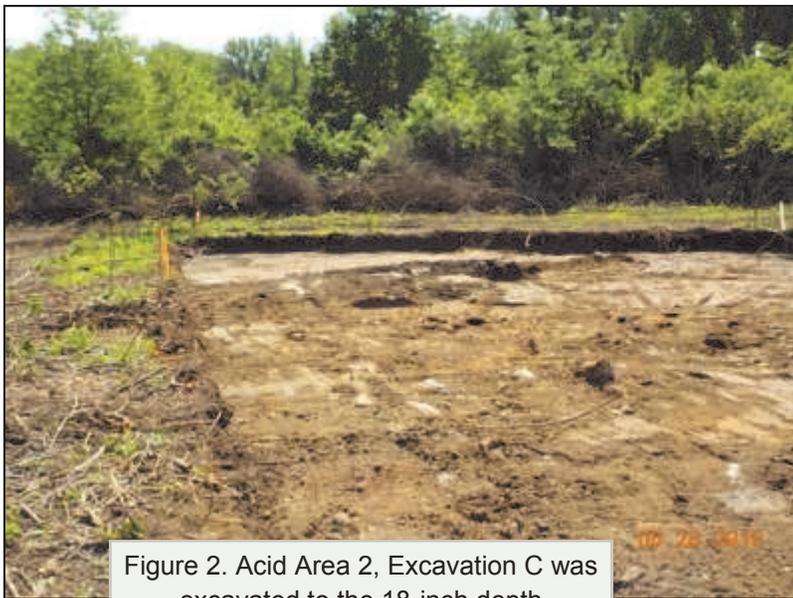
Figure 2. Acid Area 2, Excavation C was excavated to the 18-inch depth

At AA2 and AA3, USACE will be using soil screening analysis to evaluate concentrations of PCBs with respect to the remedial goals (RG) and to determine the depth of each excavation. Screening the PCB concentrations in the soil may eliminate the need for additional excavation to reach clean soil, or soil that is below the RG for Aroclor 1254 of <1 milligrams per kilogram (mg/kg) and a combined Aroclor 1254/1260 of <2 mg/kg. Additionally, in the event the concentrations of PCBs in the walls of the excavation exceed the RG, then expanding the excavation in a horizontal direction may be required. The soil screening analysis would allow USACE to expand the excavation horizontally, if necessary, at no additional cost if the excavation does not reach the scoped depth of 36 inches.

The cost for excavation in both areas to a depth of 36" was based on the findings from the Remedial Investigation / Feasibility Study phase; however, excavation is initially being conducted to 18-inches (Figure 2) in hopes of reducing soil volumes and other associated costs (i.e., disposal of soil and purchase of backfill). Screening samples will be collected at 18 inches and used to compare the concentrations of Aroclor 1254 and Aroclor 1260 to the RGs. If the screening samples indicate the Aroclor concentrations are below the RGs (Aroclor 1254 <1 mg/kg and combined Aroclor 1254 and 1260 <2 mg/kg), the excavation will be considered

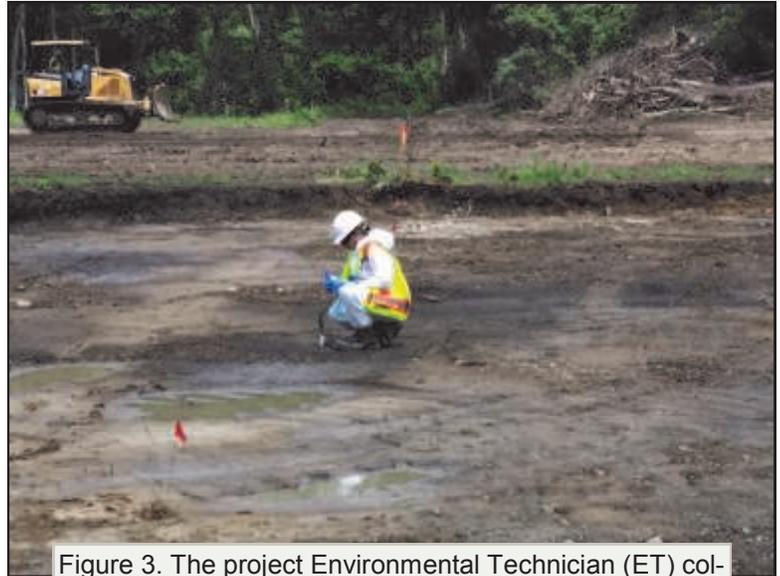
Figure 3. The project Environmental Technician (ET) collects screening samples from the floor of the excavation

complete and confirmation soil samples will be collected from the soil along the floor (Figure 3) and walls of the excavation and submitted to the laboratory for analysis.

Screening the PCB concentrations in the soil before proceeding to confirmation sampling is an effective tool used to determine if the soil is potentially (1) below the RG, (2) has met the clean-up requirements as well as (3) being an efficient use of project funding. The soil screening samples do not require the extensive review or validation process that confirmation soil samples require. The screening samples are simply a tool to indicate if confirmation samples should be collected for definitive analysis. The confirmation samples are subject to extensive review and validation processes because the sample results are the basis for decision-making about the excavation, including if the excavation can be backfilled (or closed), and that it no longer presents a risk to human health or the environment. Currently in AA2, USACE is utilizing the soil screening analysis and will use the same process when AA3 gets underway.

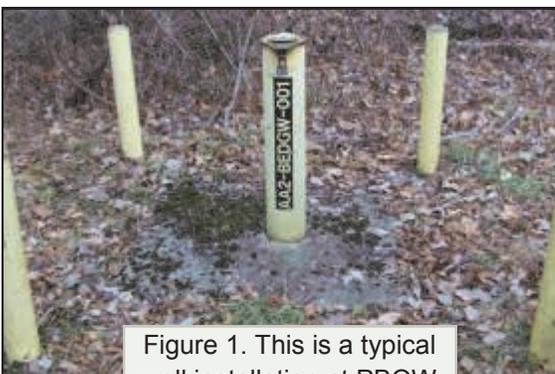
Figure 1. This is a typical well installation at PBO

The US Army Corps of Engineers (USACE) Huntington and Nashville Districts installed and maintained a network of 122 groundwater monitoring wells (Figure 1) at Plum Brook Ordnance Works (PBO) located in Sandusky, Ohio. The wells were installed beginning in 1989 through 2011 as part of the environmental remediation efforts at the former explosives manufacturing facility. The signing of the No Further Action Decision Document for Groundwater in July 2014 led to USACE's decision to initiate the abandonment efforts which began in the fall of 2014.

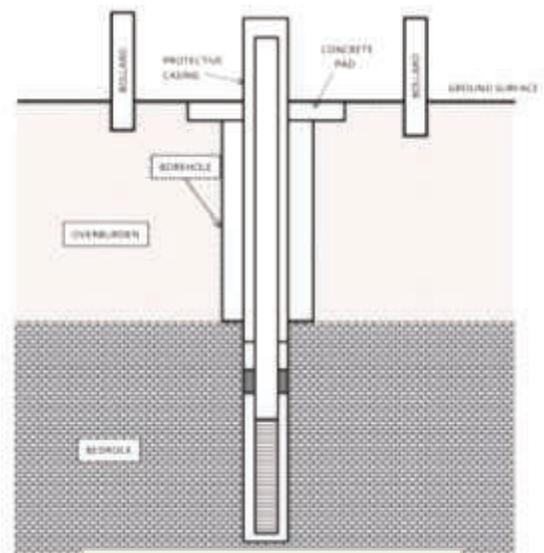
Figure 2. This is a typical bedrock well installation at PBO

The monitoring wells included overburden (shallow) wells and bedrock wells (Figure 2) with average installation depths of approximately 20 feet and 66 feet, respectively. The overburden wells were abandoned by one of two methods. If possible the monitoring well was removed by attaching a nylon tow strap around the casing and using a mini-excavator to pull up the casing out of the ground using the excavator arm. The open borehole was then sealed with bentonite from the bottom of the borehole to the ground surface (Figure 3). Bentonite is a type of clay that swells when hydrated, providing a low-permeability

Because of the greater depths bedrock wells were installed and the fact they have steel outer casing cemented into the bedrock, these monitoring wells were abandoned in place by filling the well screen with clean silica sand (typically the lower 15 feet of the well) followed by a 1-foot layer of hydrated bentonite chips. The remainder of the well was filled with bentonite slurry. Filling the screened interval with sand allows groundwater flow to continue to occur in the fractured bedrock; because of the permeable nature of the unconsolidated overburden, this step was not required for the overburden monitoring wells. After the surface features were removed, the surrounding soil was excavated to approximately 4 feet bgs (Figure 4). A "hot work" permit was obtained from NASA to allow use of a torch to cut the steel casings. The outer casing was cut, then the concrete was chipped off (Figure 5) and the inner steel casing was cut. The PVC well pipe was then cut with a reciprocating saw and the excavation was backfilled with the excavated soil.

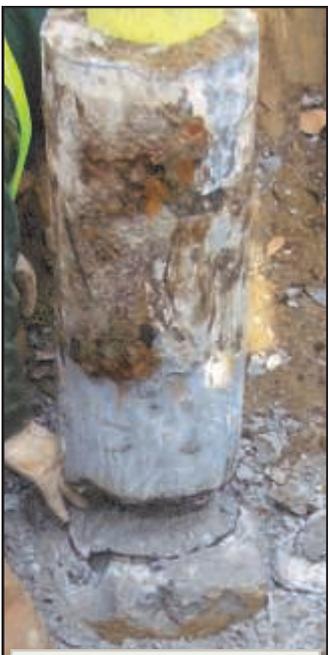
Figure 5. The outer steel casing has been cut and concrete chipped away, exposing the inner casing to be cut and removed

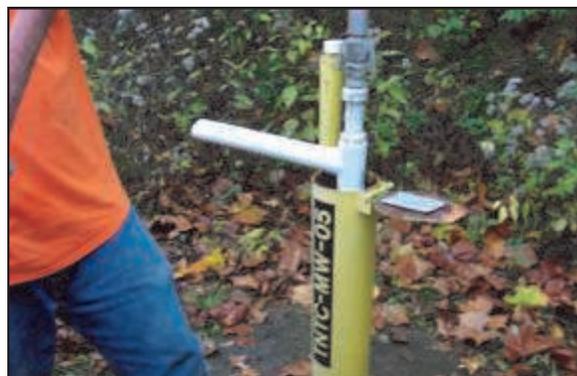
Figure 3. The operator is pumping the bentonite slurry into an overburden well in TNT Area C

barrier. This method was effective for overburden monitoring wells installed at shallow depths (12 feet or less). For deeper overburden monitoring wells, removal of the well was not possible without damaging or breaking the well casing. These wells were abandoned in place by filling the monitoring well casing with bentonite to the ground surface. Using a mini-excavator, surface components of the monitoring wells (concrete pad, bollards) were then removed the soil surrounding the well was excavated to a depth of approximately 4 feet below ground surface (bgs) to allow access to the well casing. The PVC well casing was cutoff using a reciprocating saw and the excavation was backfilled with the excavated soil.

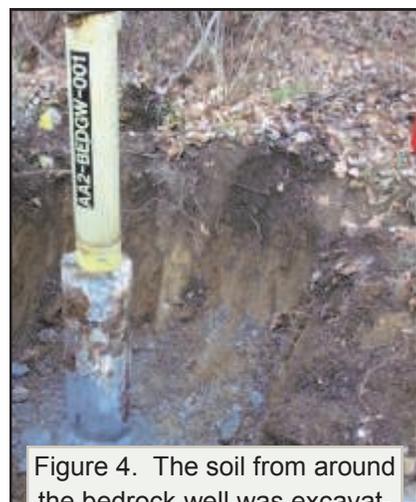
Figure 4. The soil from around the bedrock well was excavated to expose the steel casing

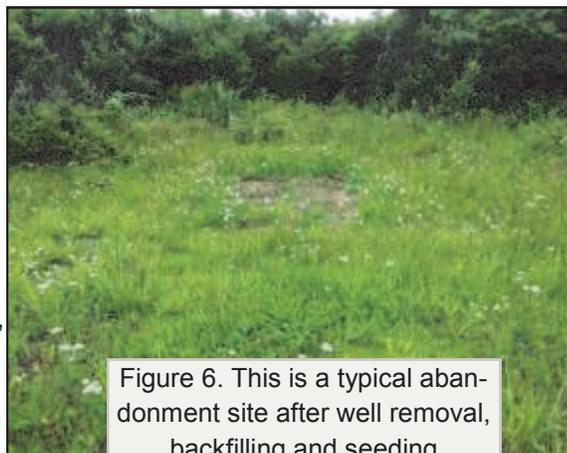
Figure 6. This is a typical abandonment site after well removal, backfilling and seeding

In the spring of 2015, after the snow had melted and the initial backfill had settled, each well abandonment site was topped-off with additional soil, graded to prevent ponding of water on the abandonment site and then seeded with prairie grass. Straw was placed over the grass seed to prevent erosion, help retain soil moisture, and prevent birds from eating the grass seed (Figure 6).

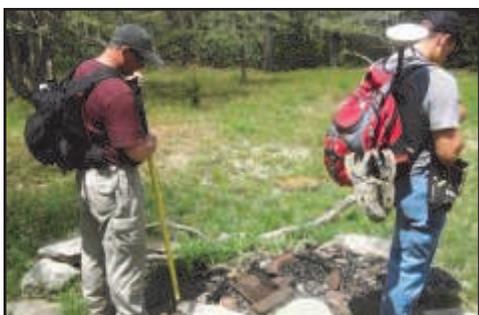
Figure 9. Geo-data is collected and the campsite area swept by UXO Safety Specialist with magnetometer

Encountered campsites not shown on historic geo-data sets were recorded and a UXO Safety Specialist swept the area for signs of UXO. In Figure 9, note the GPS (global positioning system) antenna on the right, the bent-down head of the field person adding data to the field Geographic Information System (GIS) device, and the two-sensor differential field magnetometer in use on the left by the UXO expert (the “yellow stick”). No suspected UXO were located during this trail assessment operation. UXO protocol only allowed removal of surface detritus if ferric metal was detected. Items such as pocket knives and tent stakes were recovered at or within

an inch of the surface. The piezo-electric speaker in the detector did not indicate a response signature for UXO and the recovered items were within the detritus zone (top, thin layer of forest debris).

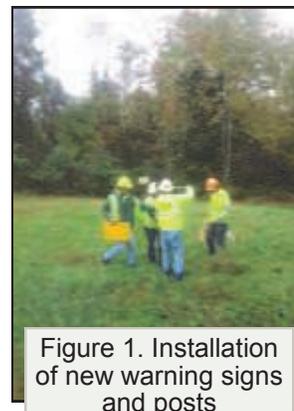
Figure 1. Installation of new warning signs and posts

The 2014 *Corrective Action Contract* included repair for the following: (1) reinstallation of warning signs and posts that were damaged or leaning (Figures 1 & 2); (2) clean up of the former TNT Cap 4 area that had undergone remediation; (3) paint and repair of guardrail gates that had been vandalized; (4) herbicide spraying of invasive knotweed in the TNT area (Figures 3 & 4); (5) reinstallation of loose bollards around monitoring wells;

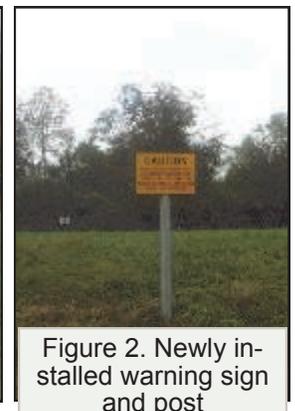
Figure 2. Newly installed warning sign and post

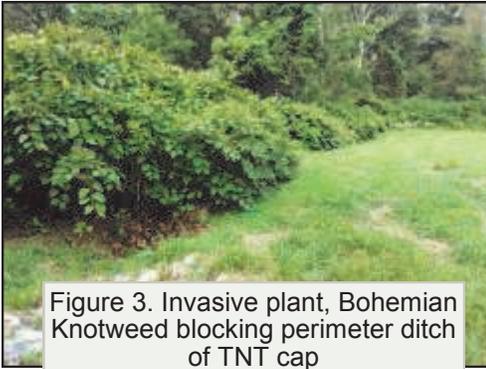
Figure 3. Invasive plant, Bohemian Knotweed blocking perimeter ditch of TNT cap

In the past, the invasive knotweed had been limited to the ditches and culvert outlets at some TNT caps,

but had recently begun to show up on the top of the caps. Because of the aggressive nature of knotweed, it was decided to start eliminating the stands located at TNT Caps 6, 8, 9, and 10. The eradication of all the knotweed around these caps will likely be added to several future corrective action contracts to ensure complete removal and the integrity of the soil caps. Knotweed is a non-native invasive plant that can establish large monotypic stands and have negative impacts on native species, ecosystems, and building structures. Due to an extensive system of rhizomes it is difficult to control. The leaves and hollow bamboo-like stems die back at the end of the growing season and new shoots sprout from large system of rhizomes.

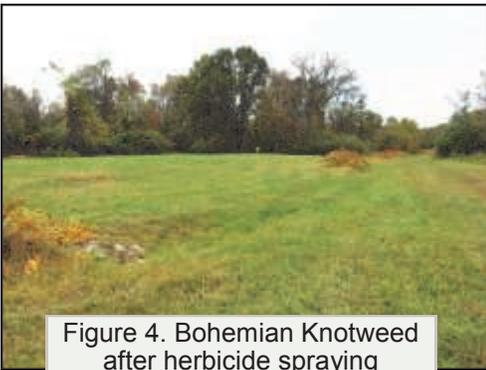
Figure 4. Bohemian Knotweed after herbicide spraying

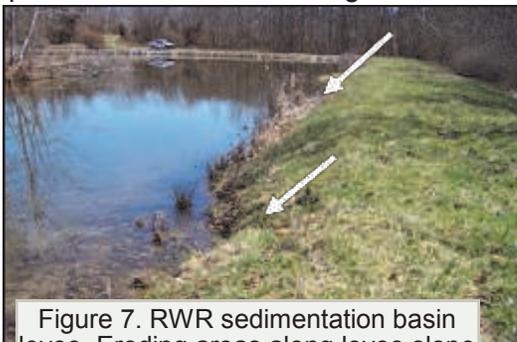
During the O&M repairs it was found that muskrats located at the RWR were creating the holes and eroded areas along the levee. Although there are measures that can be taken to help eliminate the muskrats from tunneling into the levee, this contract contains the first repairs that were needed on the slope of the levee since its construction. The MWMA manages the muskrats in this area by annual trapping. No additional steps will be taken on future O&M contracts to prevent the muskrats along the levee unless more frequent and additional damage to the levee occurs.

Figure 7. RWR sedimentation basin levee. Eroding areas along levee slope

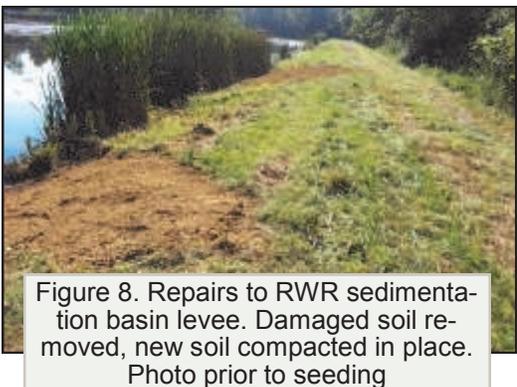
Figure 8. Repairs to RWR sedimentation basin levee. Damaged soil removed, new soil compacted in place. Photo prior to seeding

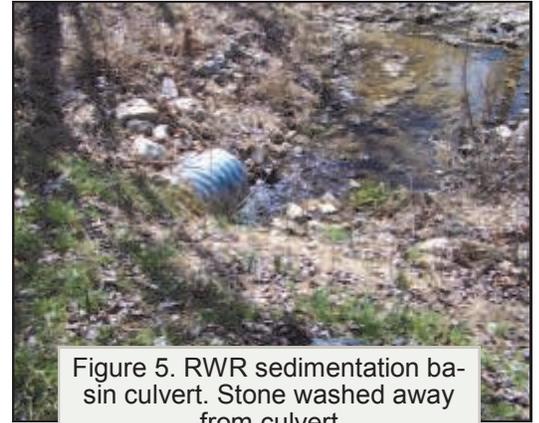
Figure 5. RWR sedimentation basin culvert. Stone washed away from culvert

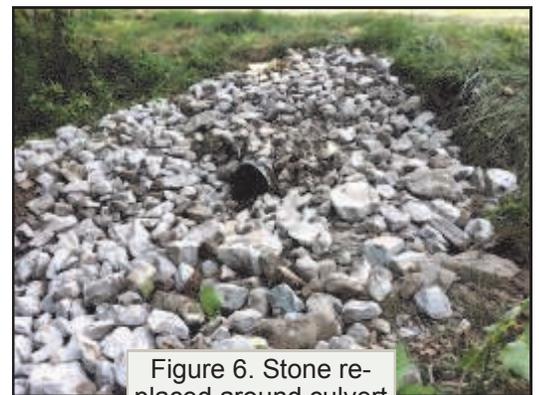
Figure 6. Stone replaced around culvert

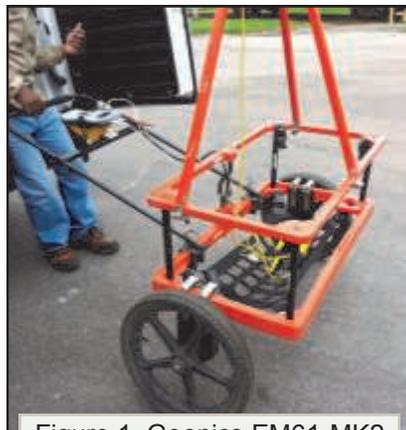
Figure 1. Geonics EM61-MK2 EM induction sensor

The results of the investigation indicated that no USTs are buried in the subsurface in the area of the ten USTs or the single smaller UST. Had a steel UST been present, the EM and magnetic data would likely exhibit relatively large spatial anomalies, while the GPR would detect a broad hyperbolic anomaly. No such features were observed in the three data sets at either of the two locations.

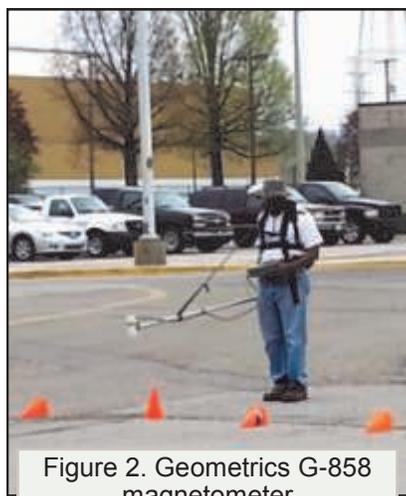
Figure 2. Geometrics G-858 magnetometer

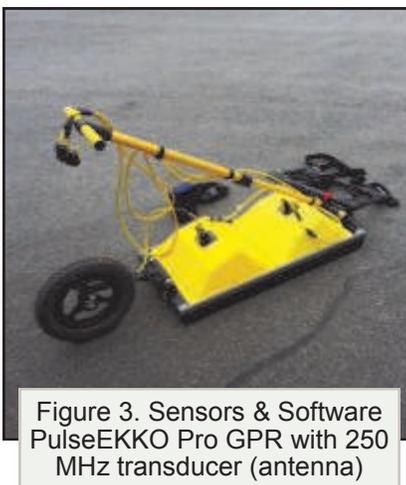
Figure 3. Sensors & Software PulseEKKO Pro GPR with 250 MHz transducer (antenna)

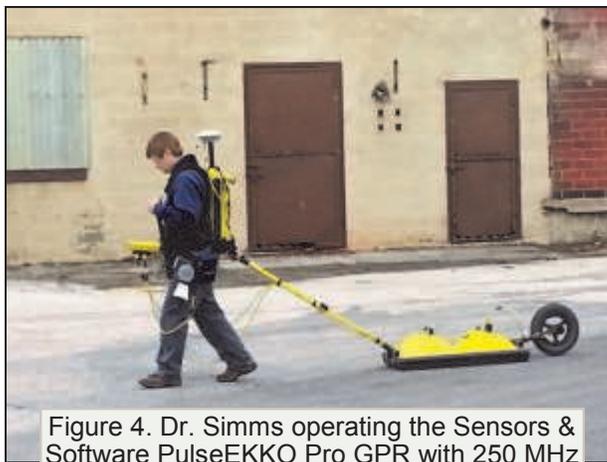
Figure 4. Dr. Simms operating the Sensors & Software PulseEKKO Pro GPR with 250 MHz transducer (antenna)

Three geophysical methods were used to survey the two UST sites: electromagnetic (EM; Figure 1), magnetic (Figure 2), and ground penetrating radar (GPR; Figures 3 & 4). The EM and magnetic surveys are complimentary because the EM sensor can detect metal, whereas the magnetometer detects ferrous-based material, such as steel. The GPR provides a higher resolution image, but usually has a shallower depth of investigation.
