**DAM SAFETY ASSURANCE PROGRAM
EVALUATION REPORT AND
ENVIRONMENTAL IMPACT STATEMENT**

**APPENDIX H
ENGINEERING APPENDIX**

**DOVER DAM, OH
TUSCARAWAS RIVER**

NATIONAL REGISTER ASSESSMENT OF DOVER DAM

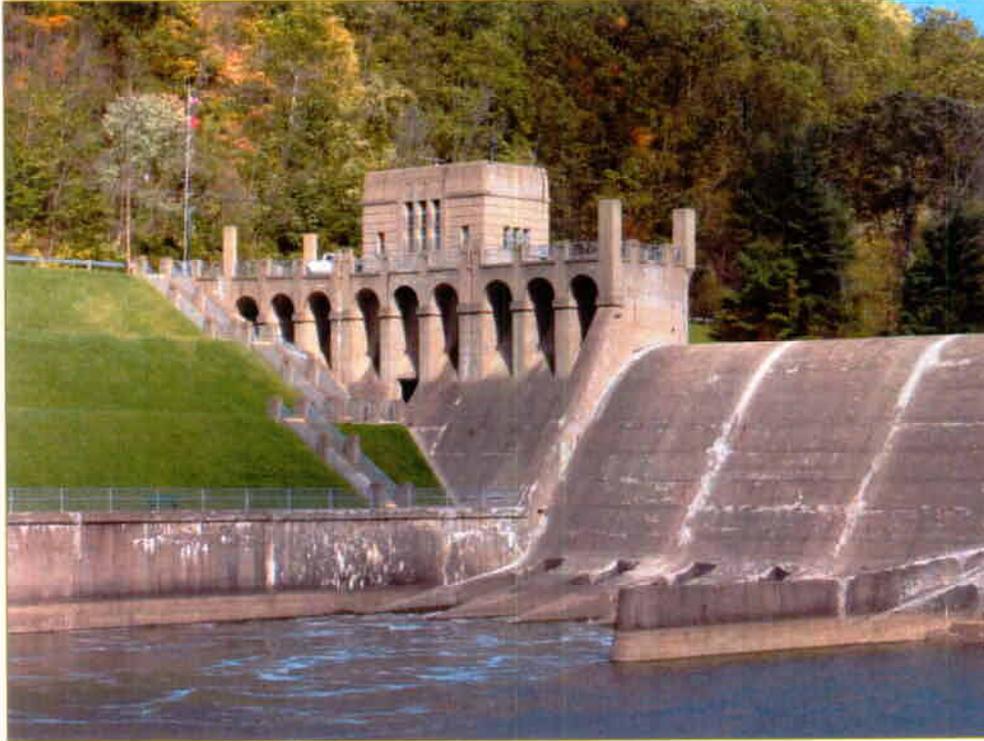
Photo 4. North abutment and operating house, looking north

The bulk of the north abutment of the dam (Photo 4) is composed of a series of five large 36'-long concrete monoliths, numbered during construction as monoliths 1–6. The abutment's west wall is decorated with an arcade of nine concrete arches on square posts. The top of this portion of the dam is flat, with Art Deco concrete and steel handrails. A large obelisk-like concrete upright with vertical linear decoration is positioned at the two downstream corners of the abutment, and a flat-roofed concrete operating house sits atop this section. The control house (Photo 5, Photo 6)) features horizontal recessed bands, a stepped top, and a set of triple windows on the downstream wall. The center frieze of the downstream wall contains three recessed concrete panels with shield motifs. The north wall of the control house has a modern steel overhead door, above which is a concrete panel with an inscription of "Dover Dam 1935" in Roman lettering. A long staircase on the downstream side of the

north abutment leads down to a platform that overlooks the stilling basin. The handrail for these steps has the same design as the handrail on the roof of the main north abutment. The entire length of the north abutment is 192', and it is 25'6" wide.

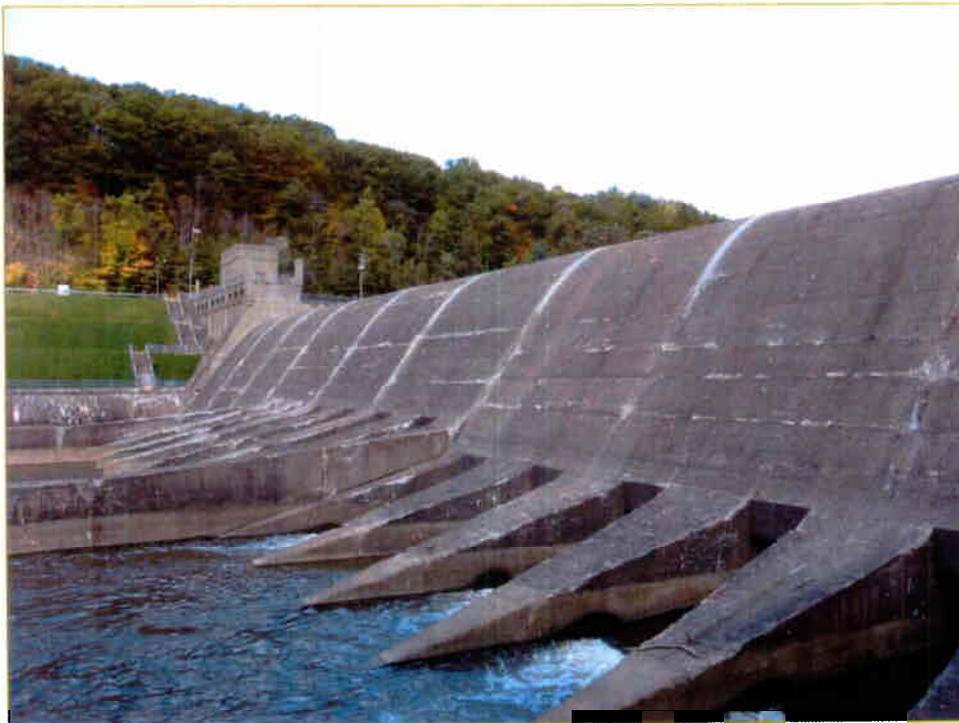
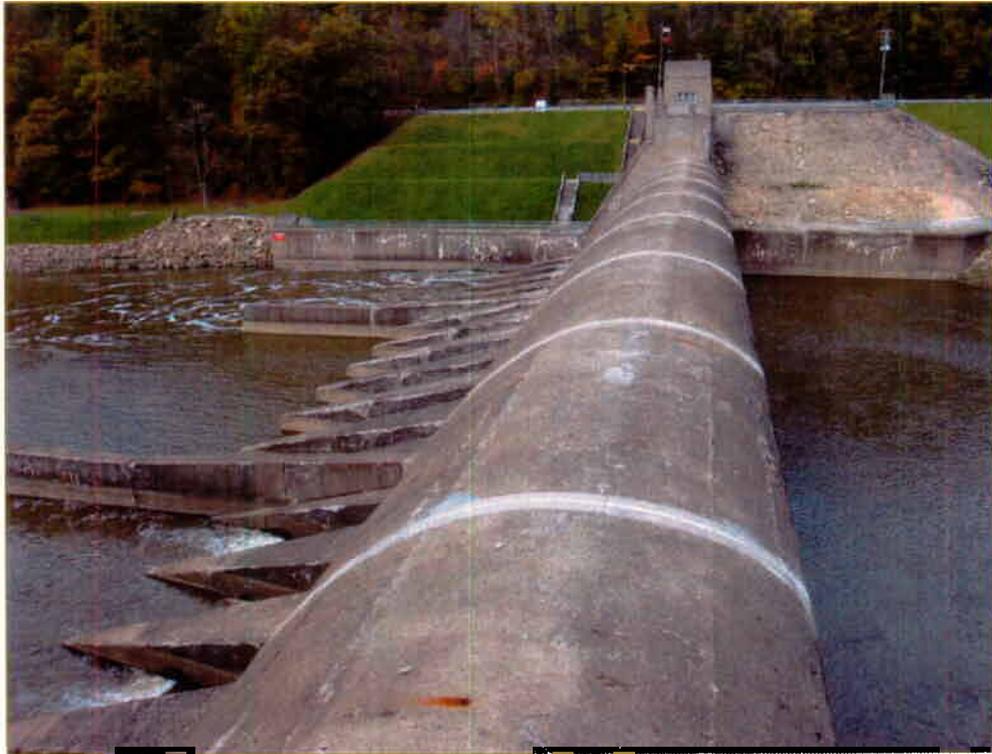
Photo 7. Spillway, looking north

The central portion of the dam is a 338'-long uncontrolled ogee spillway with a total width of about 100' (Photo 7–Photo 9). The spillway features 18 gated sluices controlled by slide gates that operate by hydraulic cylinders (Advanced Technology 2001:Sec. 2 2–3). The sluices are split up into groups of six, with 7'-by-7' gates on the six north sluices and the six middle sluices, while the six sluices to the south have 5' by 10' gates. Inside the spillway is a barrel-vaulted operating gallery (Photo 10), which is essentially a tunnel through the middle of the solid concrete mass of the spillway. The operating gallery holds the gate machinery for the sluice gates and allows access to this equipment.

The central spillway is a 338' wide uncontrolled spillway constructed of reinforced concrete and is ogee-shaped. The spillway has a total of 18 gated sluices that are controlled by a series of slide gates that are operated by hydraulic cylinders. Twelve of the sluices measure 5' x 10', while the remaining six measure 7' x 7'. The cylinders and other pieces of gate equipment are accessed via the operating gallery, a barrel vaulted tunnel that runs through the center of the spillway. The south abutment is adorned on the downstream face with an arched arcade with eighteen openings, and features a concrete deck with Art Deco railings similar to those on the north abutment. A concrete entrance house sits on top of the south abutment deck. A 100' stilling basin with concrete floor, concrete baffles, and four wing walls is positioned on the downstream side of the dam. Few alterations have been made to the exterior of the dam other than concrete patching, removal of a small number of original lighting fixtures, and the replacement of the north garage door of the operating house.

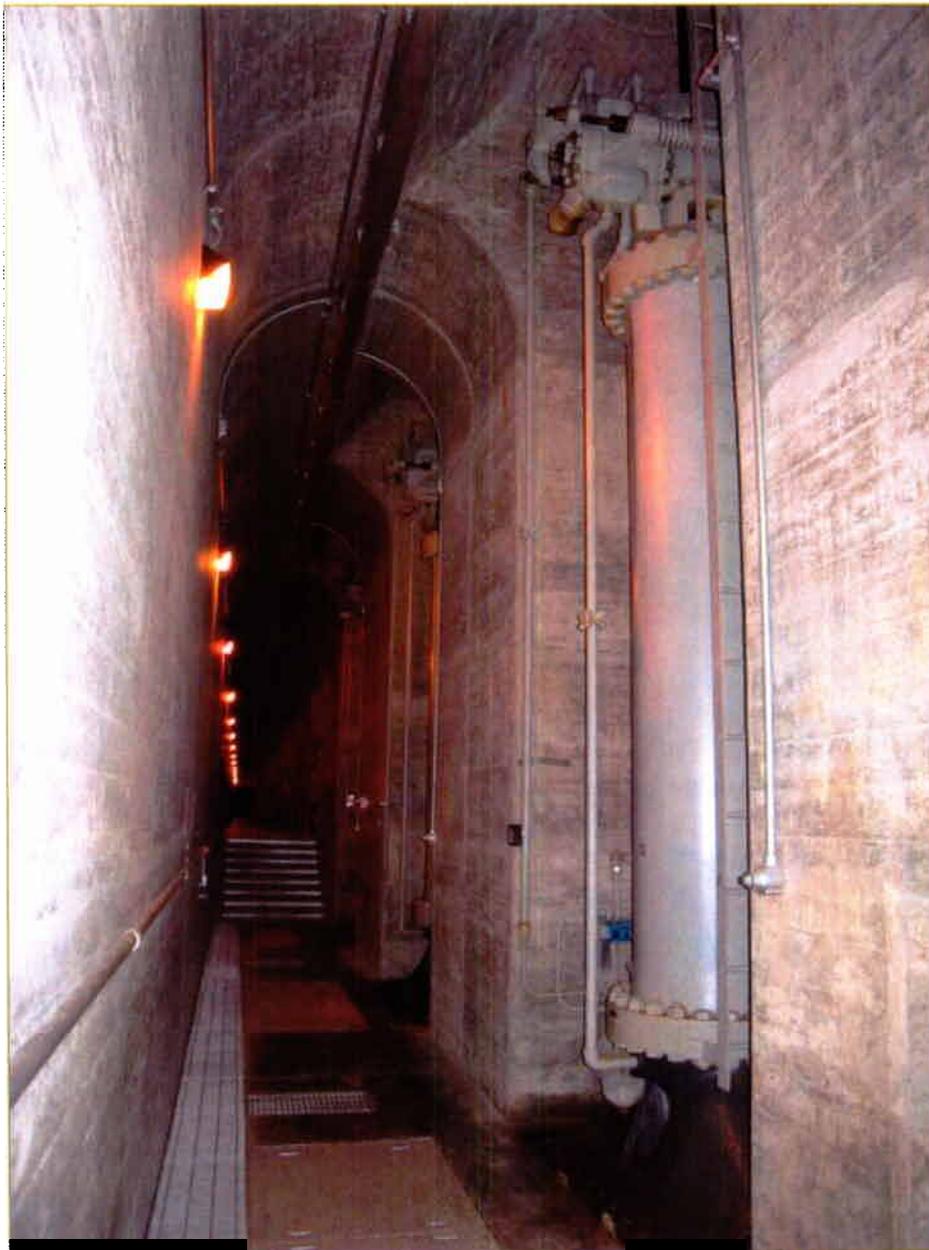
Photo 10. Operating gallery, looking southeast

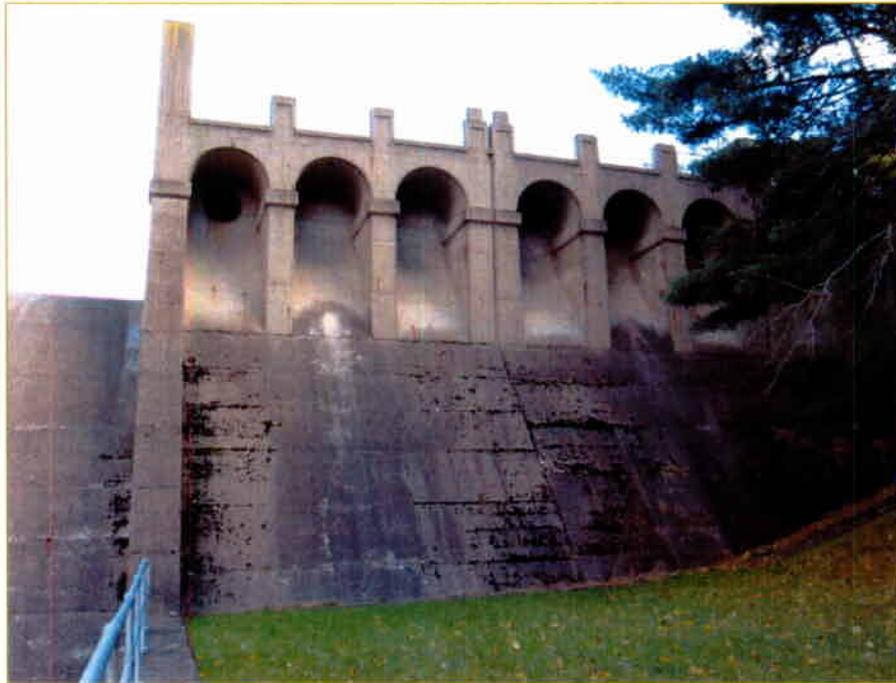
Photo 11. South abutment, looking northeast

The south abutment is similar to the north abutment and is 274' long and 25'6" wide (Photo 11, Photo 12). The bulk of the abutment is composed of eight massive concrete monoliths numbered 16–23 during construction. Like the north abutment, the south is decorated with an arched arcade on the west (downstream) side, but with a total of 18 arches. The top of the

abutment has a flat walkway area, metal and concrete railings, and a concrete entrance house with a flat roof.

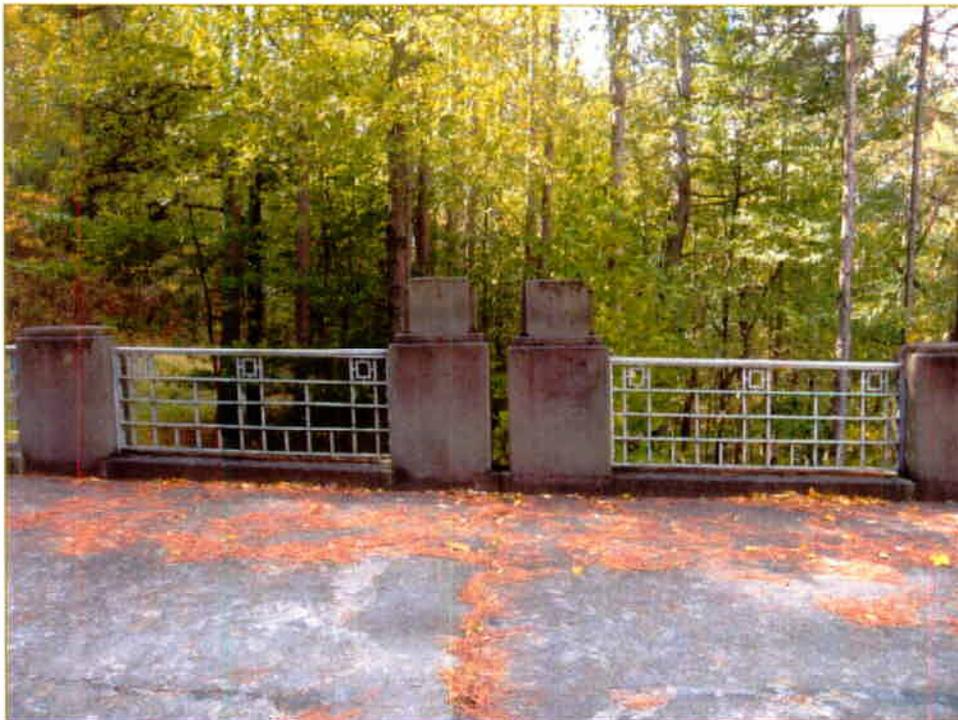
Photo 14. Art Deco railings on south abutment, looking southwest

The dam exhibits many characteristics of the Art Deco style and seems to reflect a design mode common to 1930s federal government buildings and structures in which Neoclassical elements were combined with Art Deco features (Photo 13). Neoclassical elements of Dover Dam include the massive arched arcades of the two abutments, while Art Deco features include stepped-back forms on several parts of the dam: operating and entrance houses, the concrete portions of the railings on both abutments, and the geometrical design of the metal railings on top of the two abutments and along the concrete exterior stairs on the west side of the north abutment (Photo 14).

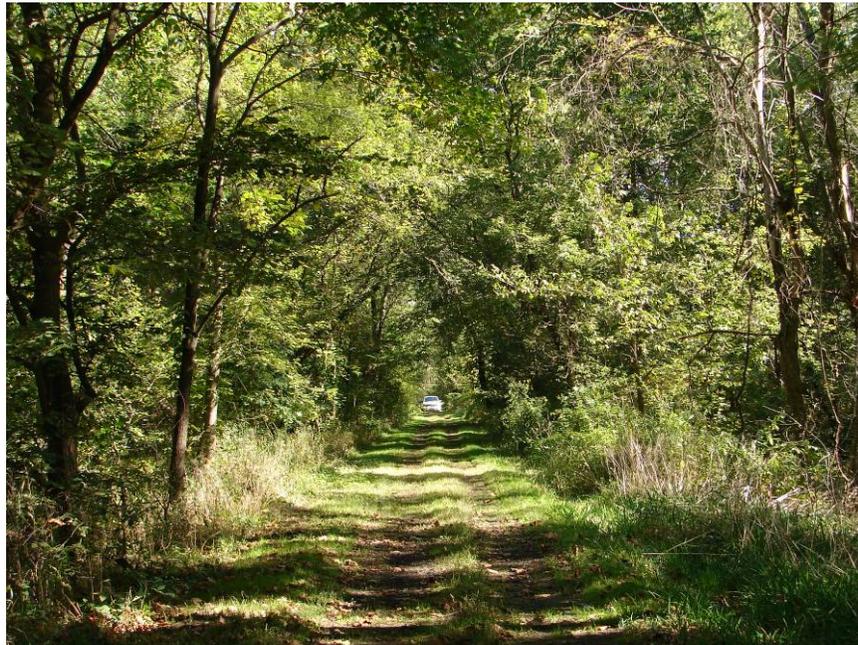
Figure 4. Tuscarawas River upstream from Dover Dam.

On September 21, 2006, a Service biologist attended an on-site meeting with your staff, as well as Regulatory Branch staff, to review the proposed access roads from Old Zoarville Road to the Dover Dam. The proposal includes separate ingress and egress roads on beds that were used as a railroad prior to construction of the dam (Figure 5) and the more recent railroad bed built on a higher elevation. At some locations the remains of railroad ties still exist on this bed. Even with separate access roads, some widening of the existing roadway would be necessary at some segments, at least.

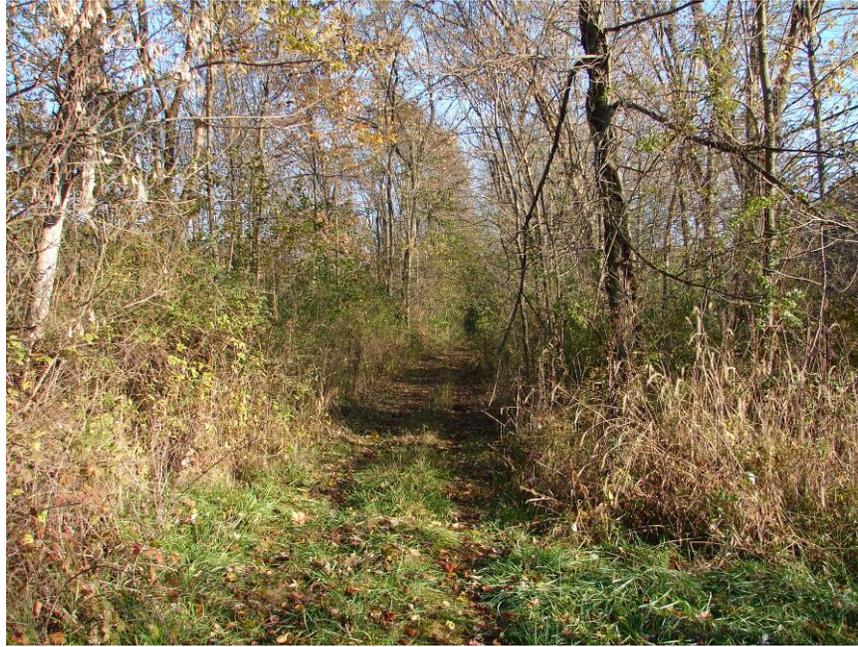
Figure 5. Typical view of old railroad bed along the upstream access road.

length is similar to the proposed upstream access road. Overall, smaller woody vegetation (Figure 6) and virtually no wetlands would be impacted with this new preferred access alternative. Therefore, the Service supports utilizing the downstream access route.

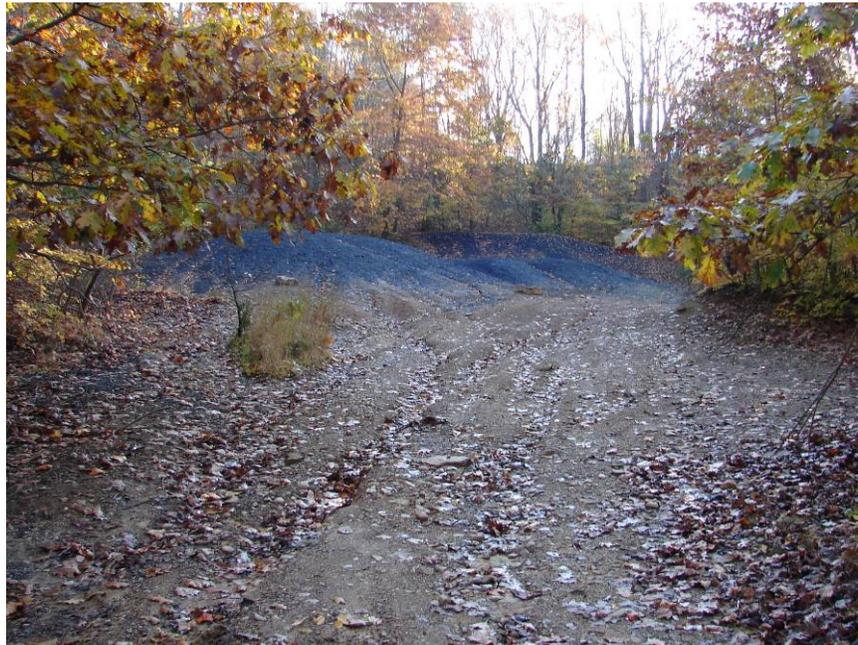
Figure 6. Typical view of old access road downstream from Dover Dam (preferred access).

7. Figure 7 shows tailings from past coal mining in the area. We recommend that this area be restored by removing these materials and planting the area with a variety of native woody plants, as mitigation for losses of shrub and tree habitat along the access road.
