**REPORT ON THE INTERIOR PAINT COLORS  
OF THE GENERAL A.G. JENKINS HOUSE  
GREENBOTTOM WEST VIRGINIA**

**JANUARY 1989**

**PREPARED FOR THE  
US ARMY CORPS OF ENGINEERS  
HUNTINGTON DISTRICT**

**Consultant:  
Michael Gioulis  
Historic Preservation Consultant  
612 Main Street  
Sutton, WV 26601**

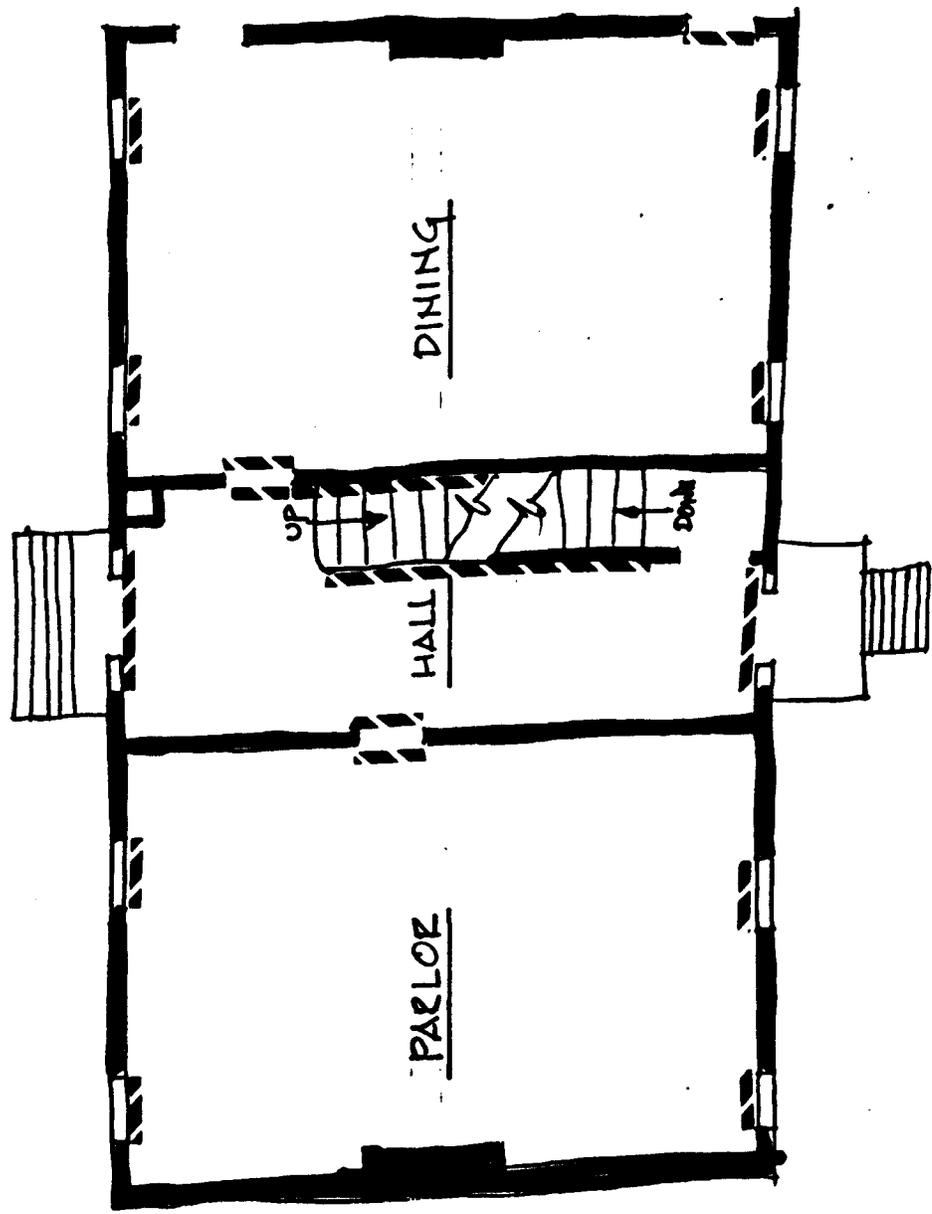
SKETCH 1 JAN 1989

FIRST FLOOR PLAN

--- LOCATION OF ORIGINAL TRIM

A related observation is the fact that most of the base trim in the house is also not original, and probably dates from the time of the wall replacement. The small remaining sections of original base are under the windows on the first floor, under the stair and in the stair stringer region; and some locations in the bedrooms. The accompanying sketch indicates the locations of these regions. The non original base trim appears to be of the Colonial Revival period of the late 1930's.

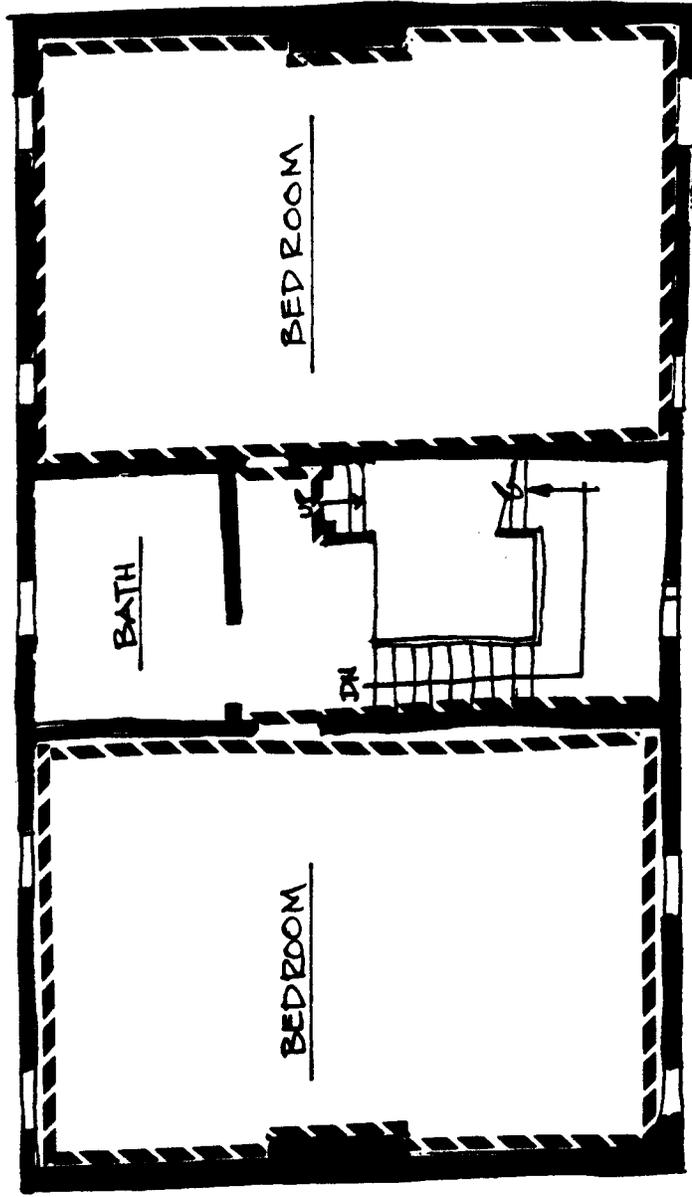
LOCATION OF ORIGINAL TRIM  
 AG JENKINS HOUSE. N SKETCH 2 JAN. 1989

SECOND FLOOR PLAN NO SCALE
