Appendix N

INVASIVE SPECIES

INVASIVE SPECIES REPORT FOR RD BAILEY LAKE, JUSTICE, WV; AND BLUESTONE LAKE HINTON, WV

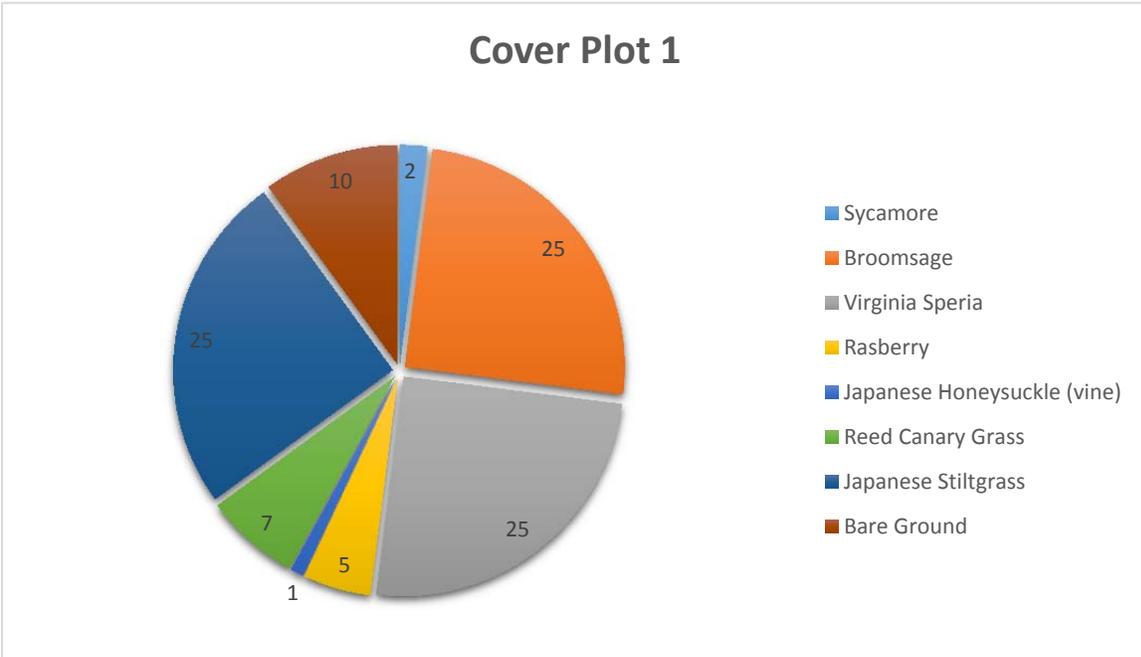
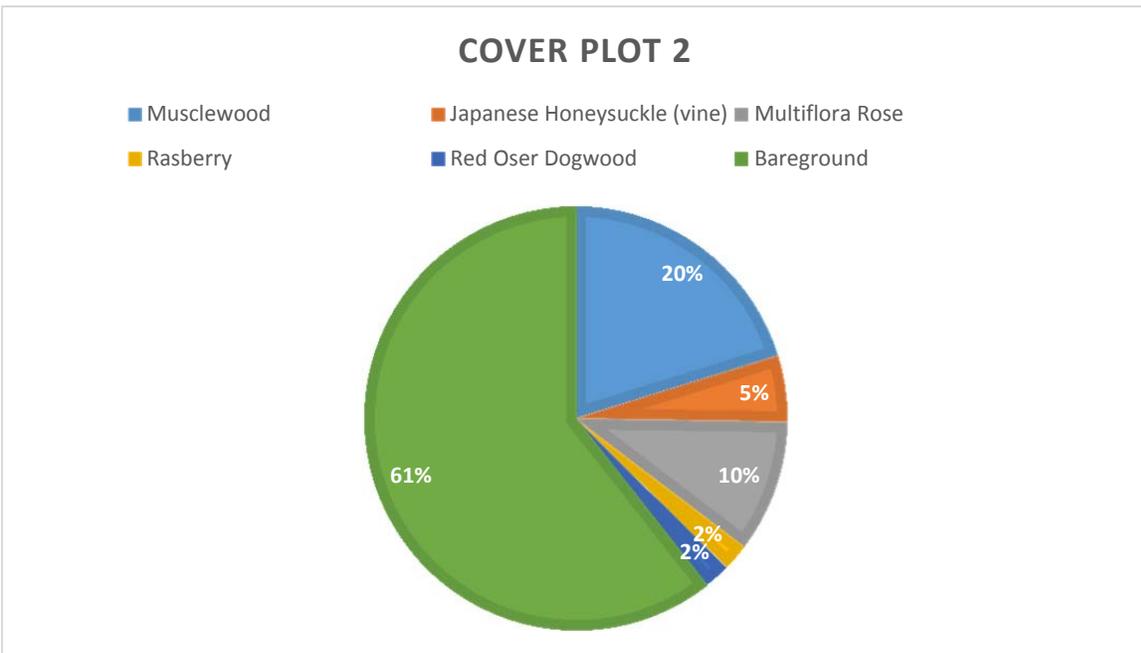
RD Bailey Lake Dam Site Cover Plots

Plot one was taken within the historic rise of approximately 5 to 10 feet of elevation rise above normal summer pool elevation. The radius of the sampling plot was 10 feet. The plot indicated out of 100 percent cover that approximately 76 percent of the area consisted of invasive species. A plot outside of the normal rise of 5 to 10 feet in elevation was also conducted at approximately 15 to 20 feet of elevation. Cover plot 2 only showed 49 percent total cover of vegetation with 15 percent being invasive species.

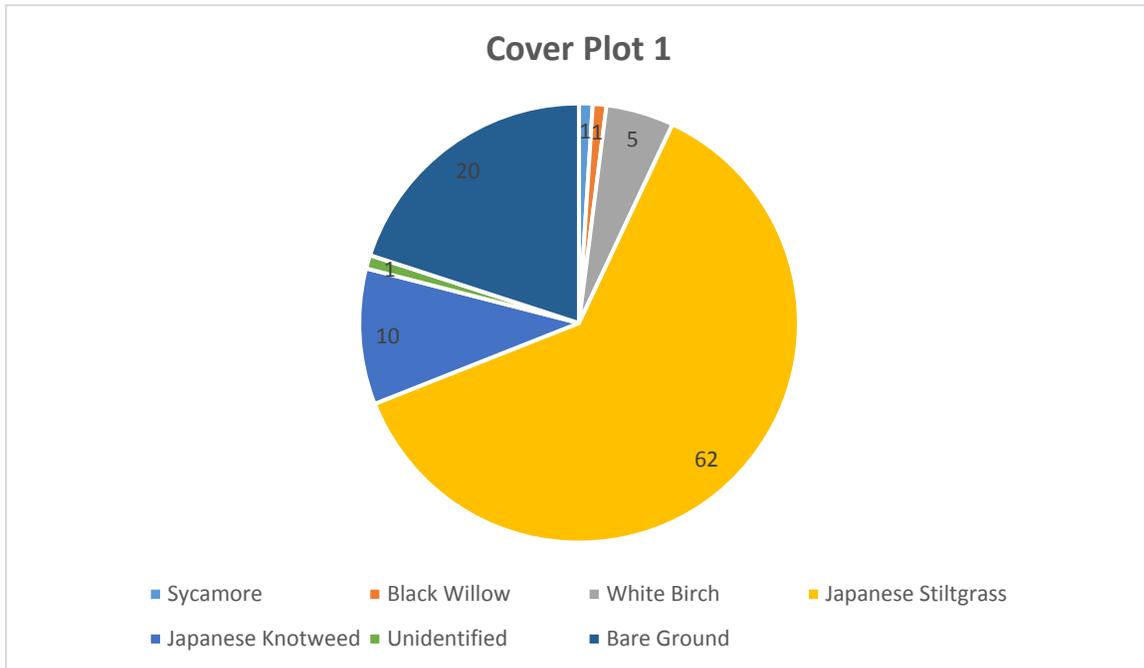
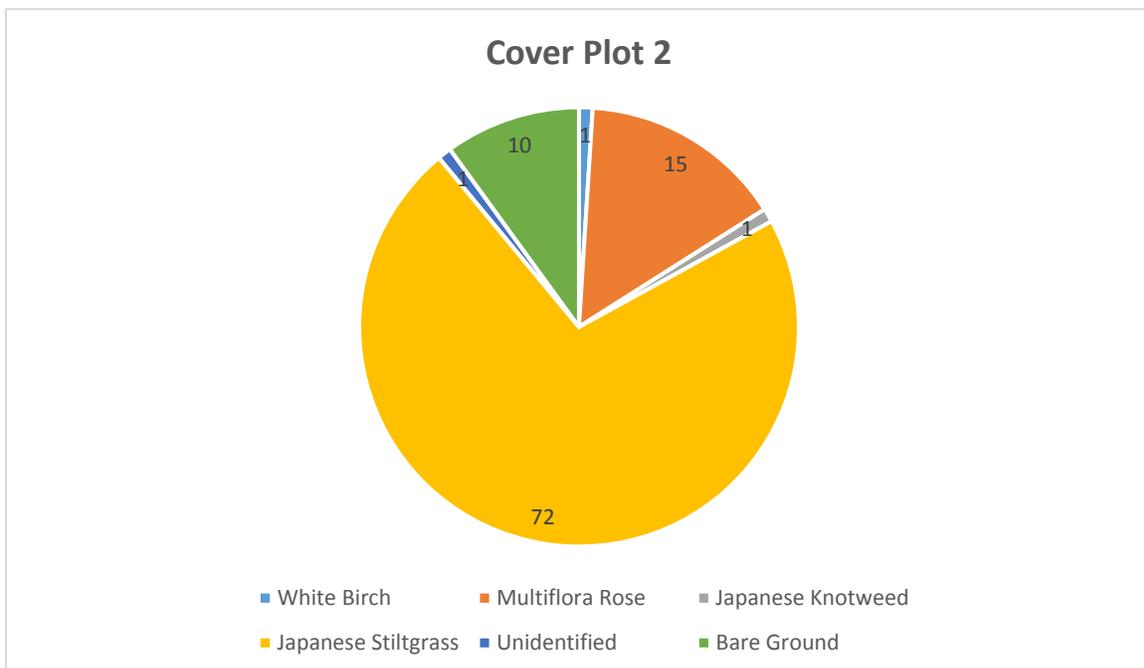
RD Bailey Lake Big Branch Cover Plots

Plot one was taken within the historic rise of approximately 5 to 10 feet of elevation rise above normal summer pool elevation. The radius of the sampling plot was 10 feet. The plot indicated out of 100 percent cover that approximately 72 percent of the area consisted of invasive species. A plot outside of the normal rise of 5 to 10 feet in elevation was also conducted at approximately 15 to 20 feet of elevation. Cover plot 2 showed approximately 90 percent total cover of vegetation with 88 percent being invasive species

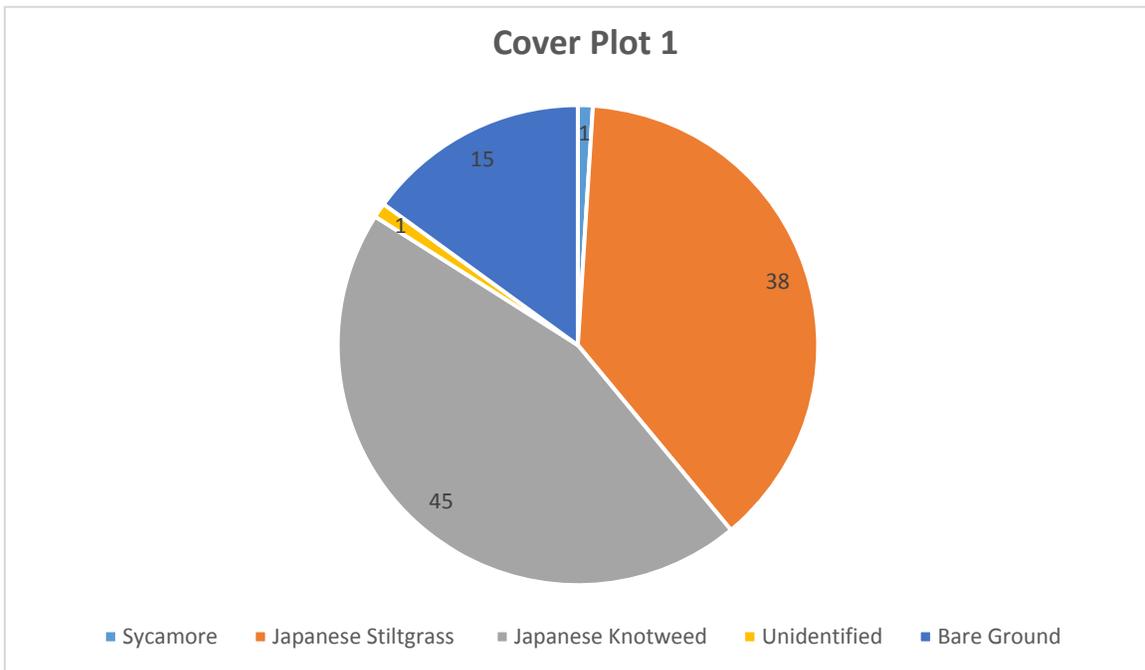
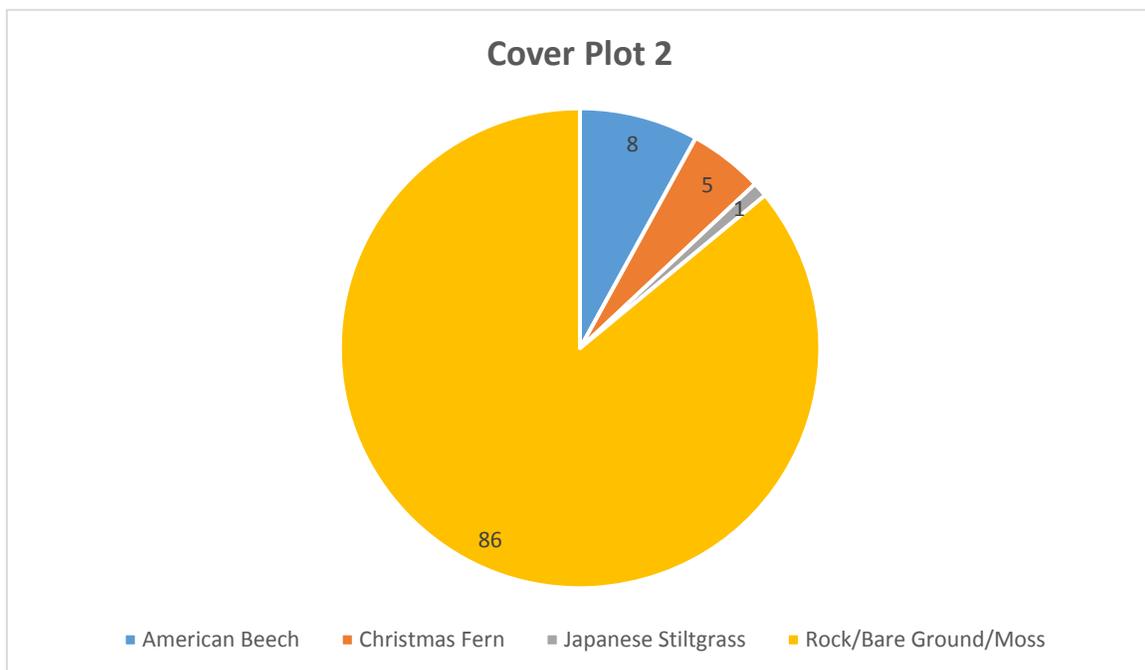
RD Bailey Lake Big Branch Site #2 Cover Plots

Plot one was taken within the historic rise of approximately 5 to 10 feet of elevation rise above normal summer pool elevation. The radius of the sampling plot was 10 feet. The plot indicated out of 100 percent cover that approximately 83 percent of the area consisted of invasive species. A plot outside of the normal rise of 5 to 10 feet in elevation was also conducted at approximately 15 to 20 feet of elevation. Cover plot 2 only showed approximately 14 percent total cover of vegetation with 1 percent being invasive species.

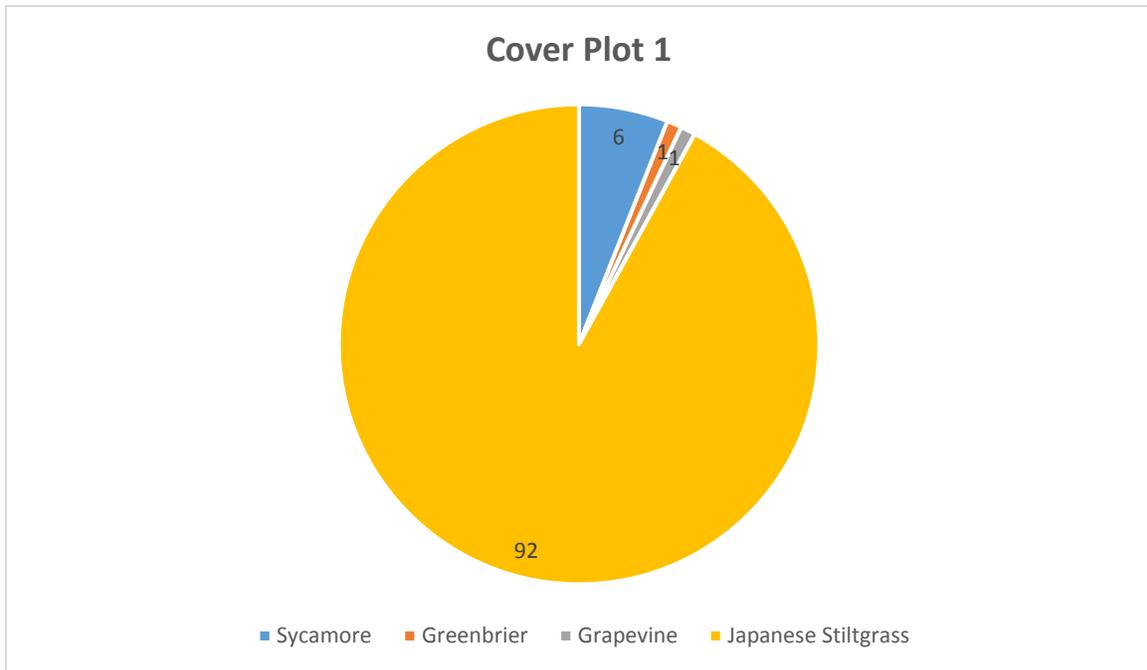
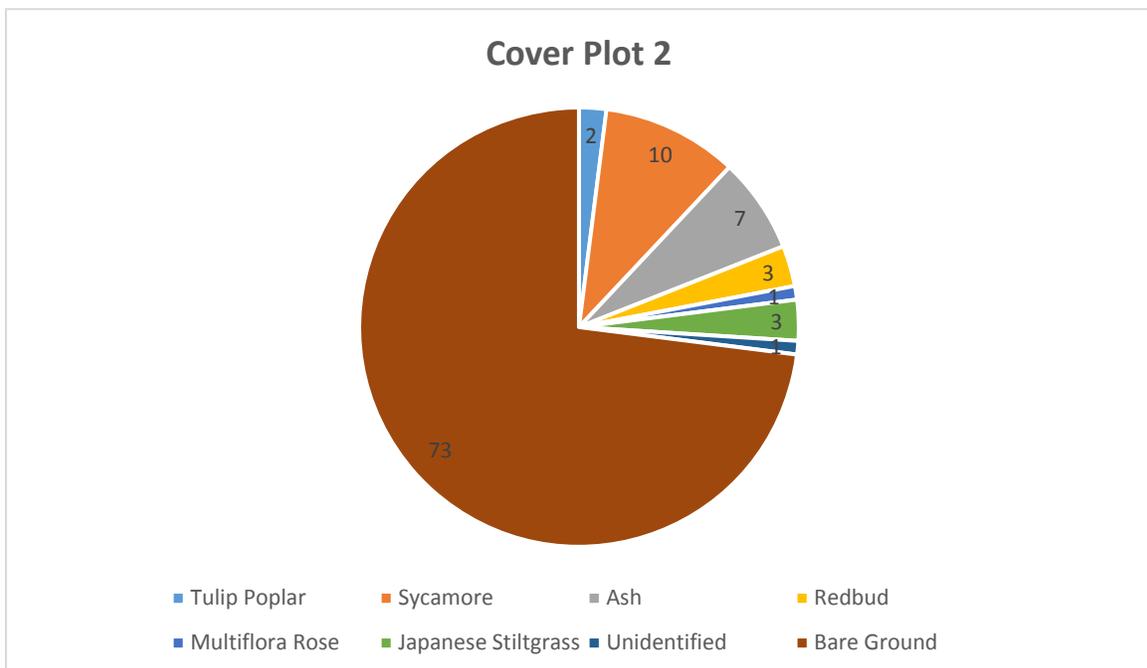
RD Bailey Lake Guyandotte Point Cover Plots

Plot one was taken within the historic rise of approximately 5 to 10 feet of elevation rise above normal summer pool elevation. The radius of the sampling plot was 10 feet. The plot indicated out of 100 percent cover that approximately 92 percent of the area consisted of invasive species. A plot outside of the normal rise of 5 to 10 feet in elevation was also conducted at approximately 15 to 20 feet of elevation. Cover plot 2 only showed approximately 27 percent total cover of vegetation with 4 percent being invasive species.

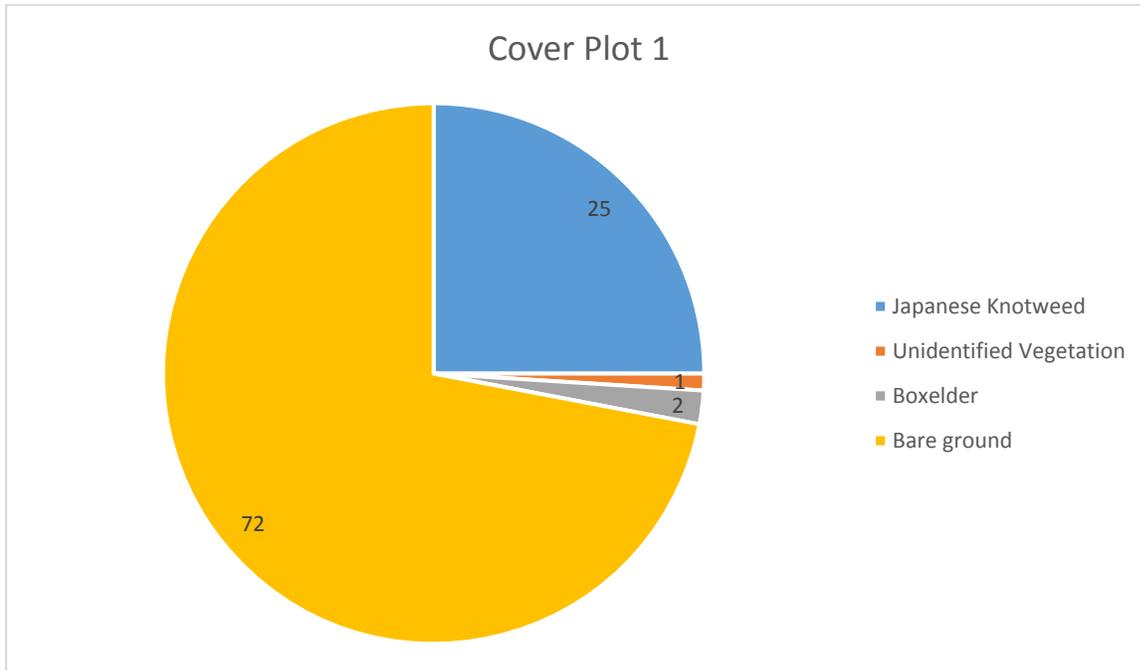
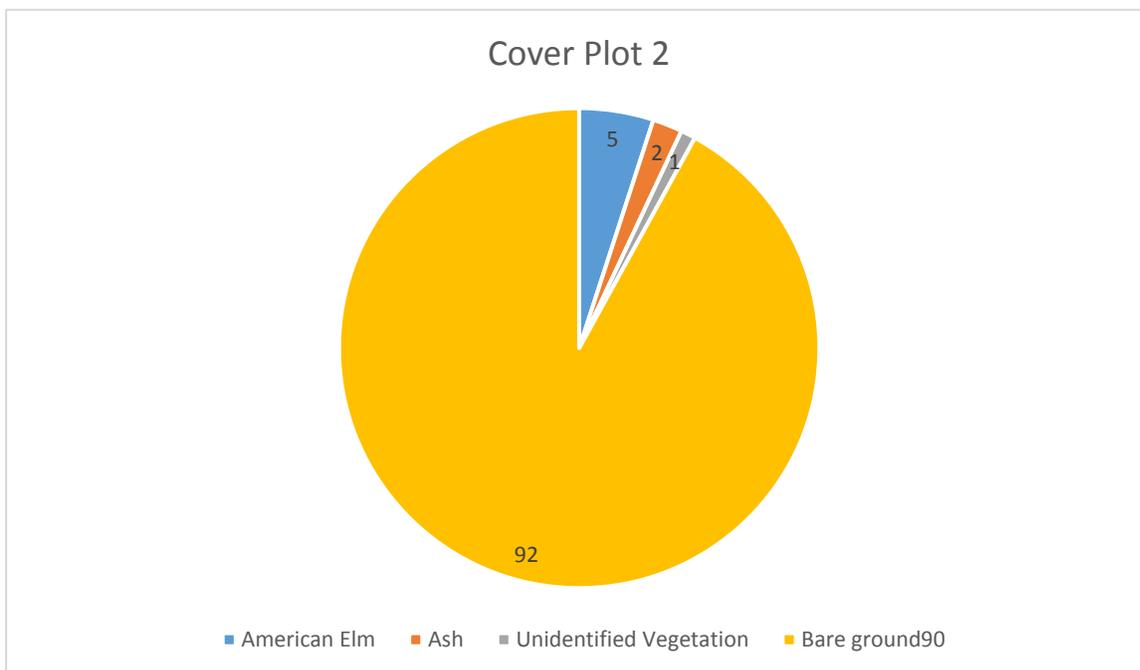
Bluestone Dam Site Cover Plots

Plot one was taken within the historic rise of approximately 5 to 10 feet of elevation rise above normal summer pool elevation. The radius of the sampling plot was 10 feet. The plot indicated out of 100 percent cover that approximately 72 percent of the area had no cover and of the remaining 25 percent was covered with invasive species. A plot outside of the normal rise of 5 to 10 feet in elevation was also conducted at approximately 15 to 20 feet of elevation. Cover plot 2 only showed 8 percent total cover of vegetation with no invasive species being identified.

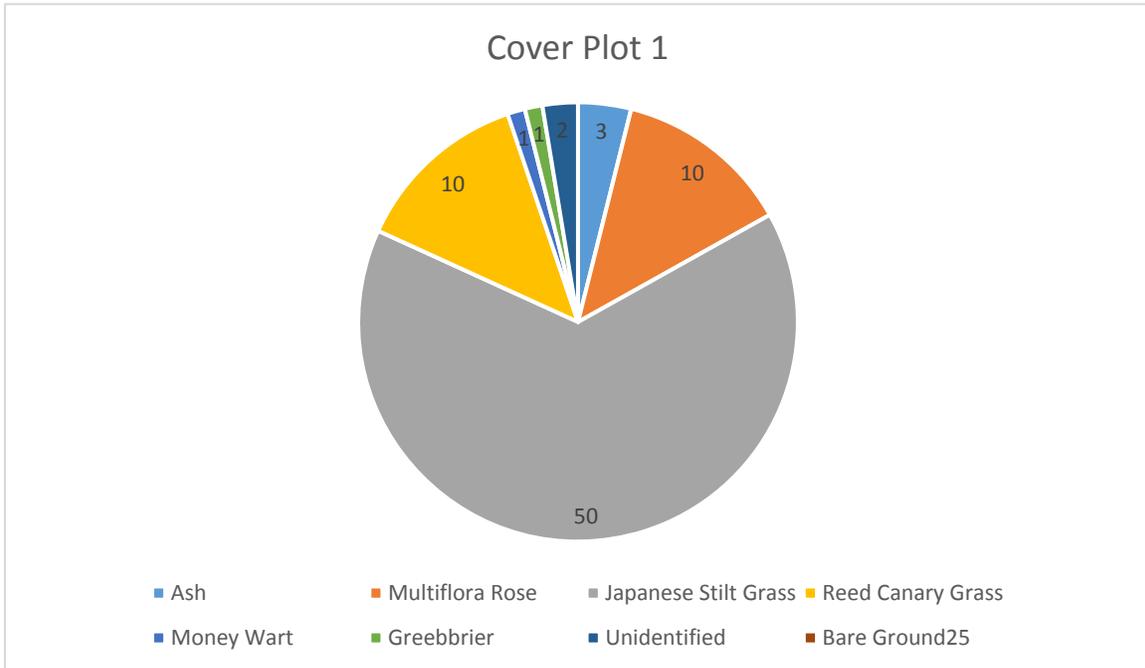
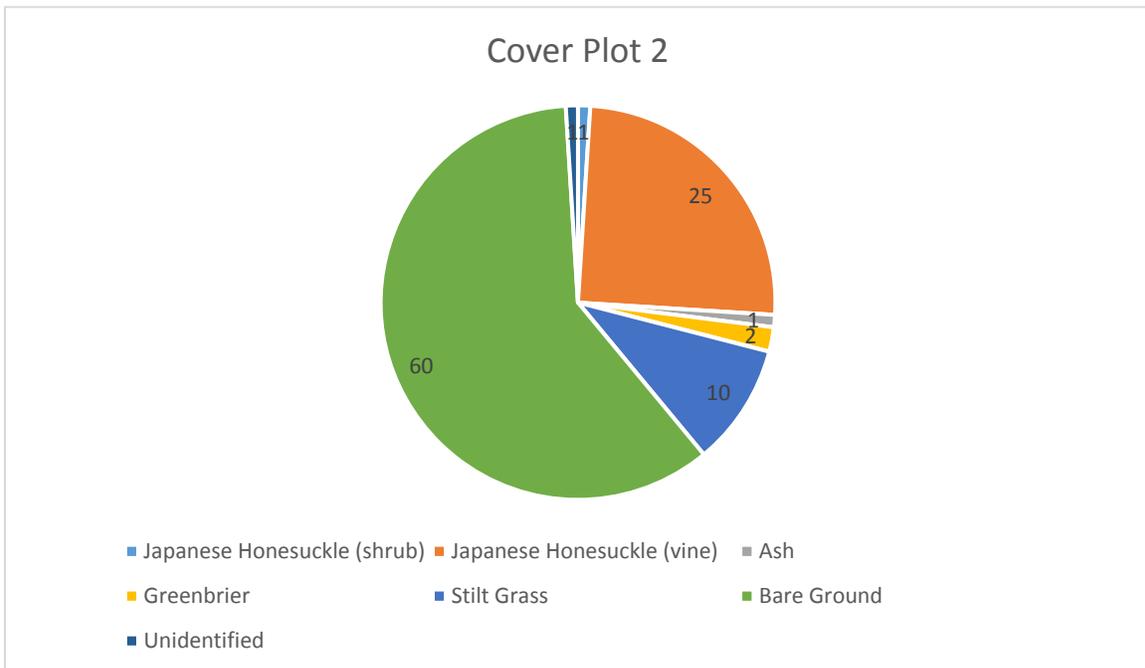
Bluestone Lake Leatherwood Landing Cover Plots

Plot one was taken within the historic rise of approximately 5 to 10 feet of elevation rise above normal summer pool elevation. The radius of the sampling plot was 10 feet. The plot indicated out of 100 percent cover that approximately 70 percent of the cover area consisted of invasive species. A plot outside of the normal rise of 5 to 10 feet in elevation was also conducted at approximately 15 to 20 feet of elevation. Cover plot 2 only showed 40 percent total cover of vegetation with 36 percent being invasive species.

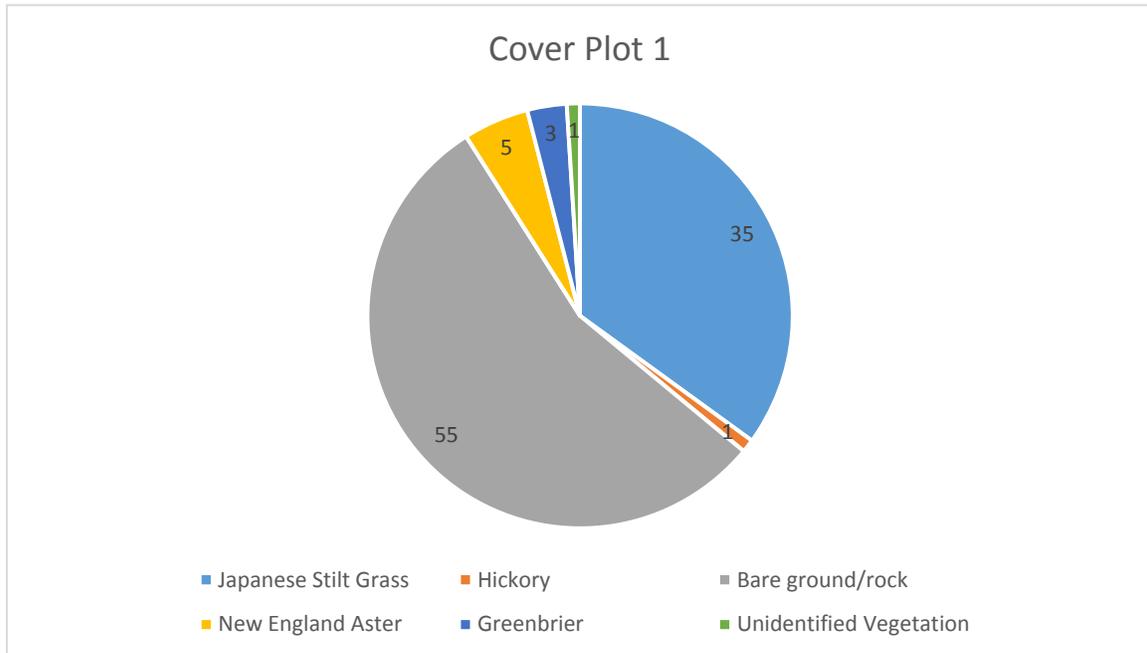
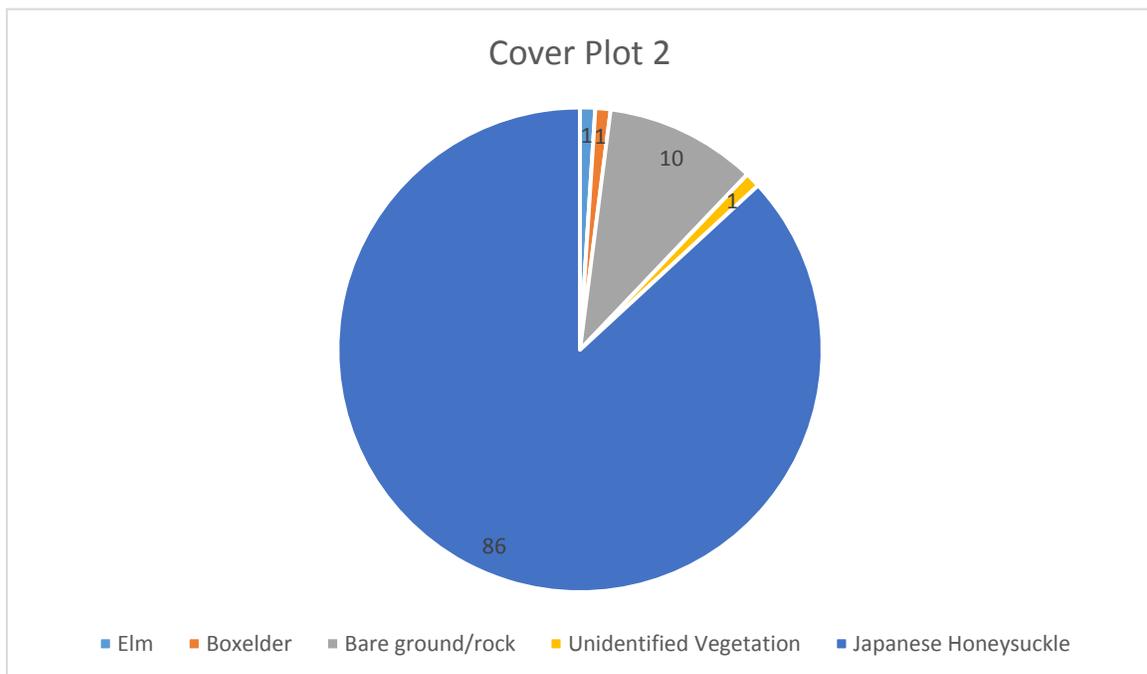
Bluestone Lake Pit Area Cover Plots

Plot one was taken within the historic rise of approximately 5 to 10 feet of elevation rise above normal summer pool elevation. The radius of the sampling plot was 10 feet. The plot indicated out of 100 percent cover that approximately 35 percent of the cover area consisted of invasive species. A plot outside of the normal rise of 5 to 10 feet in elevation was also conducted at approximately 15 to 20 feet of elevation. Cover plot 2 showed 86 percent total cover of invasive species.

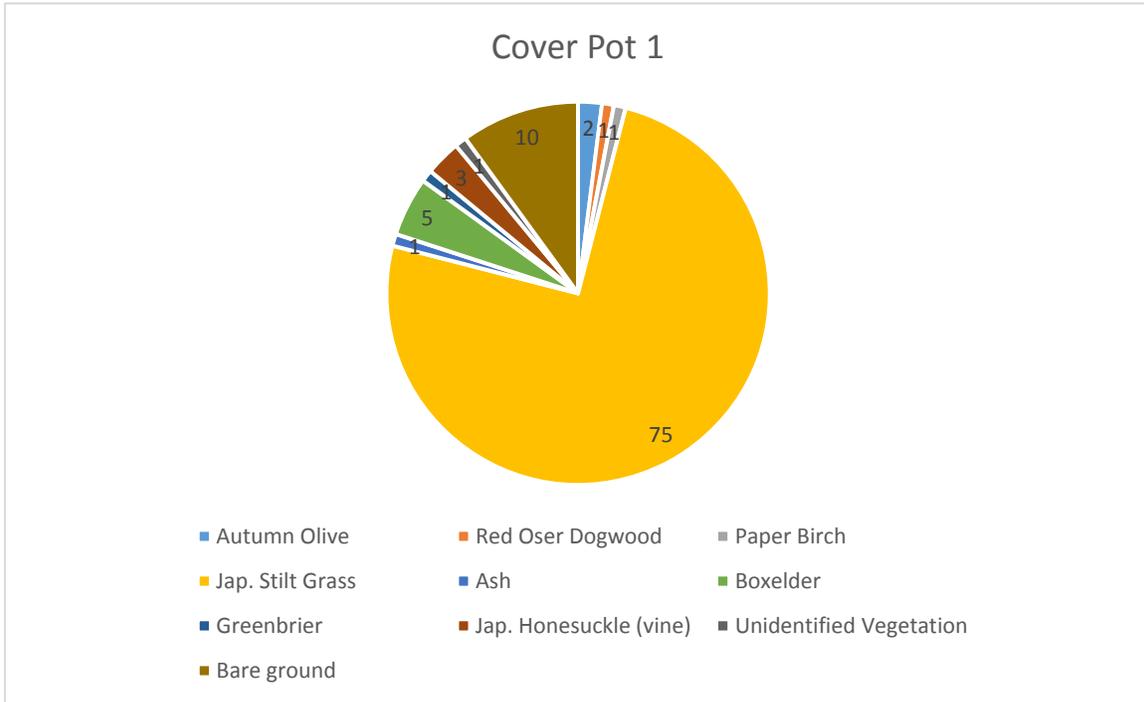
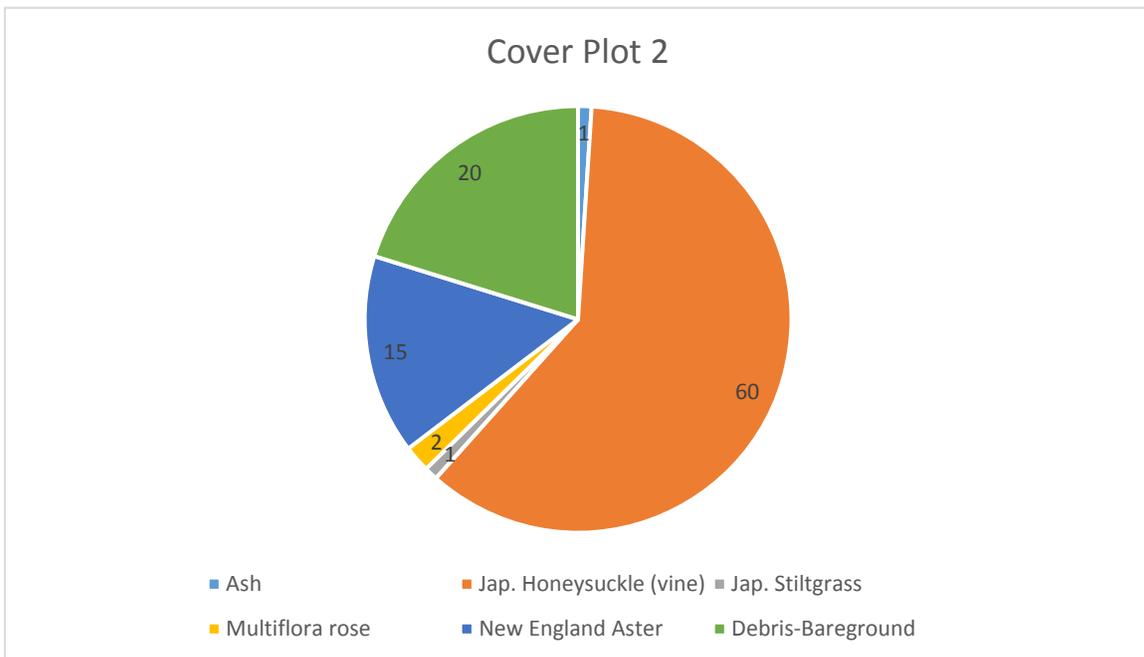
Bluestone Lake State Park Launch Ramp

Plot one was taken within the historic rise of approximately 5 to 10 feet of elevation rise above normal summer pool elevation. The radius of the sampling plot was 10 feet. The plot indicated out of 100 percent cover that approximately 80 percent of the cover area consisted of invasive species. A plot outside of the normal rise of 5 to 10 feet in elevation was also conducted at approximately 15 to 20 feet of elevation. Cover plot 2 showed 63 percent total cover of invasive species.
