FINAL
**BASELINE/AFFECTED ENVIRONMENT DATA FOR
SUPPLEMENTAL NEPA DOCUMENTATION,
ALTERNATIVE DISPOSAL SITES,
BLUESTONE DAM SAFETY MODIFICATION,
HINTON, WEST VIRGINIA**

Final
**Baseline/Affected Environment Data for
Supplemental NEPA Documentation,
Alternative Disposal Sites,
Bluestone Dam Safety Modification,
Hinton, West Virginia**

Contract No. W912737-16-D-0002
Task Order No. W9127818F0088

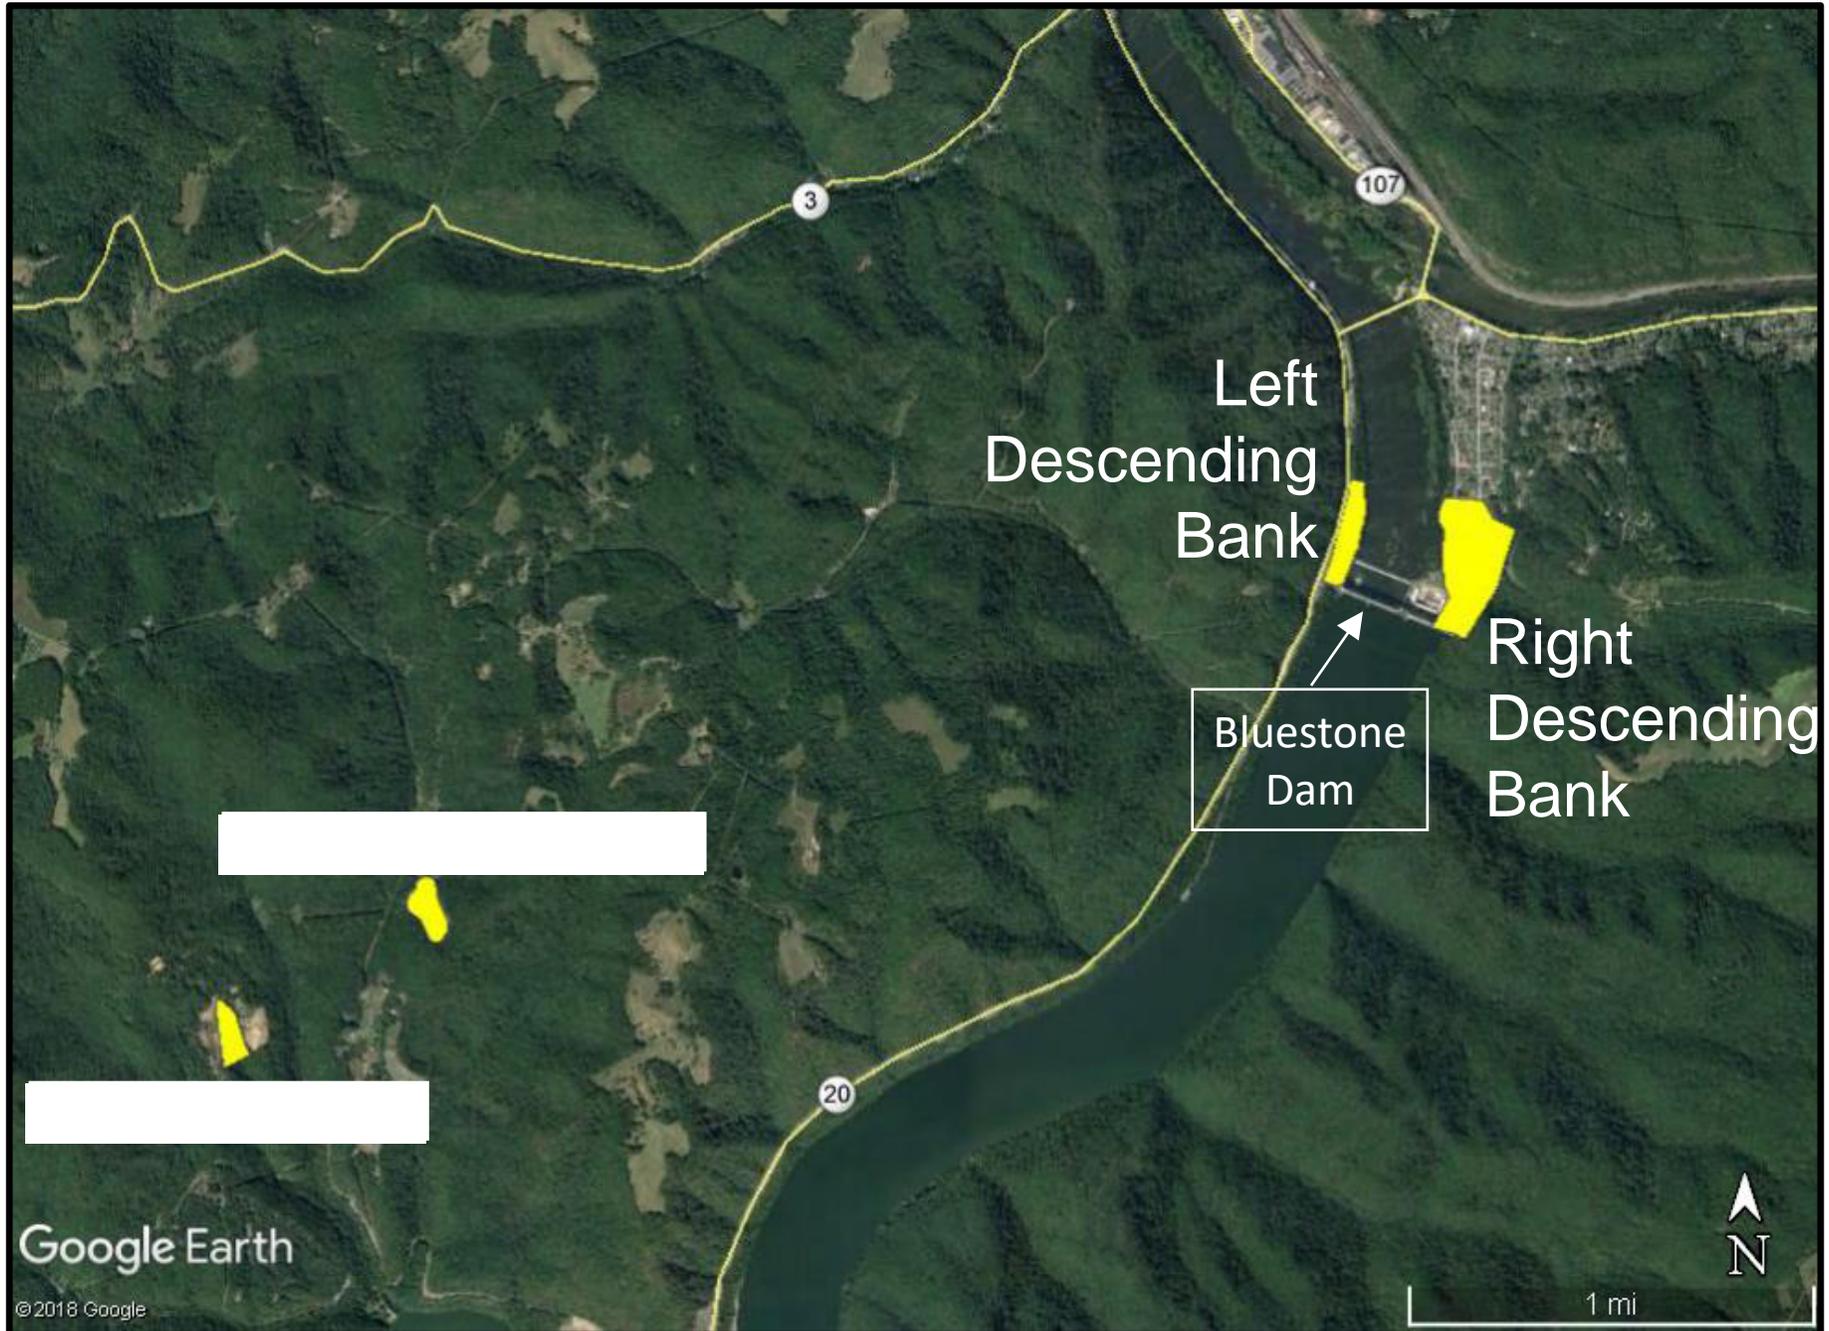
Figure 1-1: Alternative Disposal Sites

Four site disposal alternatives were identified for further analysis during PED (Figure 1-1). All of the sites are located well within the 40-mile radius originally analyzed in the 2016 Bluestone Dam Safety Modification SFEIS.

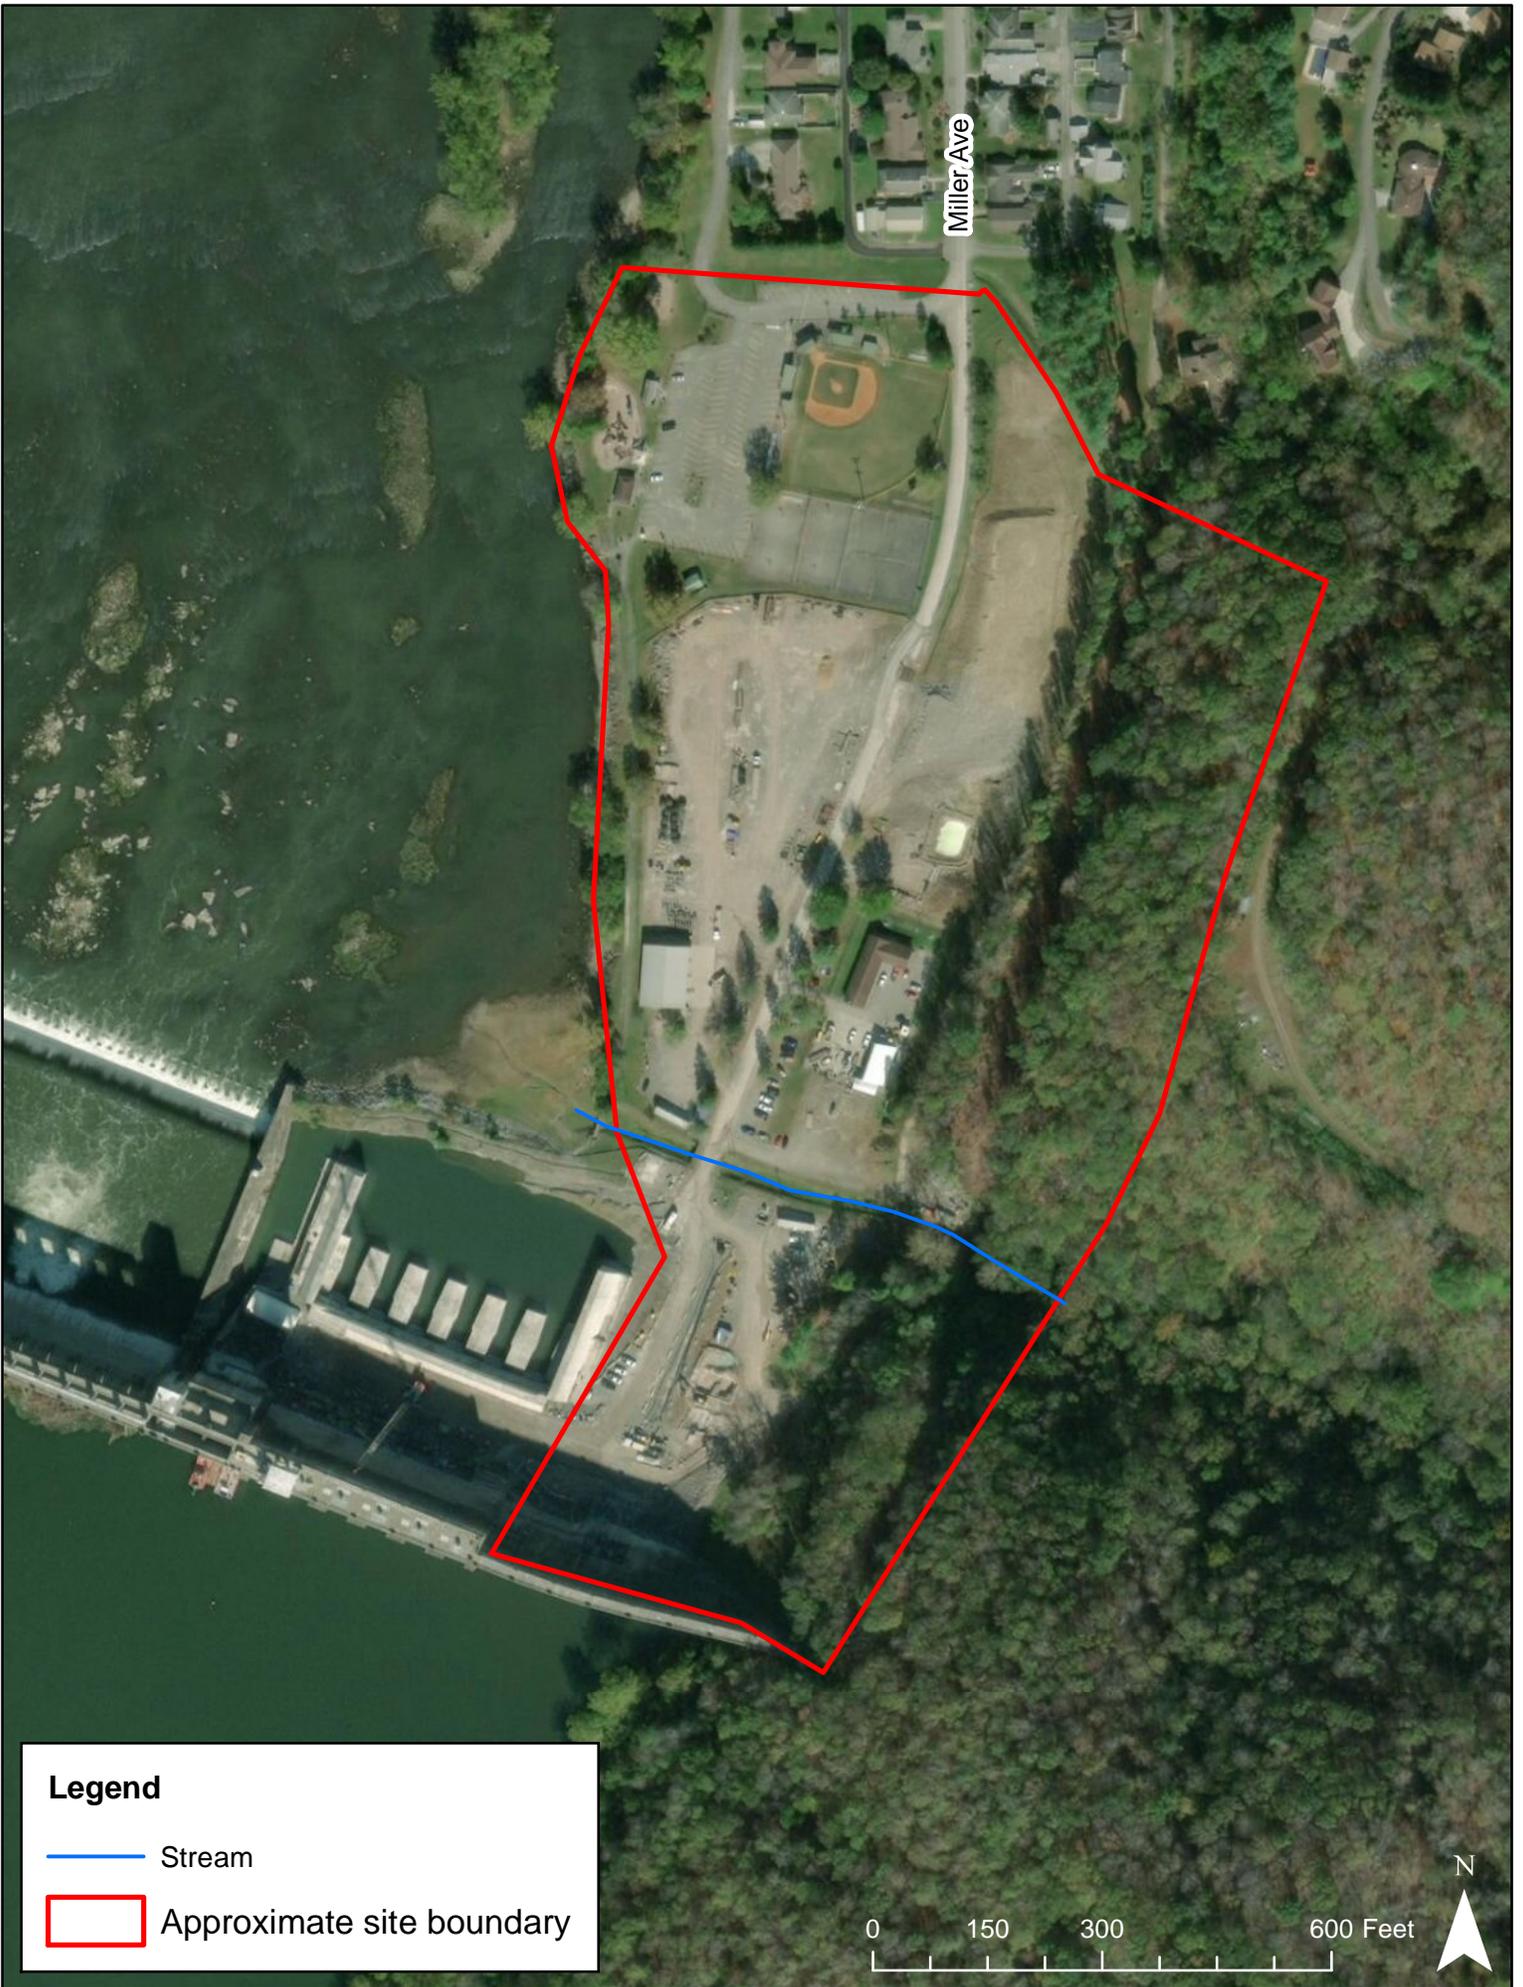
Figure 2-1: Right Bank Site Aquatic Resource Features

Within the right bank site, wetland and stream habitat is limited to a perennial stream that flows through the site from the east and into the eastern bank of the New River near the base of the dam (Figure 2-1). The stream is approximately three to five feet wide with flowing water at the time of the site survey (May 2018). As the stream

traverses through the site, the channel meanders down a steep slope then becomes channelized from the base of the slope to the New River. This stream would be considered jurisdictional “Waters of the U.S.”

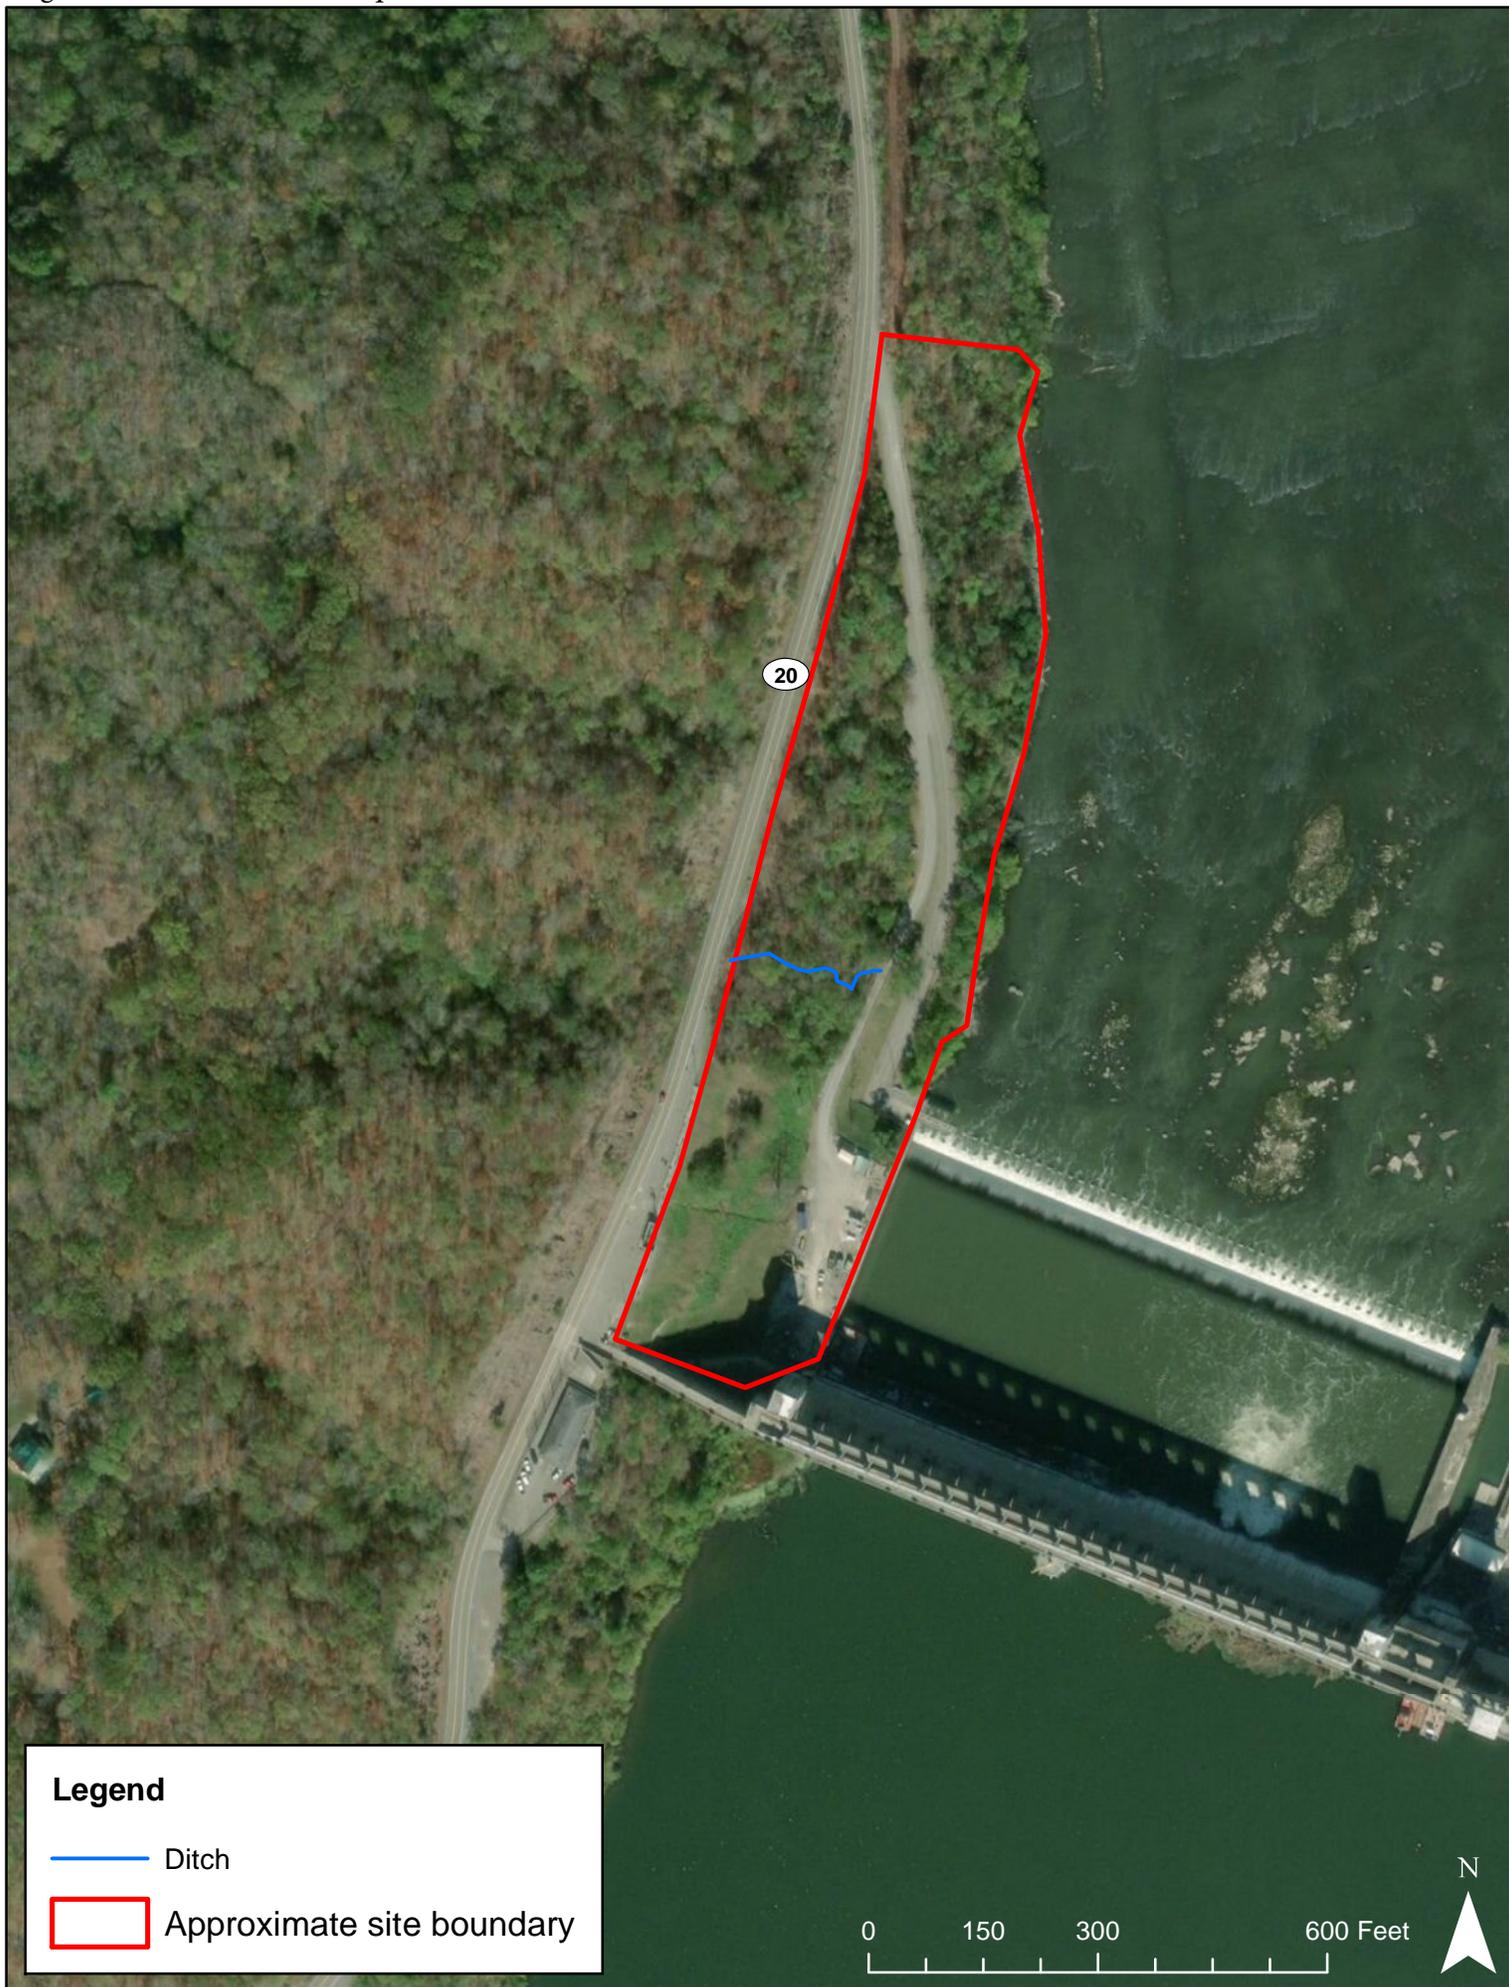
Figure 2-2: Left Bank Site Aquatic Resource Features

Within the left bank site, a ditch exists from the edge of WV Route 20 to the dam access road. This ditch would not likely qualify as jurisdictional “Waters of the U.S.” or “Other Waters” (Figure 2-2).

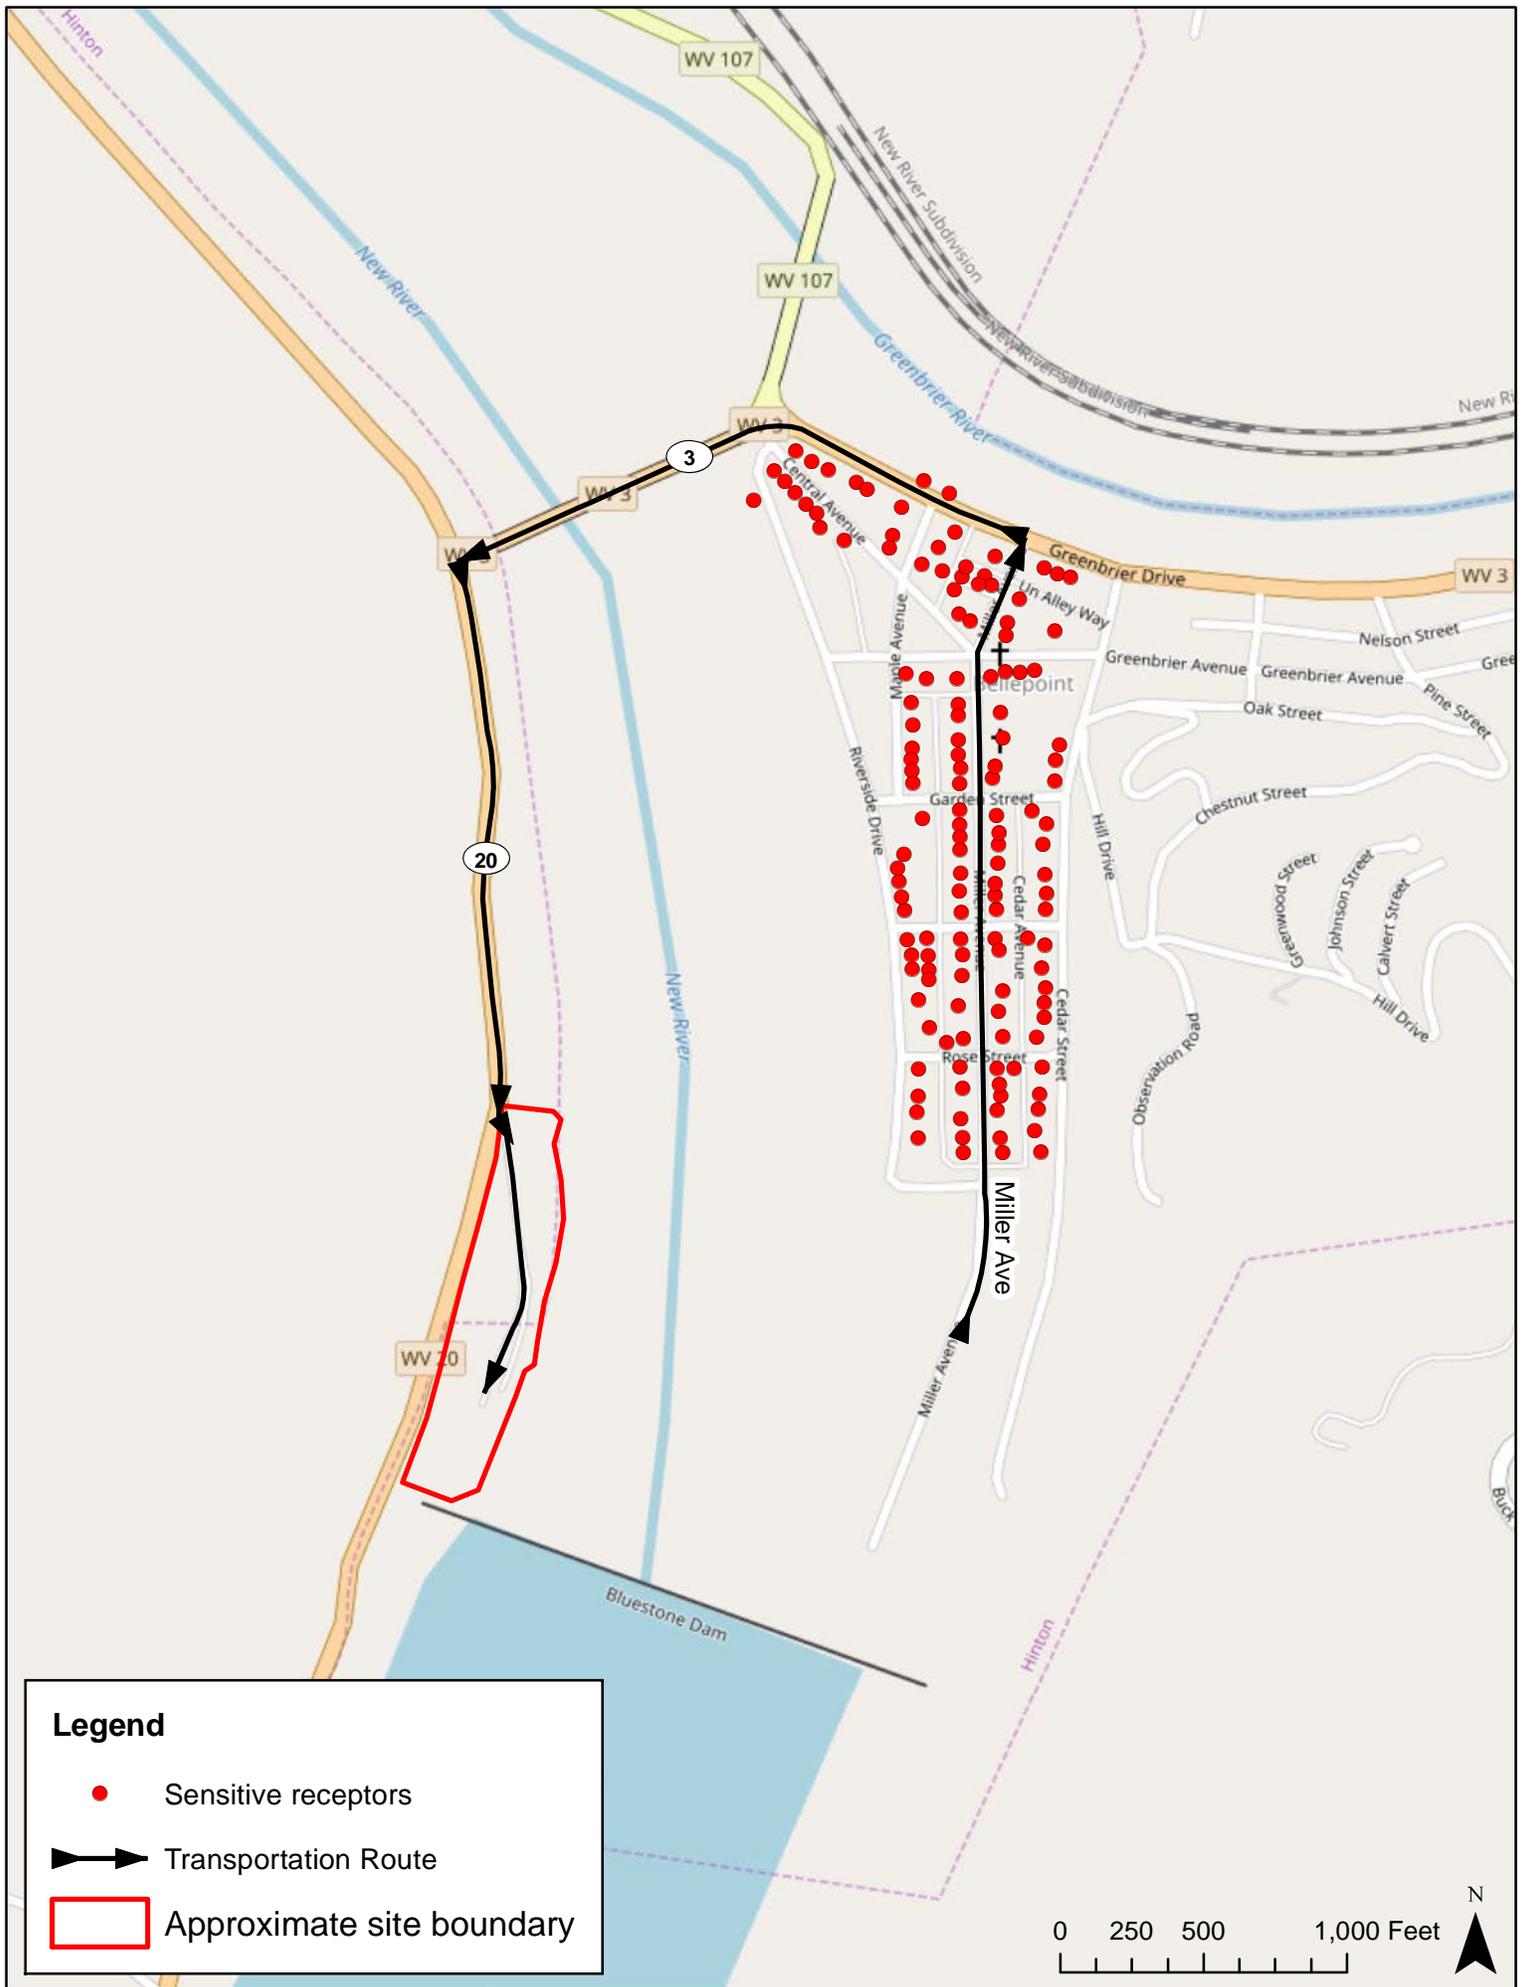
Figure 2-5: Left Bank Site Transportation Route and Noise Receptors

As described in the 2016 Bluestone Dam Safety Modification SFEIS, the ambient noise at Bluestone Dam within the right and left bank sites varies continuously and is composed of sounds from distant sources that are relatively steady, such as the flow of water through the dam, and of other sources, such as traffic sounds along WV Route 20 and ongoing construction at Bluestone Dam, that vary significantly in duration and magnitude. The CSX railroad line is located just north of Bellepoint and loud noises associated with horn blowing, diesel engines etc., while intermittent, also contribute to the ambient noise environment in the area. While there are no sensitive noise receptors in the area of the left bank site, several homes and a park which could potentially be affected by noise impacts from disposal activities are adjacent to the right bank site and transportation routes (Figure 2-5).

In order to reach the left bank site, disposal material would be hauled from the dam along approximately 1.25 miles on Miller Road in Bellepoint, 0.4 miles on WV Route 3, and 0.4 miles on WV Route 20 (Figure 2-5). Miller Avenue is a local, paved, two-lane road, and both WV Route 3 and WV Route 20 are paved, two lane, minor arterial roads. While no traffic counts are readily available for Miller Road, Table 2-2 provides available traffic counts for the portions of WV Route 3 and WV Route 20 that would be utilized for transportation between the left and right banks.

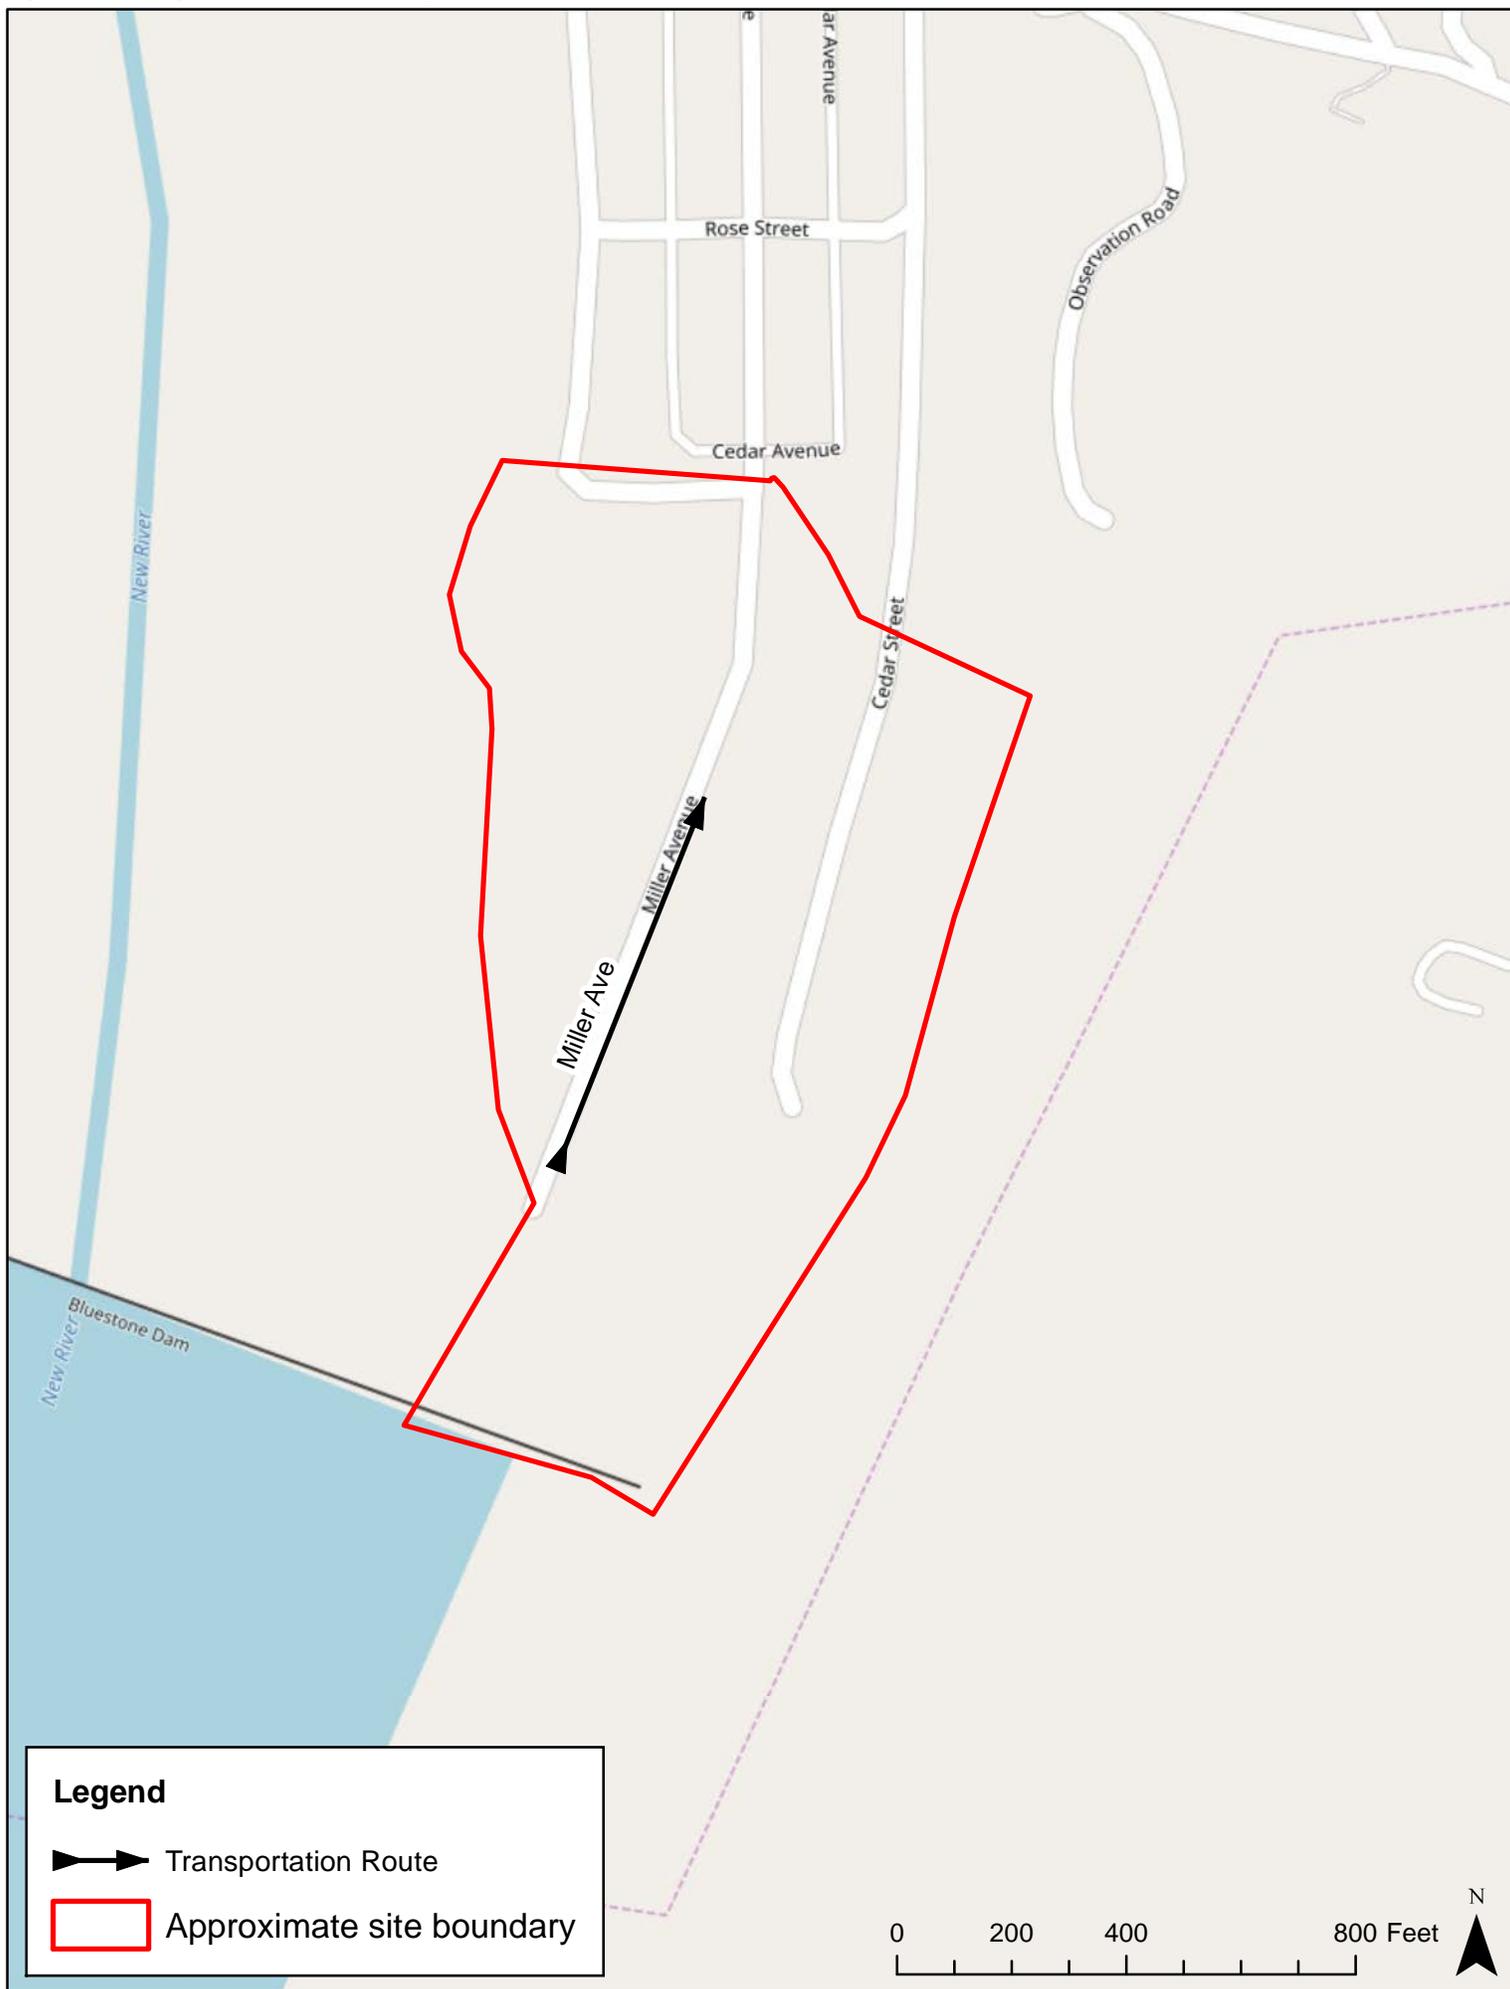
Figure 2-6: Right Bank Site Transportation Route

No state highways or local roads, with the exception of the portion of Miller Avenue traversing Bellepoint Park on the right bank, would be utilized if the right bank site is selected for use (Figure 2-6).

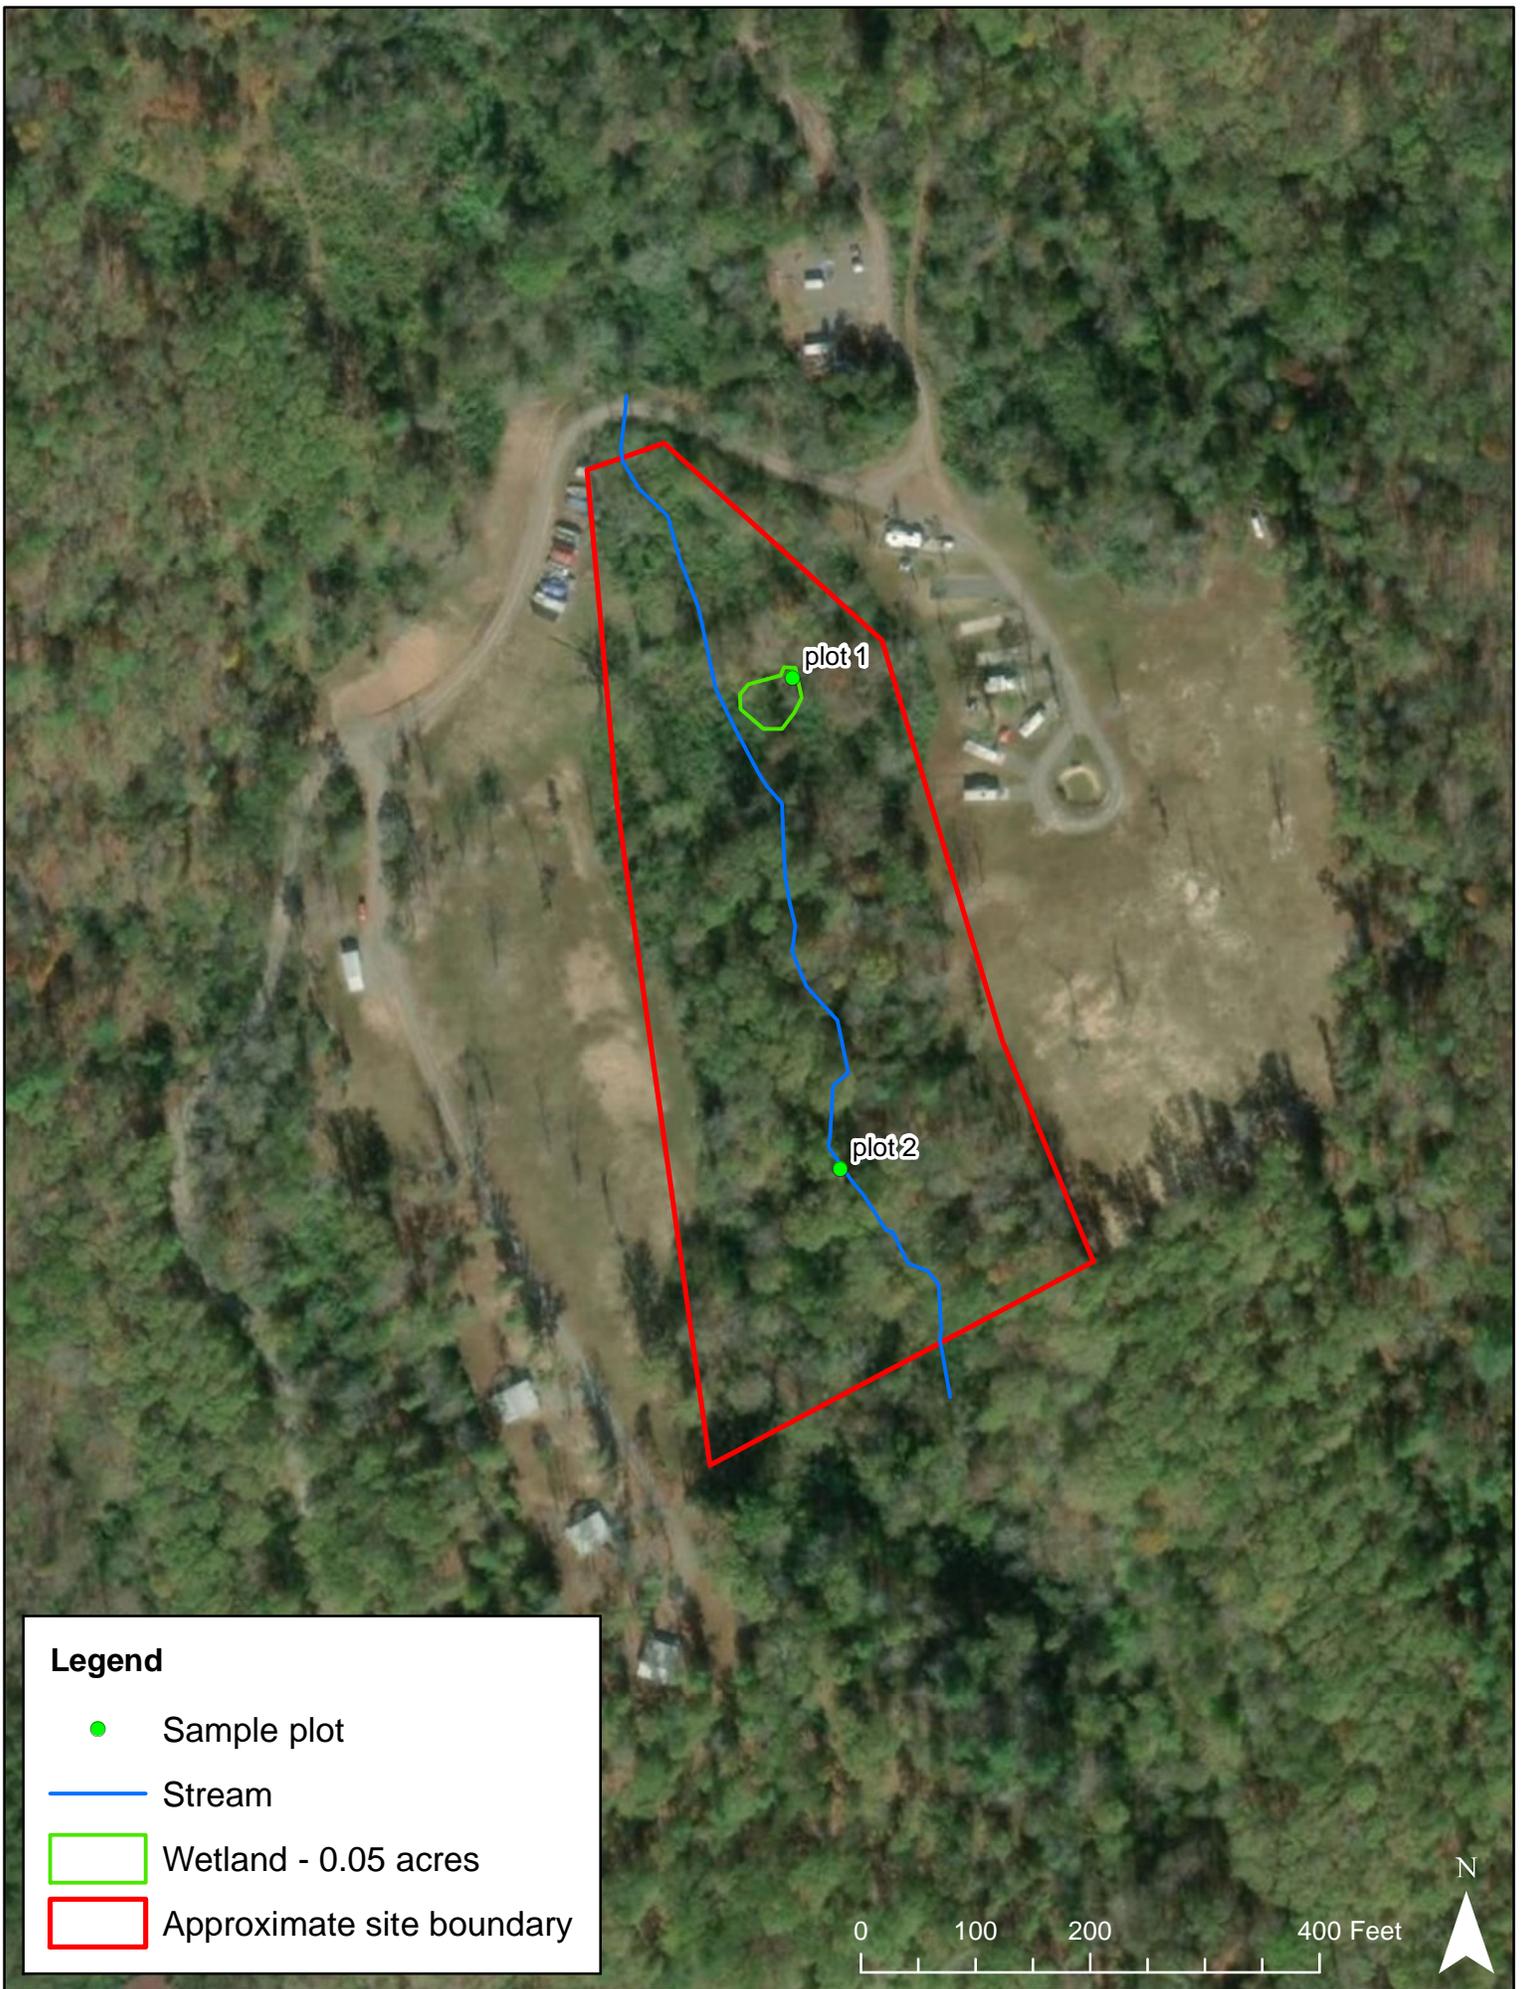
Figure 3-1:

A narrow flowing stream, ranging from two to three feet wide, traverses the site from north to south (Figure 3-1). This stream has a sandy gravel substrate with larger rocks along the sides and a depth of approximately three to eight inches within the site. Outside of this site, this stream merges with Surveyors Creek, a tributary of the Bluestone River. A few small herbaceous wetland habitats, the largest being 0.05 acres in size, are situated intermittently along the sides of the stream, such as the wetland site surveyed as shown in Figure 3-1. Appendix C contains wetland identification data sheets from the May 2018 site visit corresponding to the plots shown in Figure 3-1. These habitats consist of species such as golden ragwort (*Packera aurea*), soft rush (*Juncus effusus*), squarrose sedge (*Carex squarrosa*), false nettle (*Boehmeria cylindrica*), and Christmas fern (*Polystichum acrostichoides*).

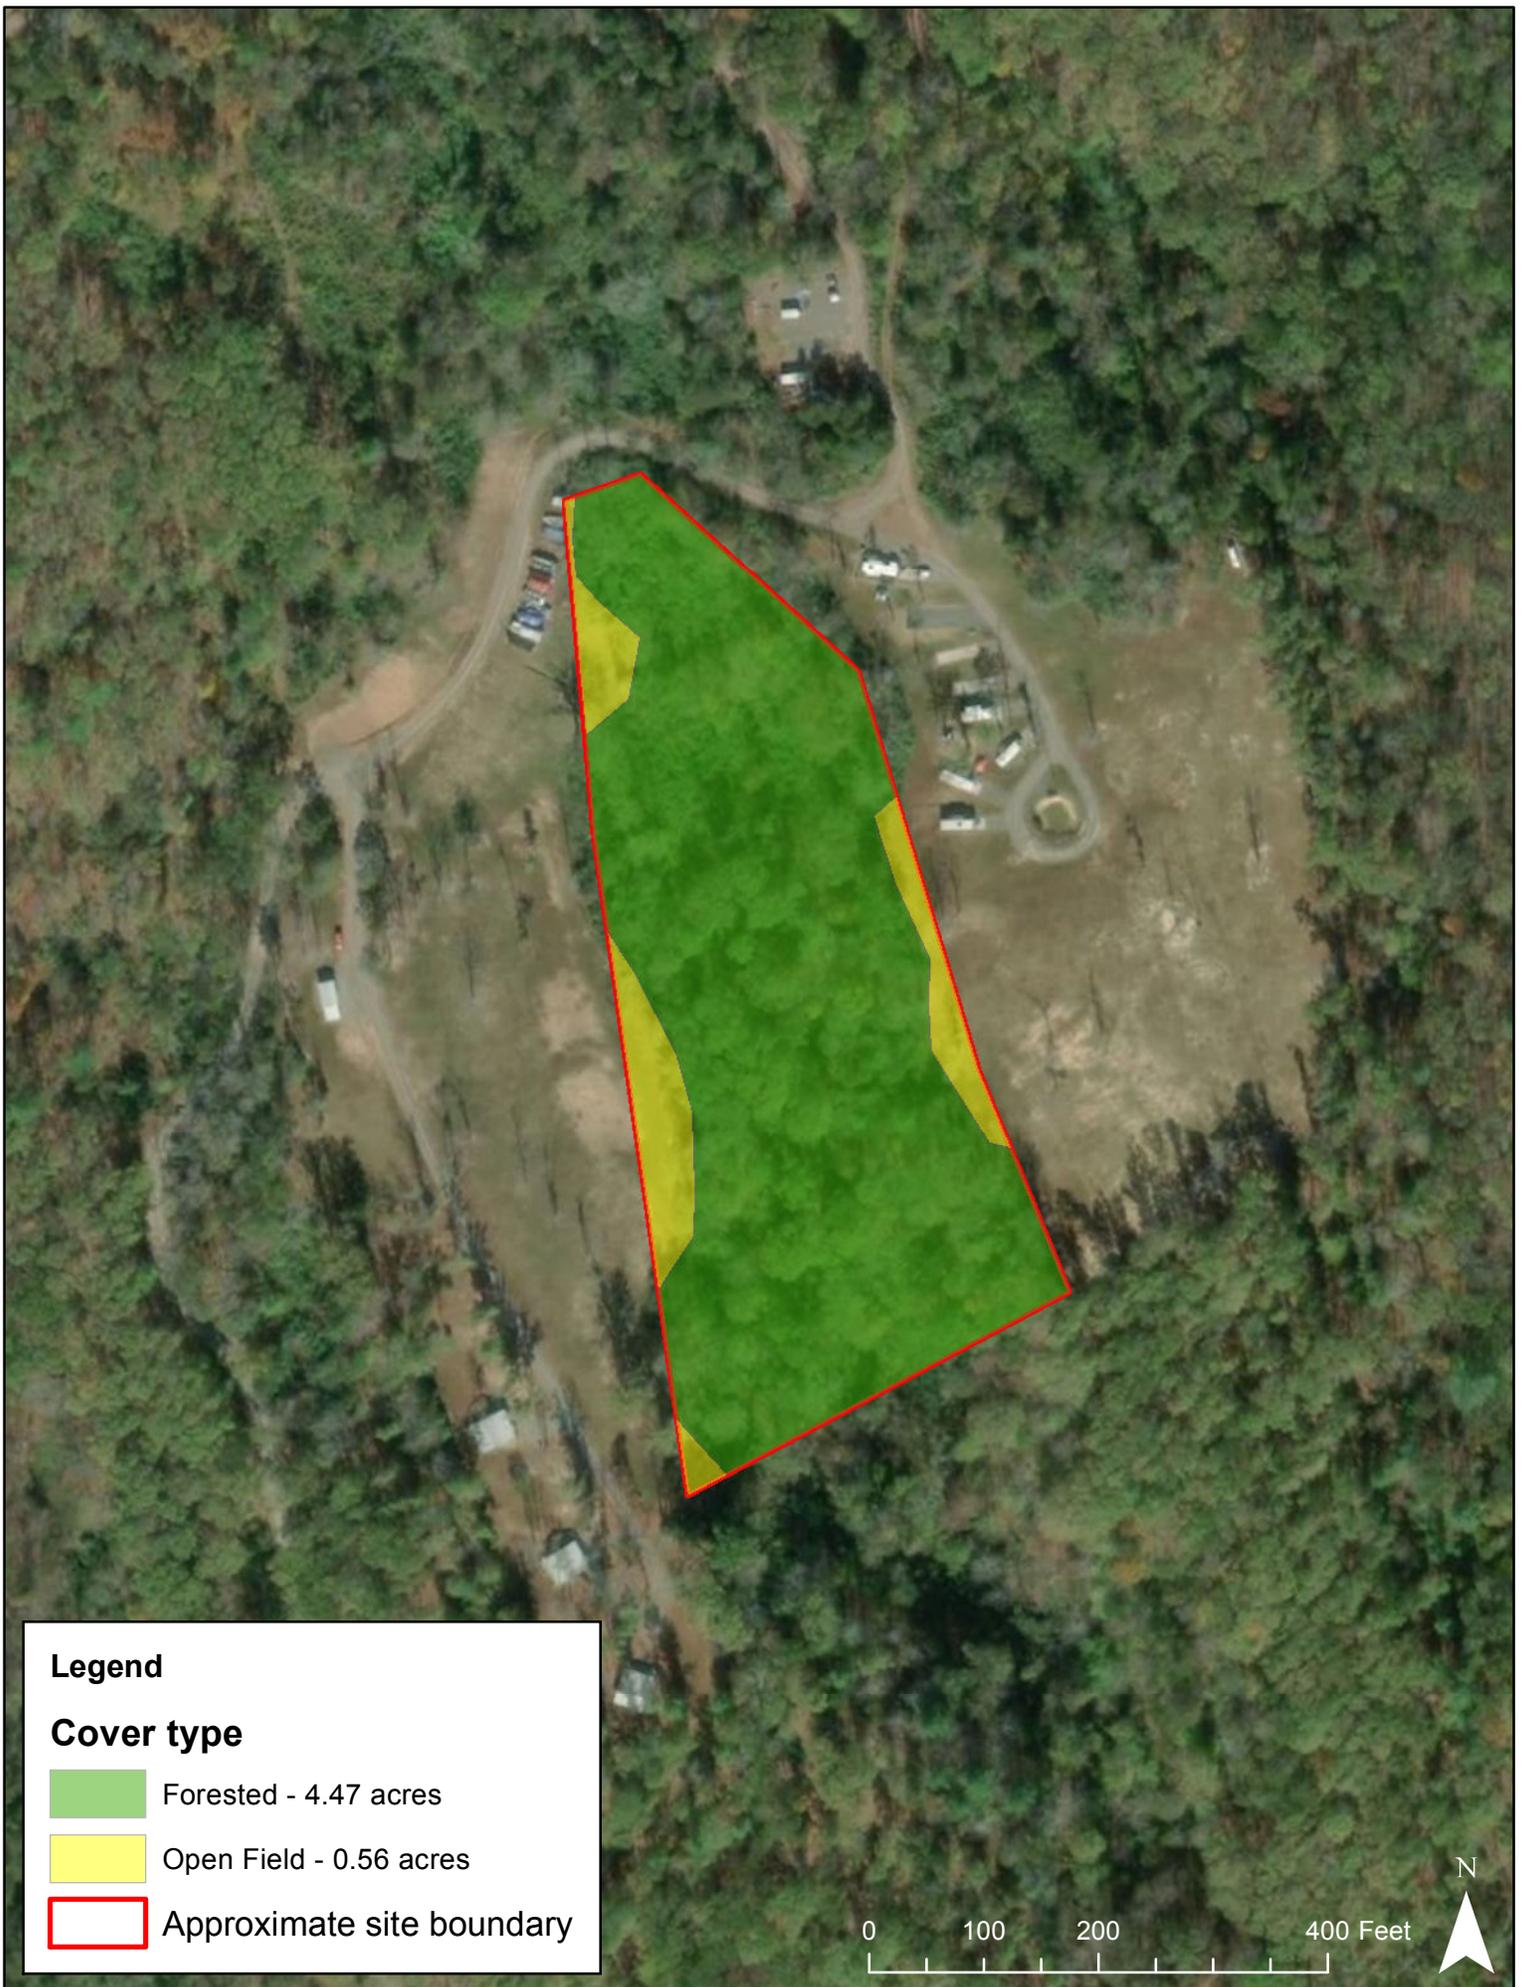
Figure 3-2:

Situated within a valley, this site consists of a hardwood forest with a small creek traversing through the center of the valley (Figure 3-2). The northern quarter of the site has an overstory dominated by pignut hickory, white ash (*Fraxinus americana*), black walnut, Northern red oak, black cherry, black locust, sugar maple, and yellow poplar (*Liriodendron tulipifera*). An opening of the overstory canopy in the uppermost portion of the site has allowed the growth of an understory of smooth sumac, autumn olive, Chinese privet, multiflora rose, and black locust which is denser than the understory of the lower three quarters of the site.
