FINAL
**BASELINE/AFFECTED ENVIRONMENT DATA FOR
SUPPLEMENTAL NEPA DOCUMENTATION,
ALTERNATIVE DISPOSAL SITES,
BLUESTONE DAM SAFETY MODIFICATION,
HINTON, WEST VIRGINIA**

Final
**Baseline/Affected Environment Data for
Supplemental NEPA Documentation,
Alternative Disposal Sites,
Bluestone Dam Safety Modification,
Hinton, West Virginia**

Contract No. W912737-16-D-0002
Task Order No. W9127818F0088

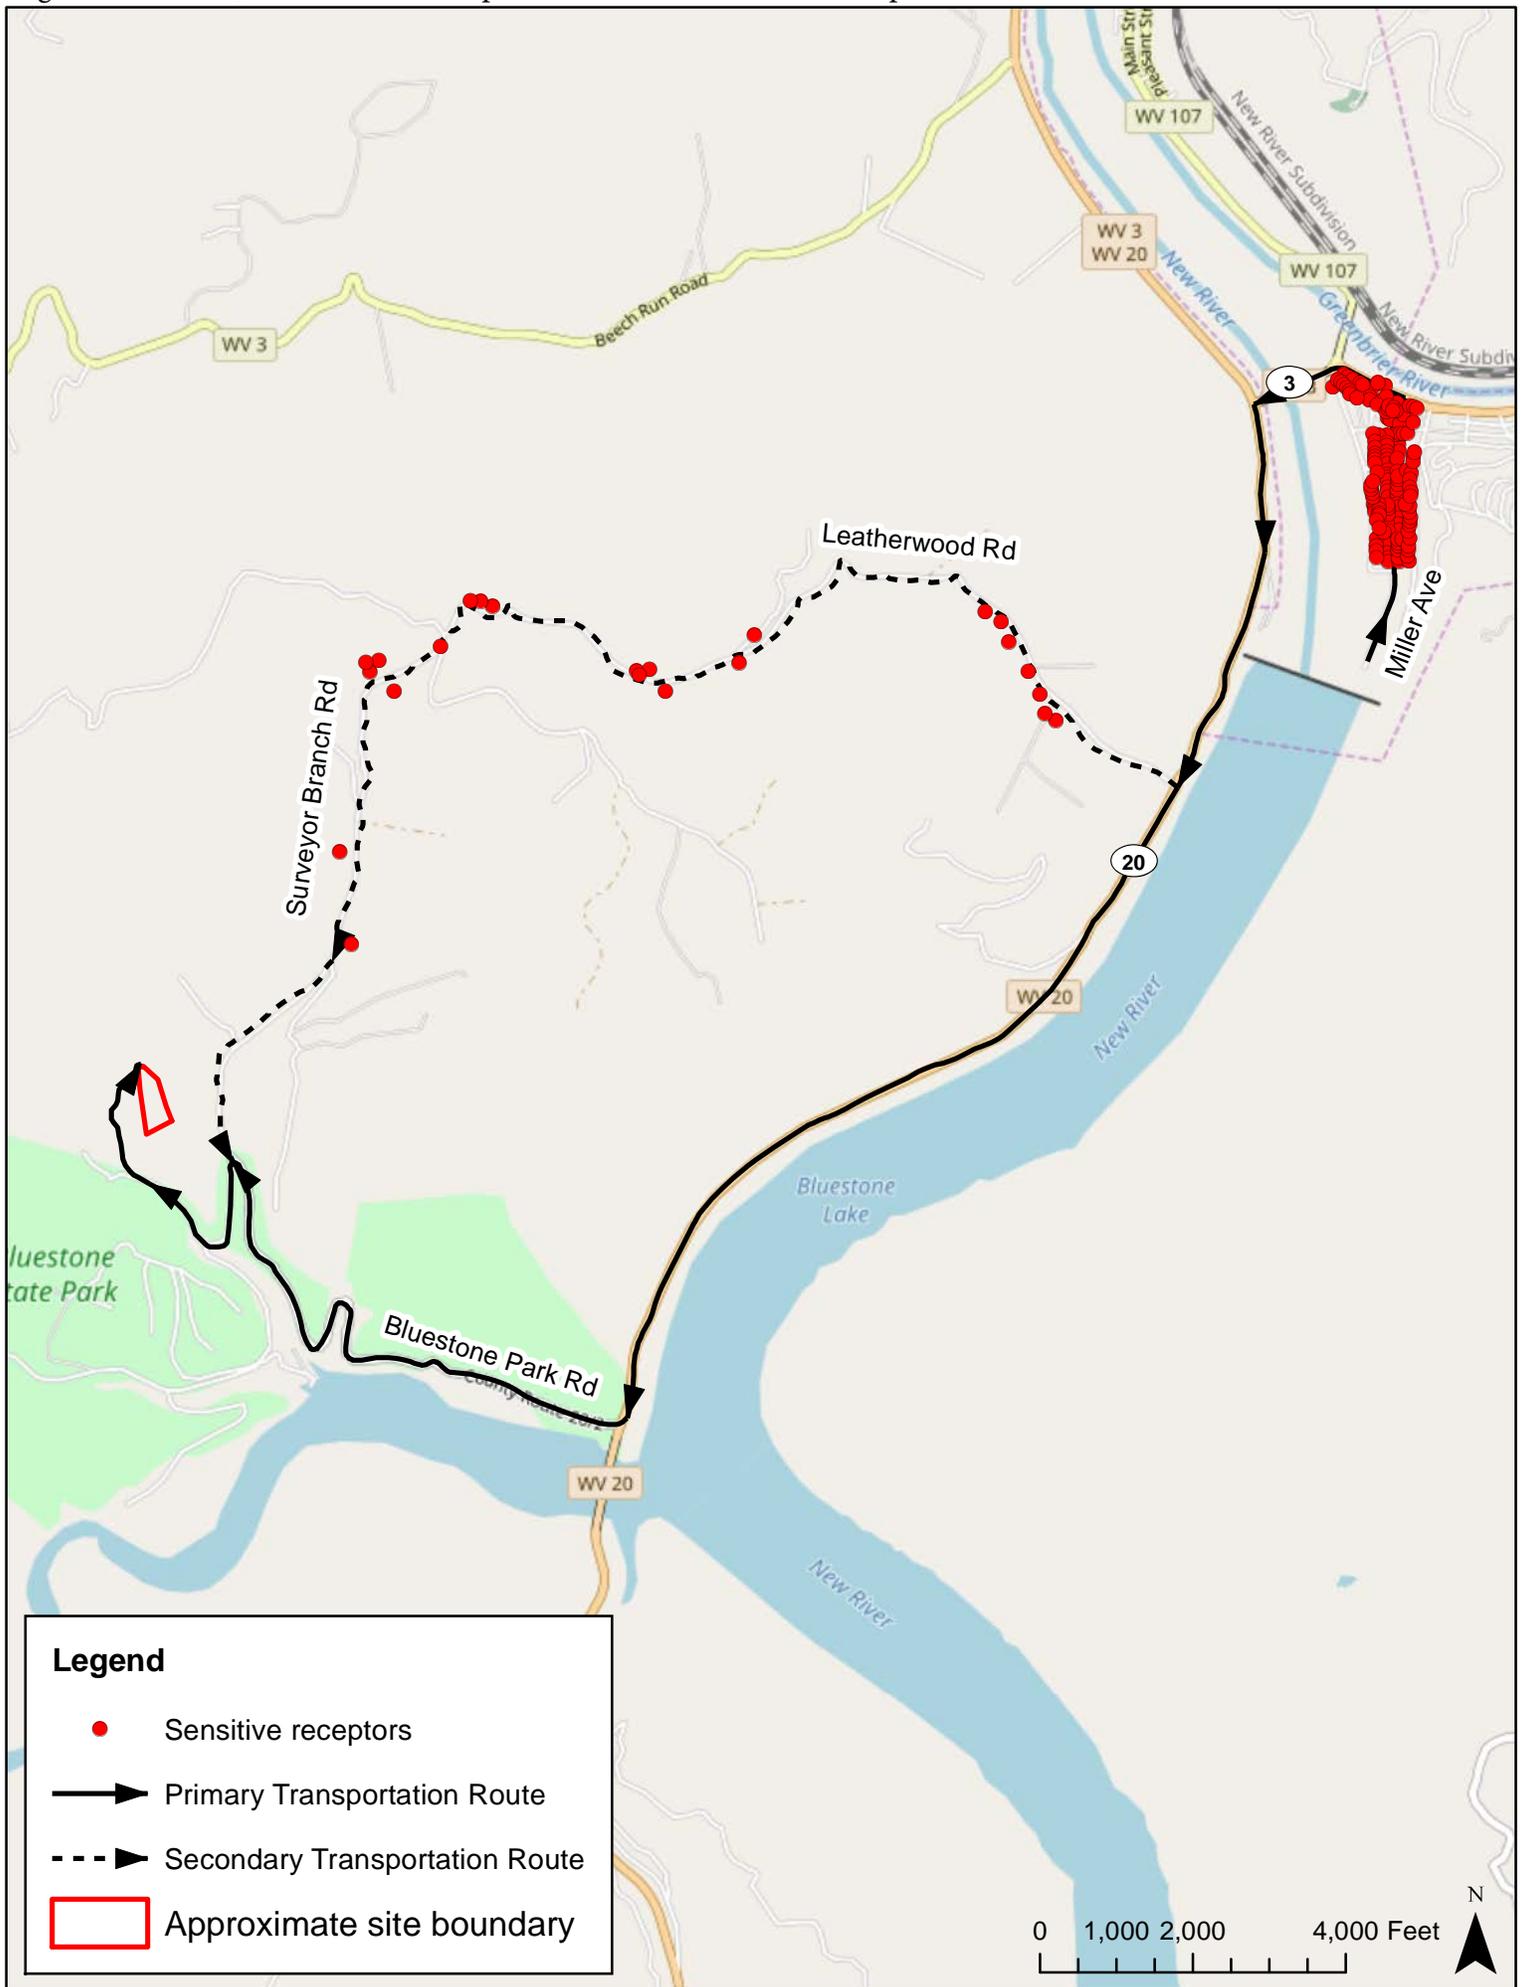
Figure 3-5ZSD\Wdai ` Site Transportation Route and Noise Receptors

This site is located within a rural portion of the county, with very limited development outside of the nearby Leatherwood Campground (one-quarter mile east of the site). Thus, the ambient noise in and around the site is limited to occasional vehicular traffic on Surveyor Branch Road and Bluestone Park Road. Numerous sensitive noise receptors, primarily residences, exist along the secondary northern transportation route (Figure 3-3).

Two different routes between the dam and this site could potentially be used to transport disposal material: a primary southern route and a secondary northern route (Figure 3-3). The southern route includes approximately 2.8 miles on WV Route 20, 1.8 miles on Bluestone Park Road, 0.2 miles on Fork Ridge Road, and 0.25 miles on an unnamed road to the site for a total of approximately 5.05 miles.

The northern route includes 0.4 miles on WV Route 20, 4.8 miles on Leatherwood Road, 1.0 mile on Surveyor Branch Road, 0.5 miles on Bluestone Park Road, 0.2 miles on Fork Ridge Road, and 0.25 miles on an unnamed road to the site for a total of approximately 7.15 miles.
