Formerly Used Defense Sites Newsletter

Summer 2014 Edition

USACE HUNTINGTON DISTRICT COMPLETES SOIL REMEDIATION IN TNT AREA A AT THE FORMER PLUM BROOK ORDNANCE WORKS IN SANDUSKY, OHIO

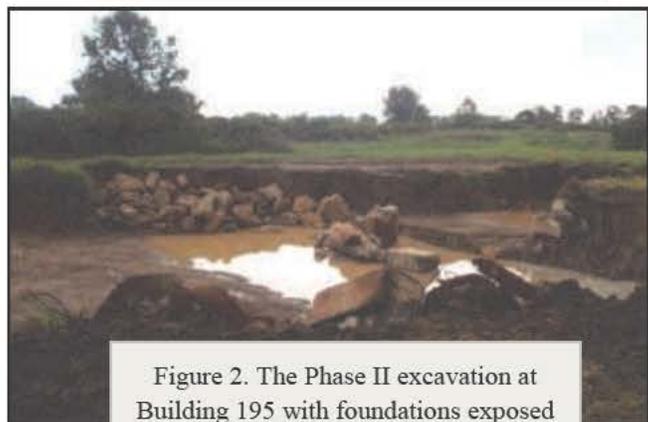
Figure 2. The Phase II excavation at Building 195 with foundations exposed

The US Army Corps of Engineers (USACE) Huntington District continues the environmental restoration at the former Plum Brook Ordnance Works (PBO) located in Sandusky, Ohio. The Formerly Used Defense Site (FUDS) Program environmental restoration conducted from January 2012 through May 2014 consisted of the Remedial Action-Construction (RA-C) effort in TNT Area A (TNT A). TNT A was one of three explosives manufacturing lines at PBO. Figure 1 depicts Building 195, which was one of the buildings in TNT A. The date of the picture is unknown but it was well after the cessation of manufacturing operations as evidenced by the heavy vegetation. Most of the manufacturing buildings have been demolished and the only evidence the buildings existed is their buried foundations (Figure 2).

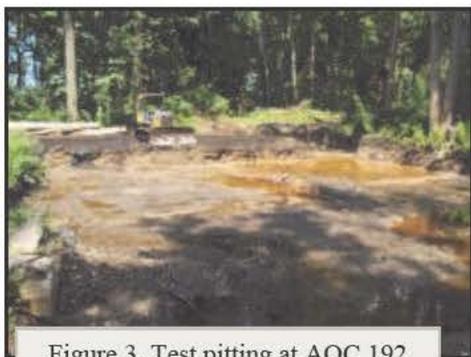
Figure 3. Test pitting at AOC 192

In May 2013, USACE initiated field efforts to excavate the remaining six AOCs in TNT A. Phase II efforts consisted of test pitting (Figure 3 and Figure 4), confirmation sampling, excavation of contaminated soil, backfilling the AOC with clean soil, soil characterization, transporting hazardous soil to the remediation pad, and transporting the non-hazardous soil to the Erie County Landfill for use as daily cover.

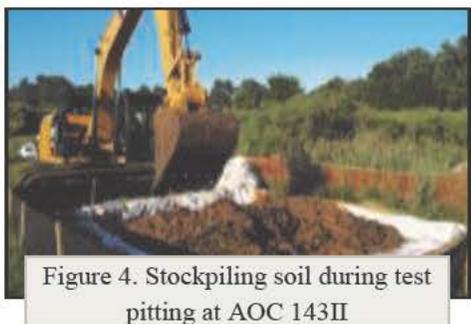
Figure 4. Stockpiling soil during test pitting at AOC 143II

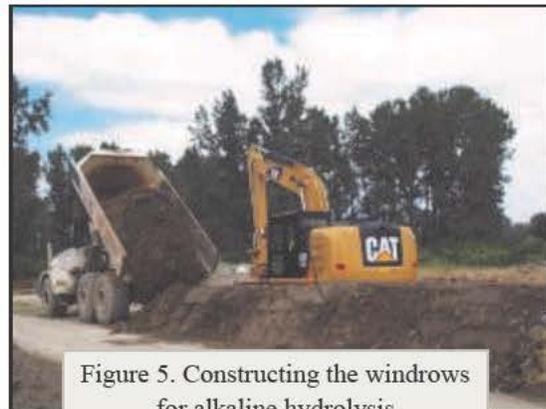
Figure 5. Constructing the windrows for alkaline hydrolysis

The Phase II stockpile soils were characterized to determine if the soil was non-hazardous or hazardous. The non-hazardous soil was transported to the Erie County Landfill for use as daily cover. The soil that was characteristically hazardous was transported (Figure 5) to the remediation pad to undergo alkaline hydrolysis remediation along with the hazardous soil from Phase I.

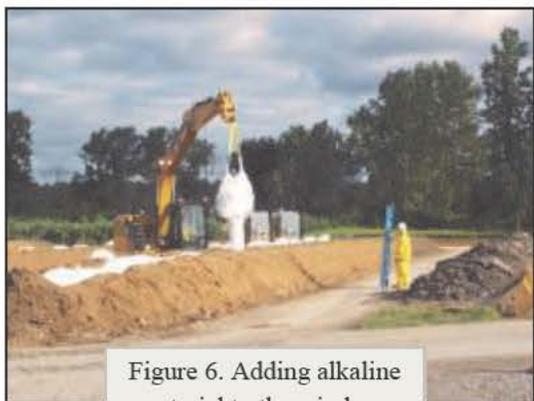
Figure 6. Adding alkaline material to the windrow

The alkaline hydrolysis process has been used at PBOW in remediating nitroaromatic-contaminated soil on past projects. During remediation of the TNT A soil, the alkaline hydrolysis (Figure 6) process reduced the nitroaromatics to levels where a portion of it could be placed back in the open excavation as backfill. Clean soil was purchased locally to complete backfilling each AOC.

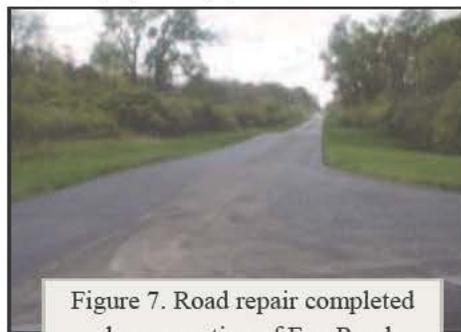
Figure 7. Road repair completed along a section of Fox Road

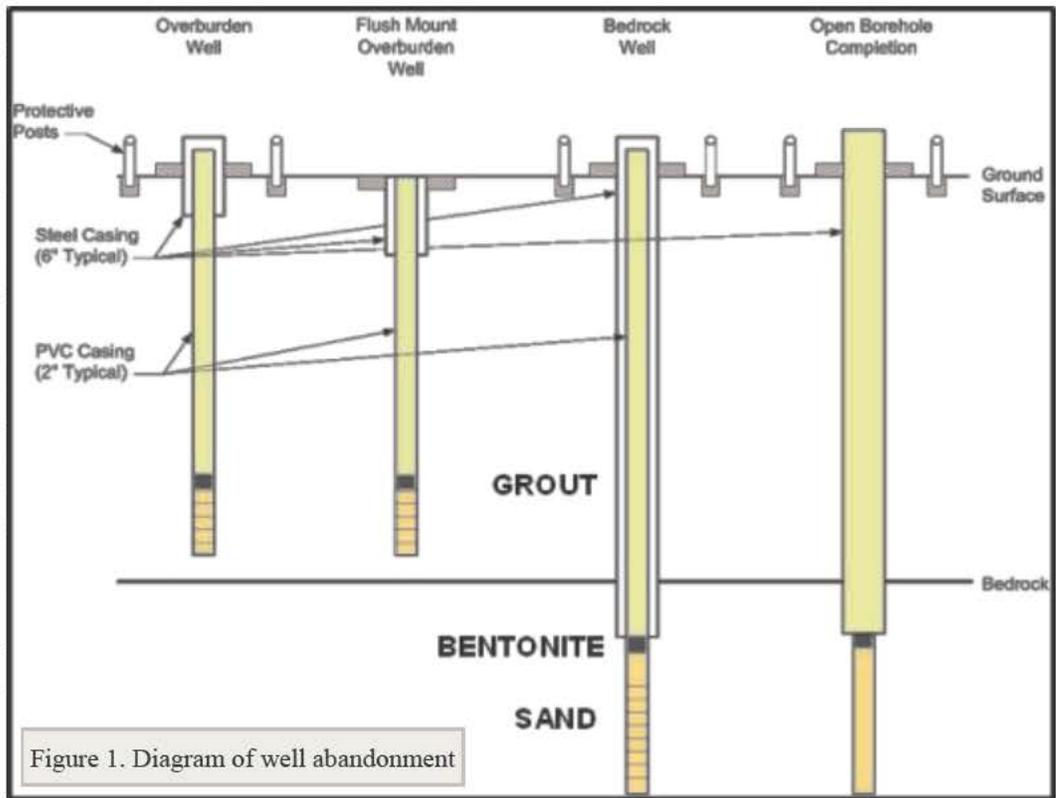
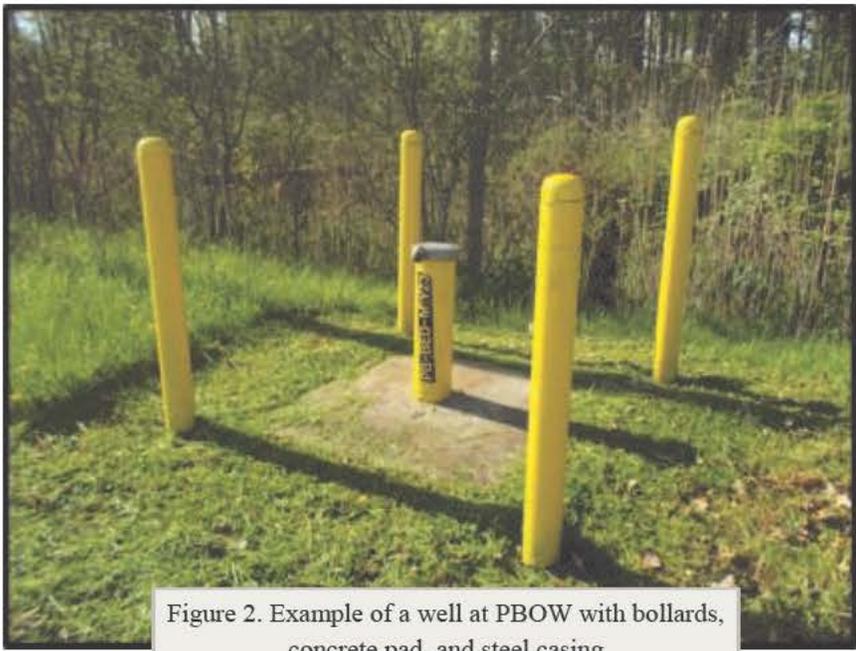
Figure 2. Example of a well at PBOW with bollards, concrete pad, and steel casing

The USACE’s groundwater monitoring wells at the PBOW site includes bedrock wells to monitor the deep groundwater and overburden wells to monitor the shallow groundwater. Abandoning the bedrock wells in-place will consist of filling the casing with sand, and then a foot of bentonite (Figure 1) will be placed on top of the sand. Bentonite is a natural clay material that will swell with moisture and seal the well from the inside. Then each well will be topped off with grout to approximately four feet below the ground surface. Once the well is sealed, a crew will remove the bollards and pad (Figure 2), then excavate to 3-4 feet below ground surface, cut the casing and remove it from the well. All of

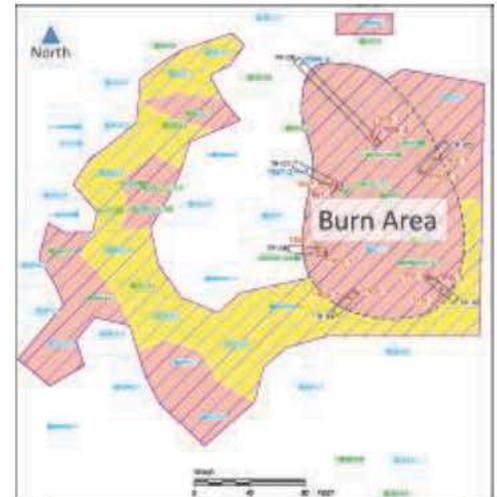
Figure 2. R2BG excavation area

The R2BG site consists of an area designated as the “burn area” (Figure 2) which was the primary area where

burning took place. The burn area was identified by a layer of burned material about 1 foot thick and approximately 1 foot below the surface. The burn area is approximately 0.4 acres. The area adjacent to the burn area was also impacted by the burning activities most likely from moving the burned materials away from the burn pile. The total volume of soil to be excavated is 7,395 cubic yards. The burn area will be excavated to a depth of 8 feet and the area outside the burn area will be excavated to a depth of 2 feet.

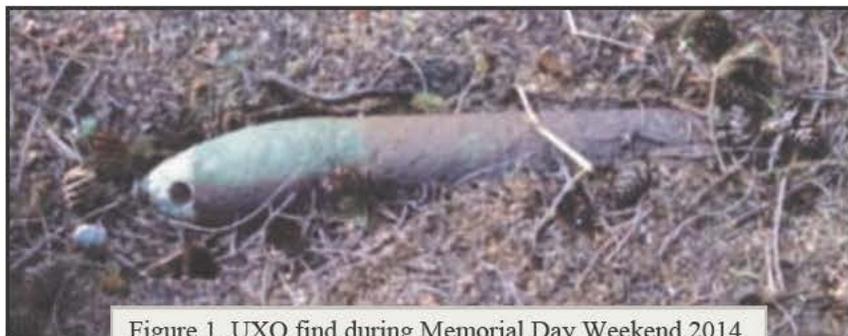
Figure 1. UXO find during Memorial Day Weekend 2014. Identified as a 4.2" mortar, white phosphorus, M2A1

Corps acts quickly to remove mortar found along Dolly Sods trails. Over Memorial Day Weekend 2014, an Unexploded Ordnance (UXO)—a 4.2” mortar containing white phosphorous—was found in the Dolly Sods Wilderness Area (DSWA) of West Virginia by Boy Scouts who were backpacking and camping in the area (Figure 1).

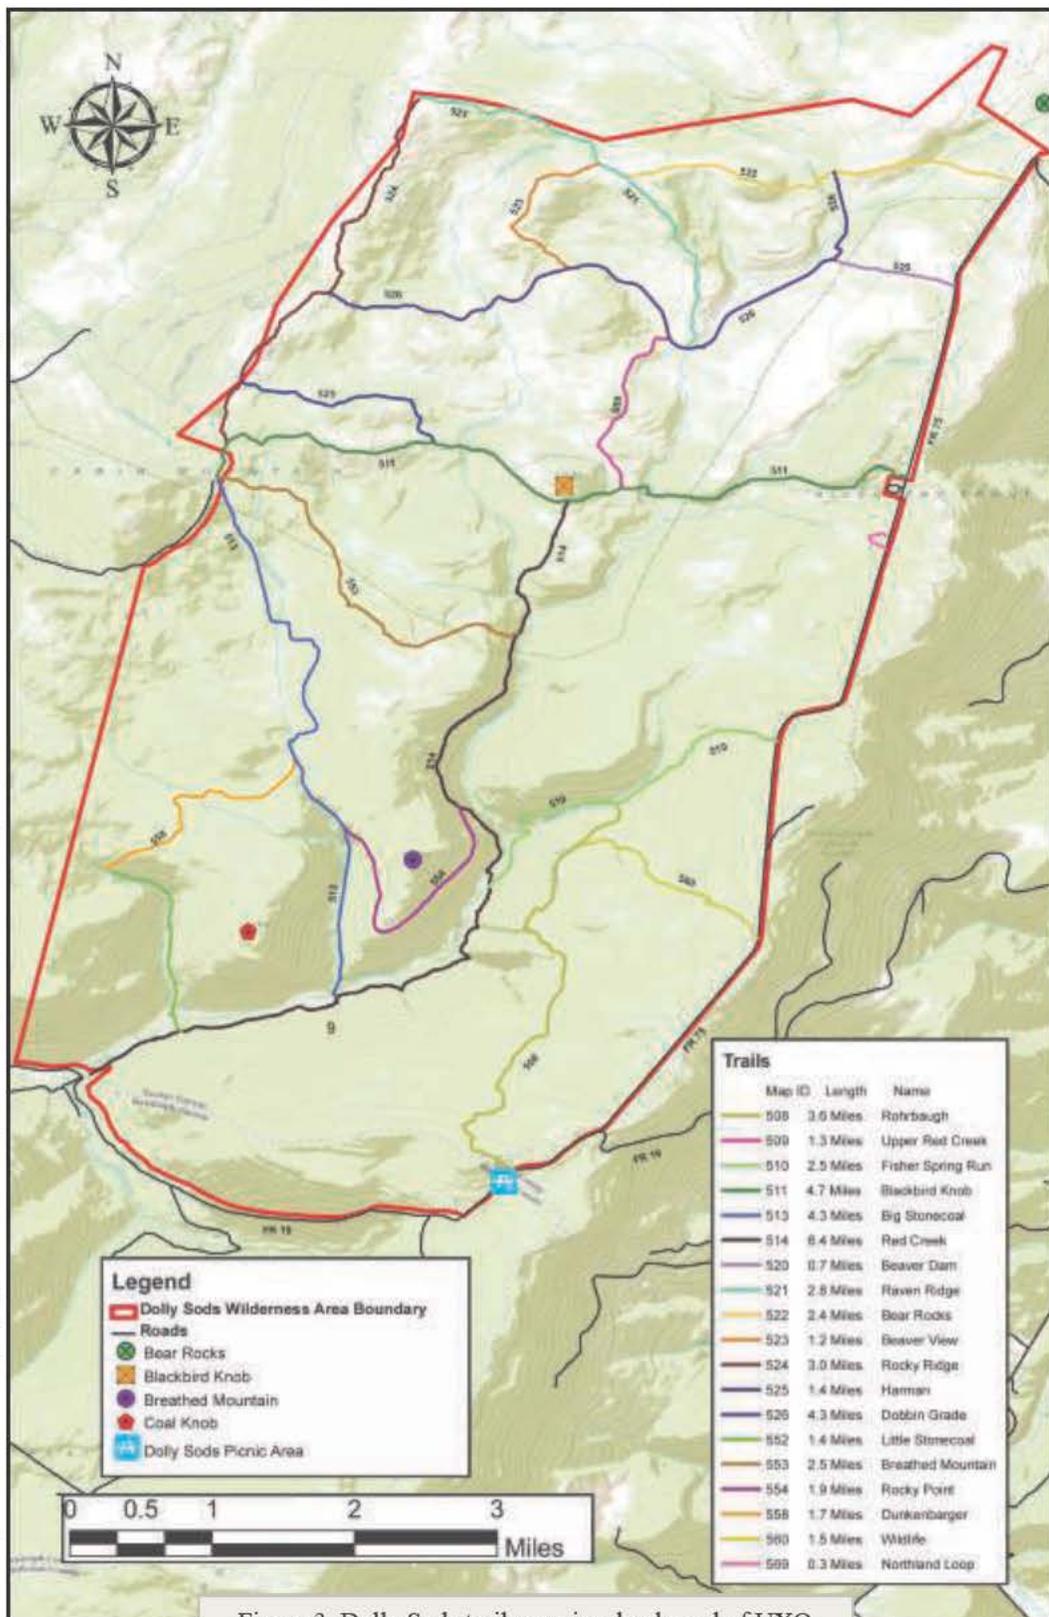
Figure 3. Dolly Sods trails previously cleared of UXO

Historically, UXO removal was performed at WVMA immediately after WWII and again in 1997-1998. The 1997-1998 removal focused on the existing trails and campsites of DSWA (see Figure 3 for current map of trails cleared). Subsequently, warning signs were posted at the trailheads to warn the public of UXO dangers outside the cleared areas. Outdoor activities at DSWA outside of the cleared areas include an increased level of risk of encountering UXO.

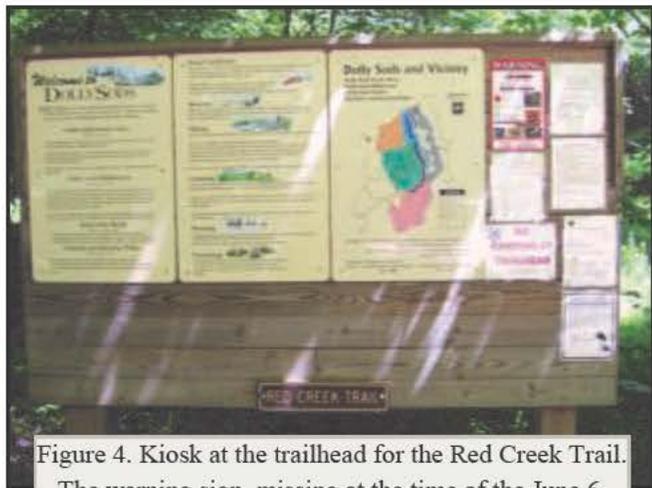
Figure 4. Kiosk at the trailhead for the Red Creek Trail. The warning sign, missing at the time of the June 6, 2014 inspection, was replaced with a duplicate sign

Also, semi-annual inspections of the warnings signs posted at the heads of the cleared trails and at the cleared campsites are made to help ensure the public is aware of UXO dangers that may exist in areas of Dolly Sods not cleared of UXO. Figures 4-5 are photos from the June 6, 2014 trailhead inspection .
