BOLIVAR DAM PROJECT PHOTOGRAPHS

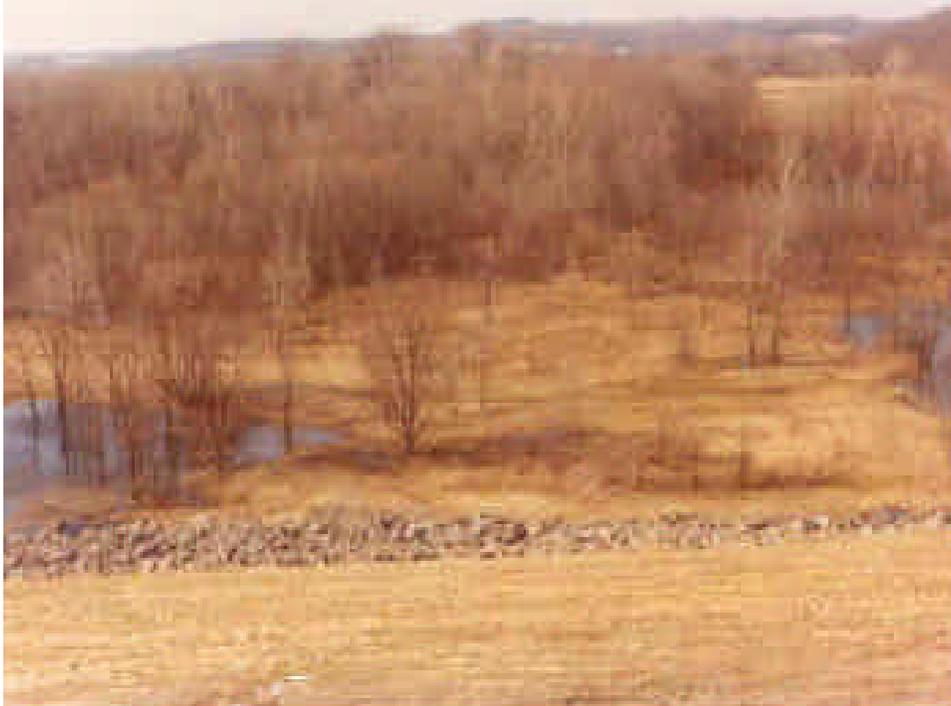
PHOTO NO. 41 **BOLIVAR DAM, OHIO** **05 MARCH 1975**
View of the toe drain seepage and ponding looking downstream from on top of the dam. Pool El. 898.0

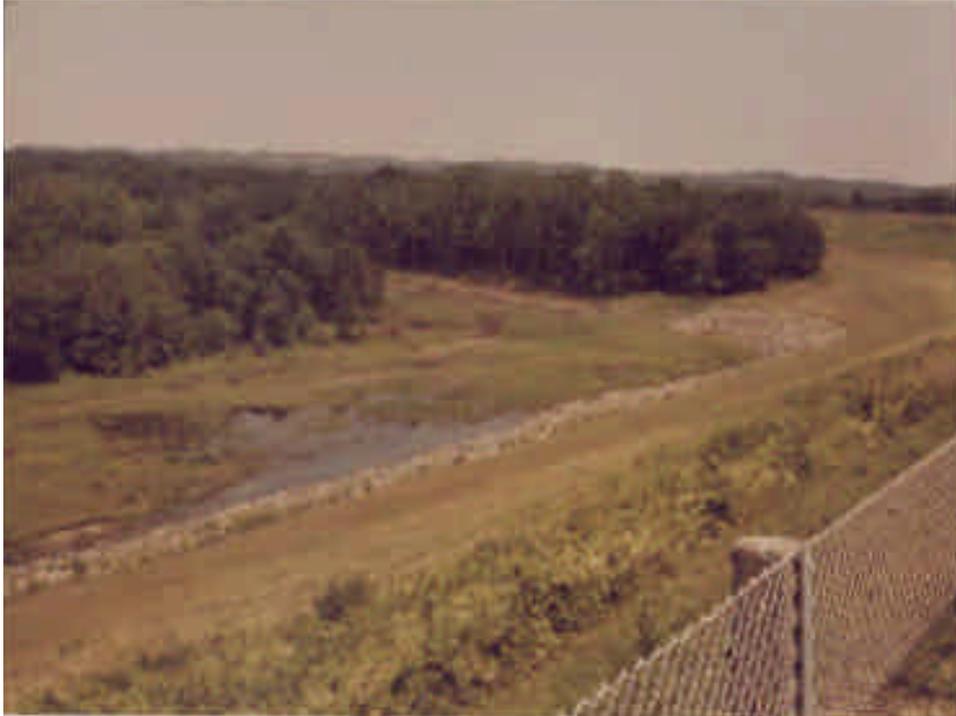
PHOTO NO. 45 **BOLIVAR DAM, OHIO** **18-19 JUNE 1981**
Downstream face and toe of the embankment. Pool El. 928.81

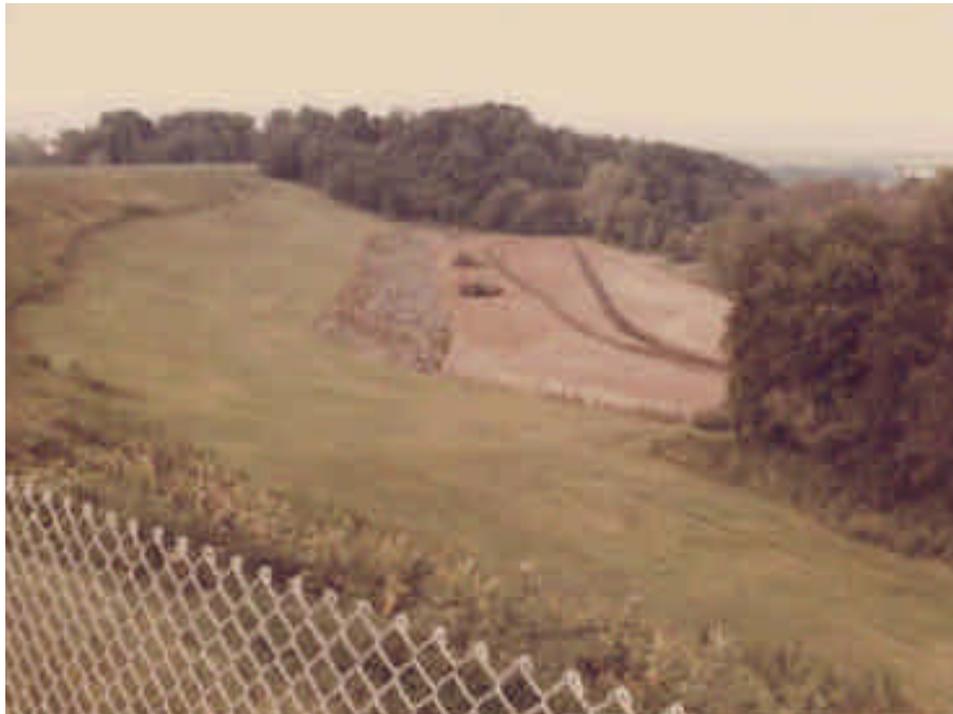
PHOTO NO. 51 **BOLIVAR DAM, OHIO** **18-19 JUNE 1981**
D/S face & toe of dam. Sand & gravel blanket essentially complete.
Note two drill rigs working on pilot holes for RWs. Pool El. 928.81

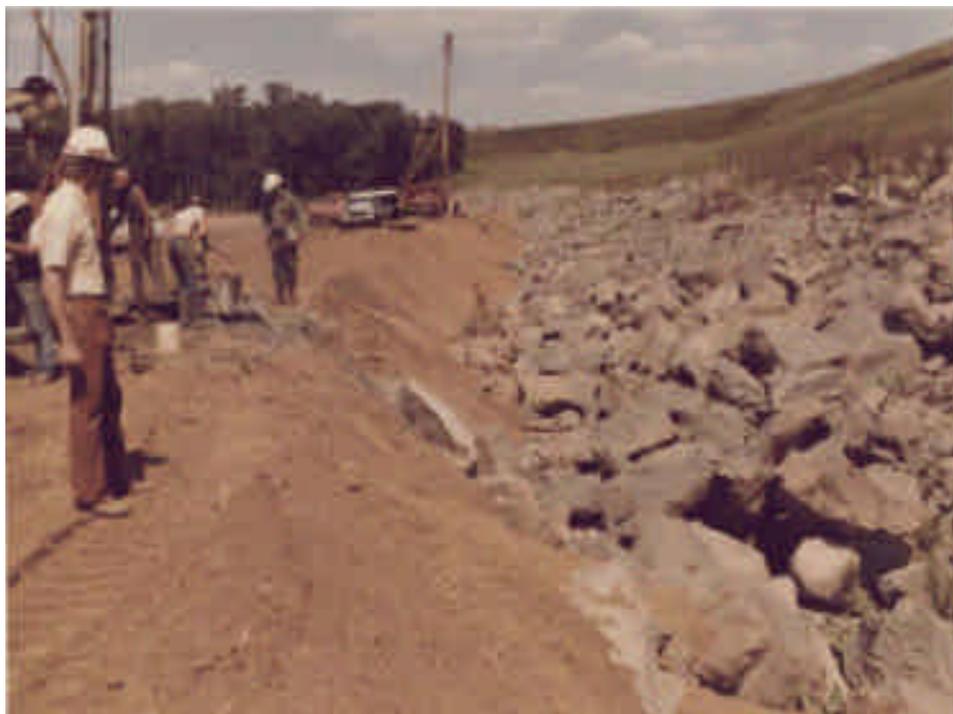
PHOTO NO. 52 **BOLIVAR DAM, OHIO** **18-19 JUNE 1981**
Closer view of the sand and gravel blanket at contact with the
embankment toe. Pool El. 928.81

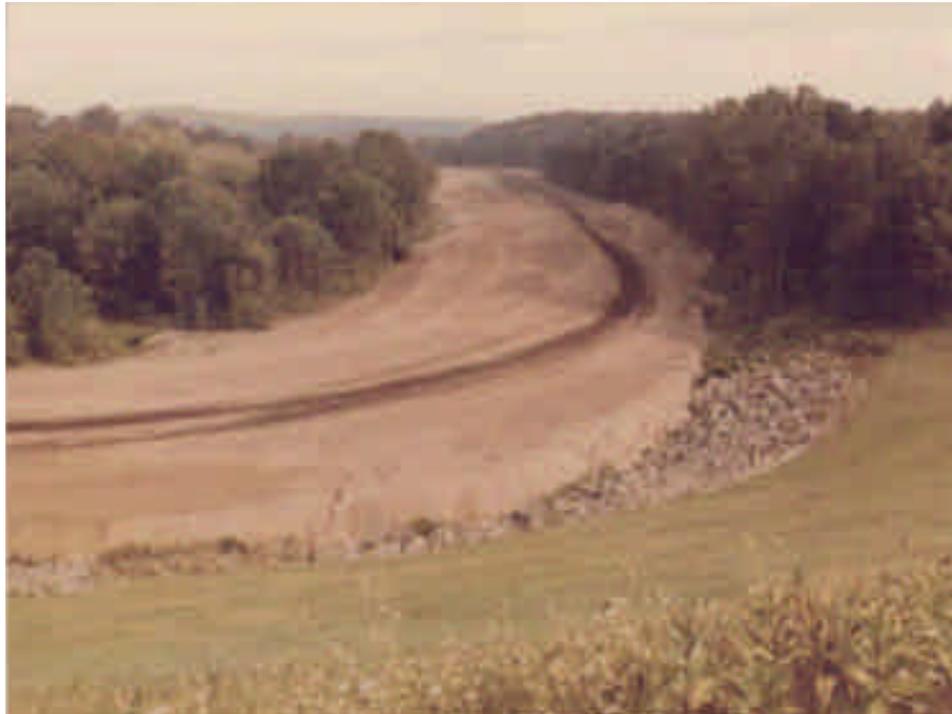
PHOTO NO. 53 **BOLIVAR DAM, OHIO** **18-19 JUNE 1981**
Sand and gravel blanket in the area downstream of the terrace section of the dam. Pool El. 928.81

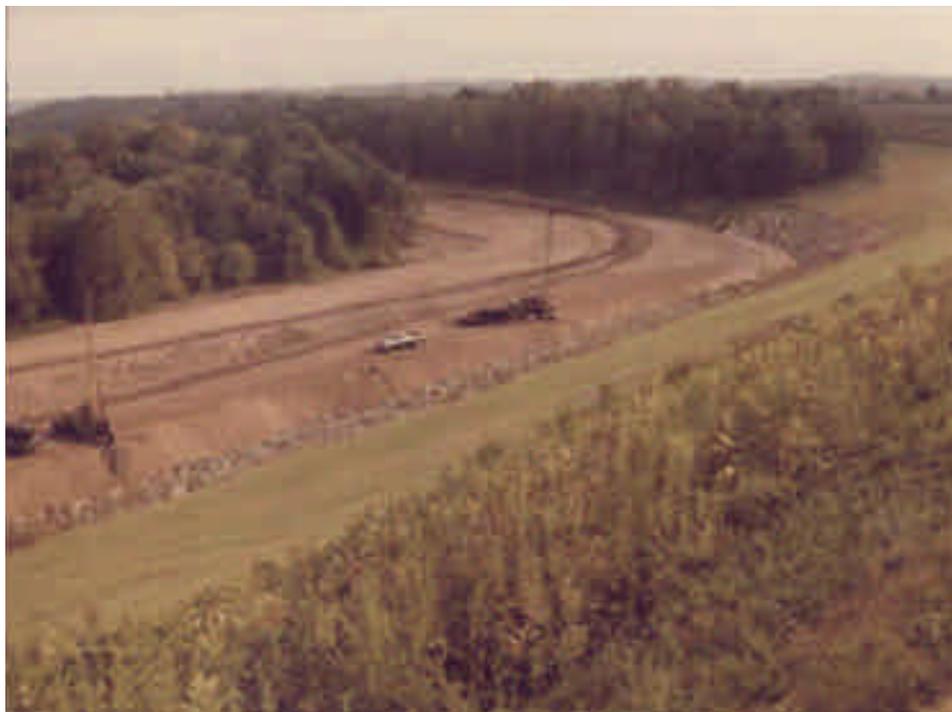
PHOTO NO. 54 **BOLIVAR DAM, OHIO** **18-19 JUNE 1981**
Sand and gravel blanket at the toe of the main embankment. Note rigs drilling relief well pilot holes. Pool El. 928.81

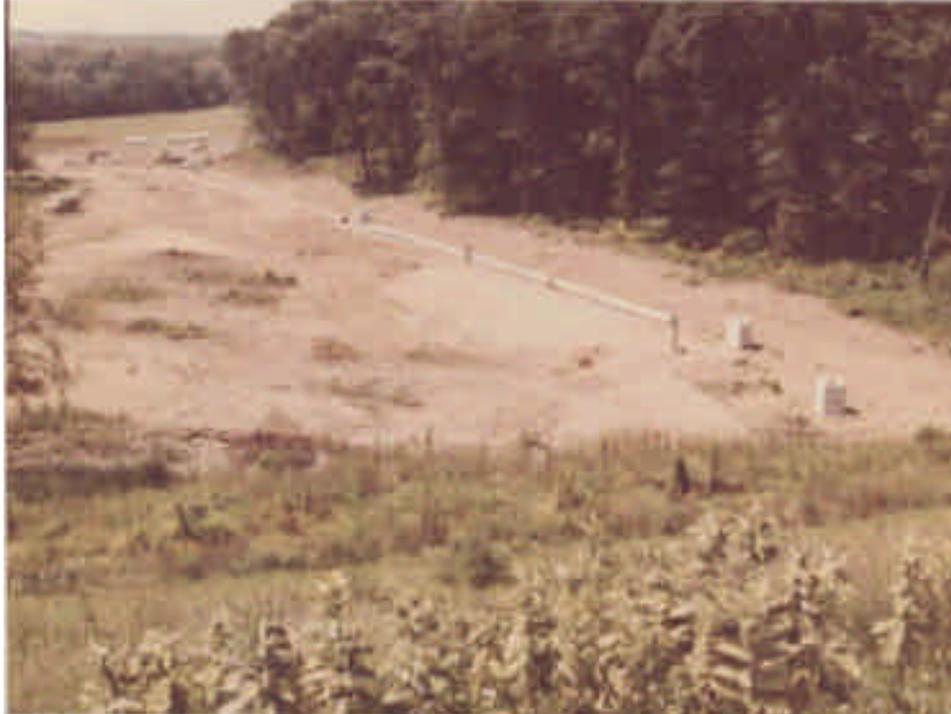
PHOTO NO. 55 **BOLIVAR DAM, OHIO** **18-19 JUNE 1981**
Manholes & perforated pipe for collection of subsurface seepage.
Location is opposite C_L dam station 27+00 to 29+50. Pool El. 928.81

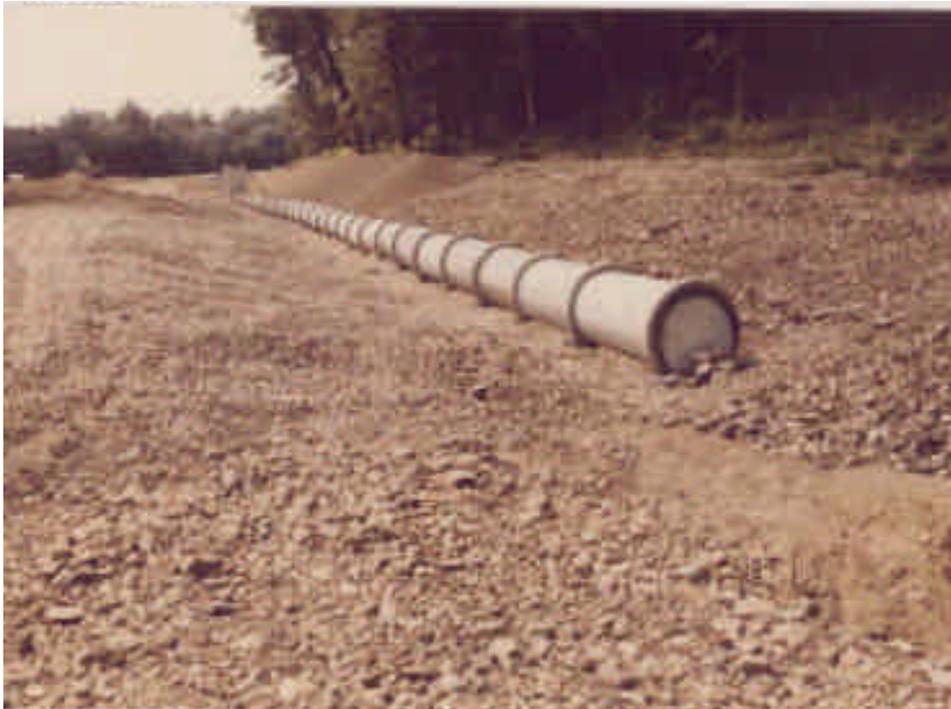
PHOTO NO. 56 **BOLIVAR DAM, OHIO** **18-19 JUNE 1981**
Closer view of the perforated seepage collection pipe shown in
Photograph No. 55. Pool El. 928.81

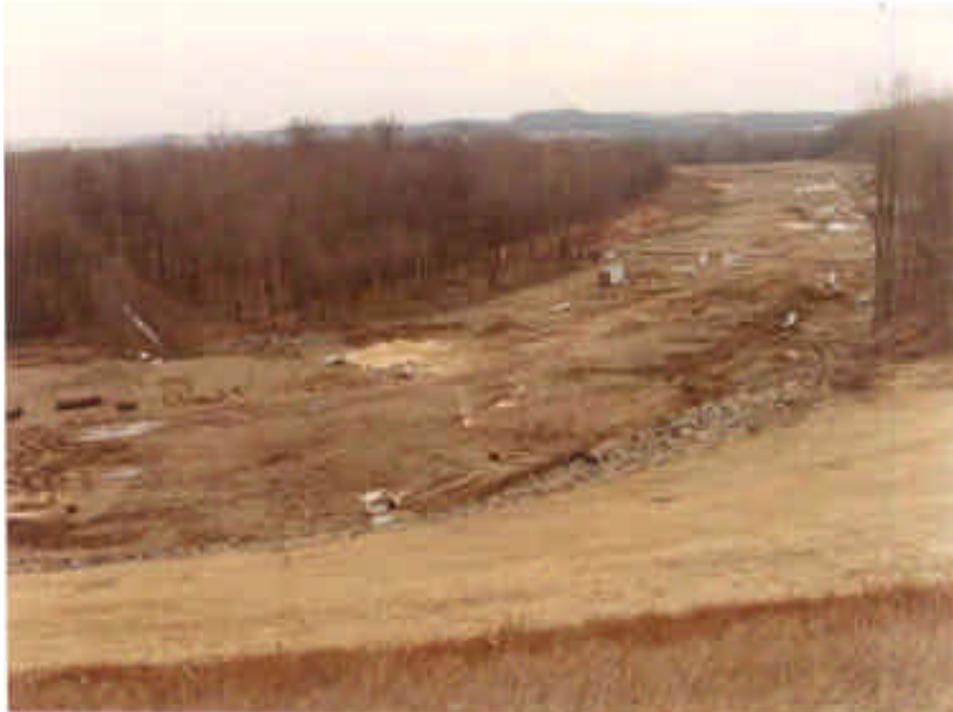
PHOTO NO. 57 **BOLIVAR DAM, OHIO** **17 MARCH 1982**
General view of relief well installation work in area downstream of
terrace section of the dam. Pool El. 897.51

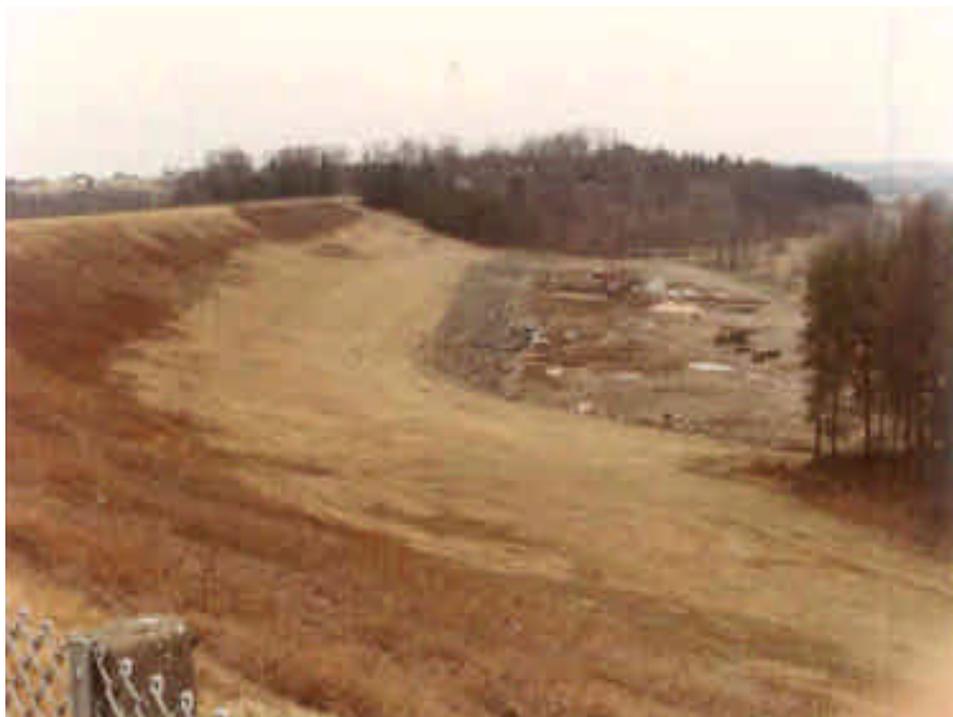
PHOTO NO. 58 **BOLIVAR DAM, OHIO** **17 MARCH 1982**
Relief well installation on sand and gravel blanket downstream of main
embankment section. Pool El. 897.51

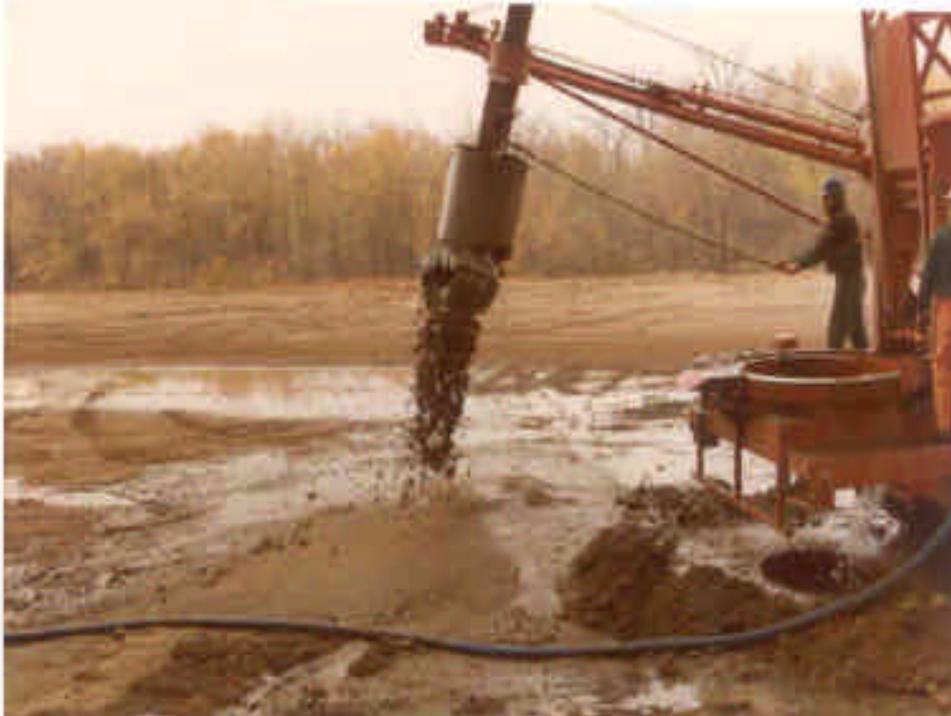
PHOTO NO. 59 **BOLIVAR DAM, OHIO** **17 MARCH 1982**
Close view of drilling equipment used for relief well installation. Pool
El. 897.51

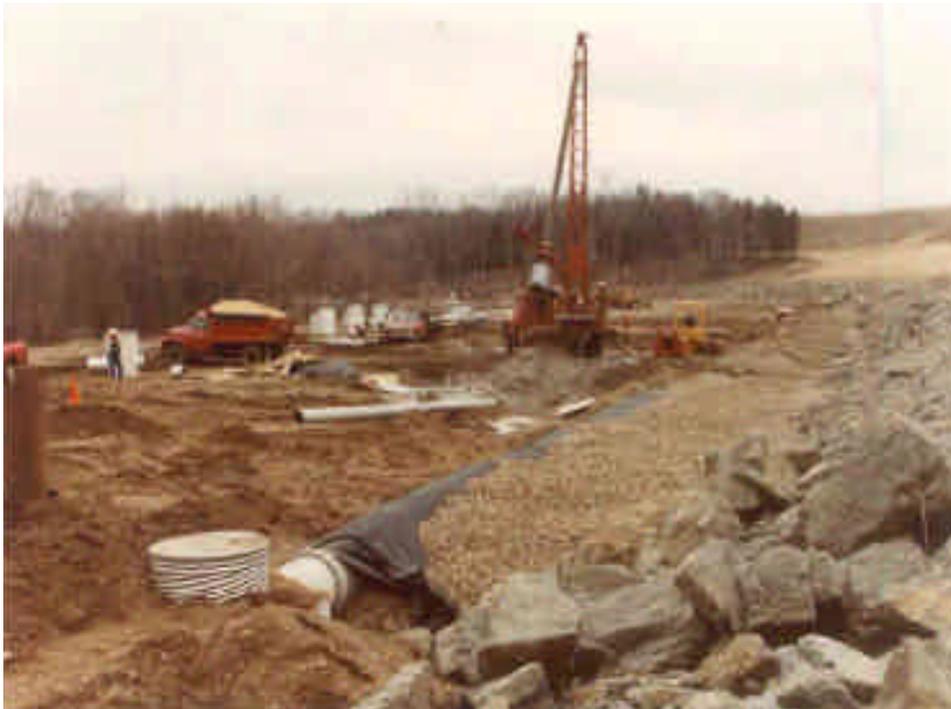
PHOTO NO. 60 **BOLIVAR DAM, OHIO** **17 MARCH 1982**
Closer view of relief well work at the downstream toe of the main
embankment. Pool El. 897.51

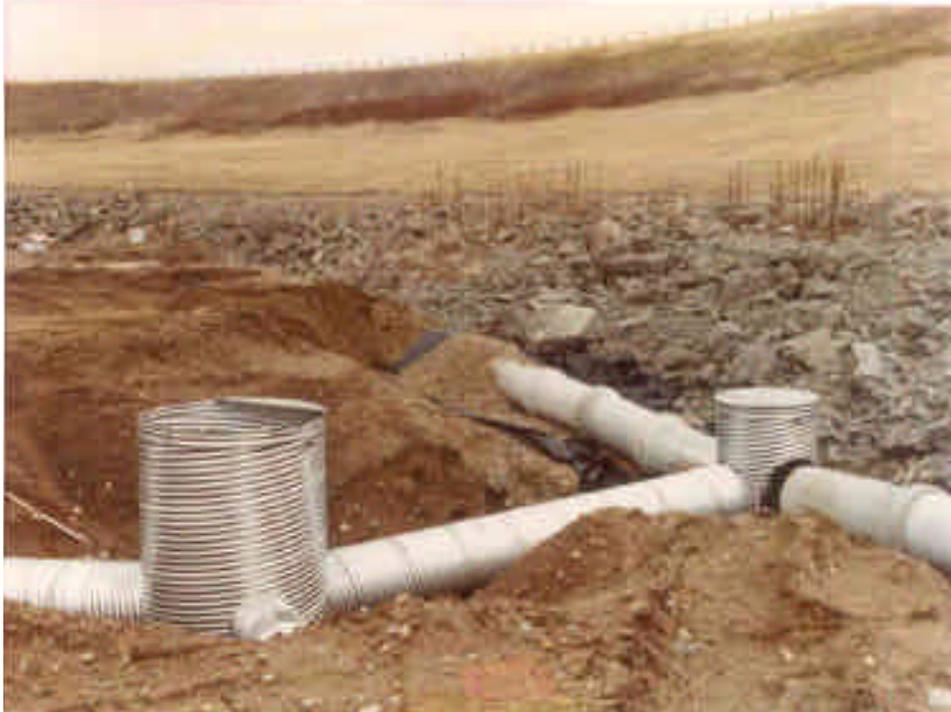
PHOTO NO. 61 **BOLIVAR DAM, OHIO** **17 MARCH 1982**
Perforated concrete pipe (24" Dia) and corrugated metal pipe connector
to handle. Pool El. 897.51

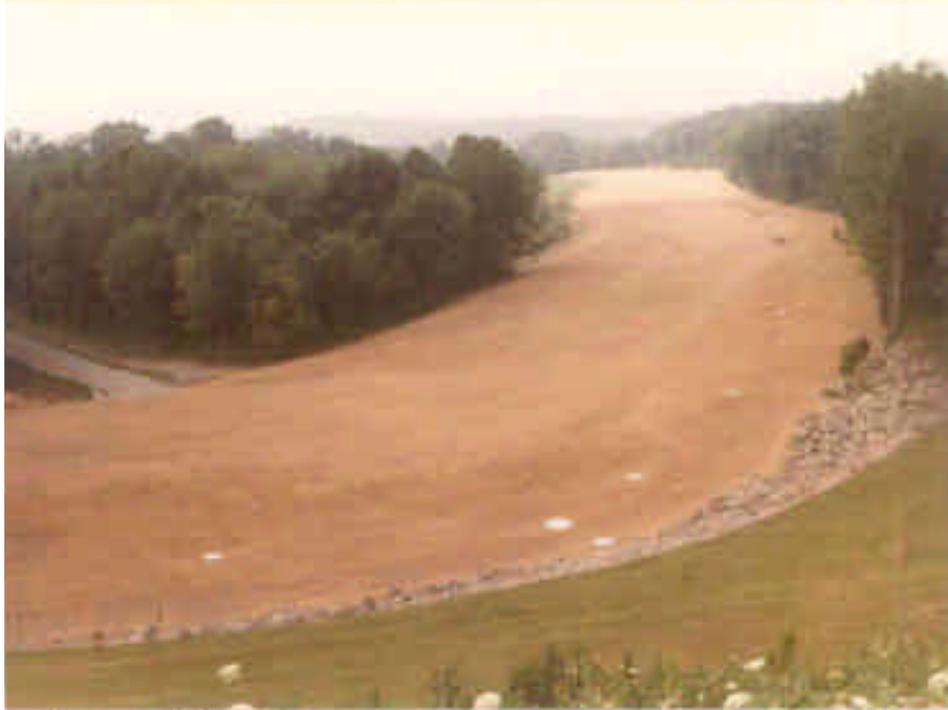
PHOTO NO. 63 **BOLIVAR DAM, OHIO** **17 MARCH 1982**
Sand and gravel blanket after completion of relief wells.
Pool El. 897.51

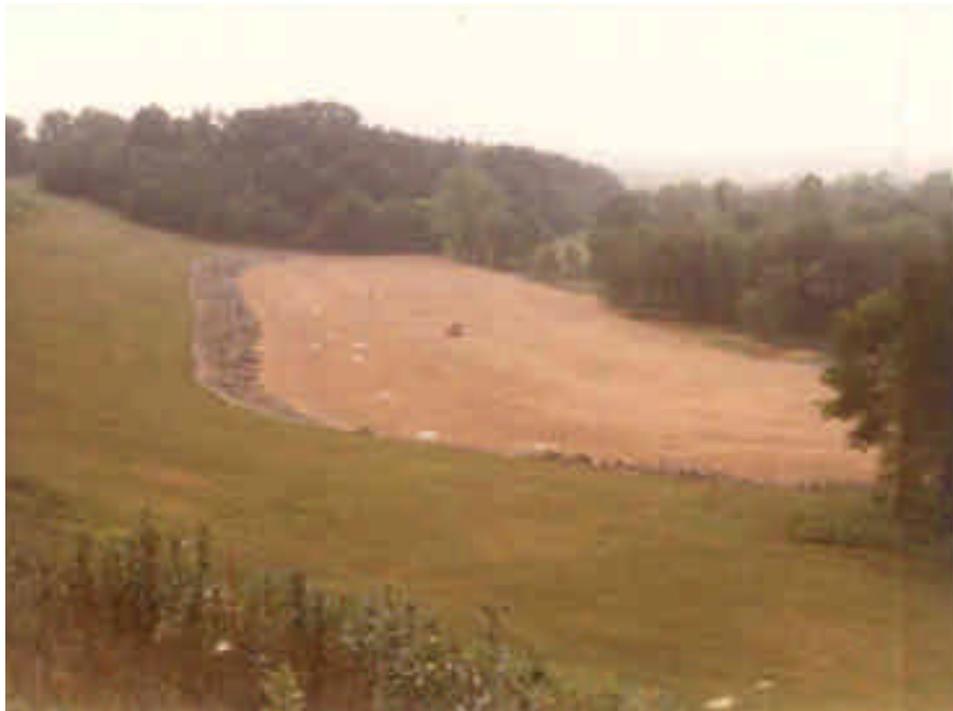
PHOTO NO. 64 **BOLIVAR DAM, OHIO** **17 MARCH 1982**
Below main embankment after relief well installation. Pool El. 897.51

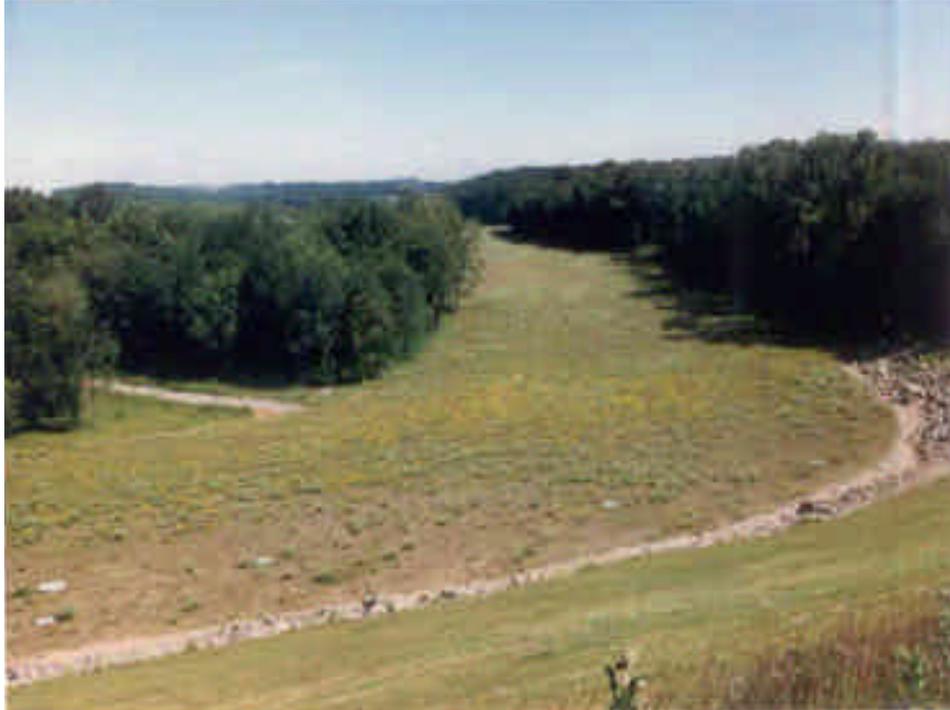
PHOTO NO. 65 **BOLIVAR DAM, OHIO** **17 MARCH 1982**
Same view as photograph No. 63 – four years later. Pool El. 897.51

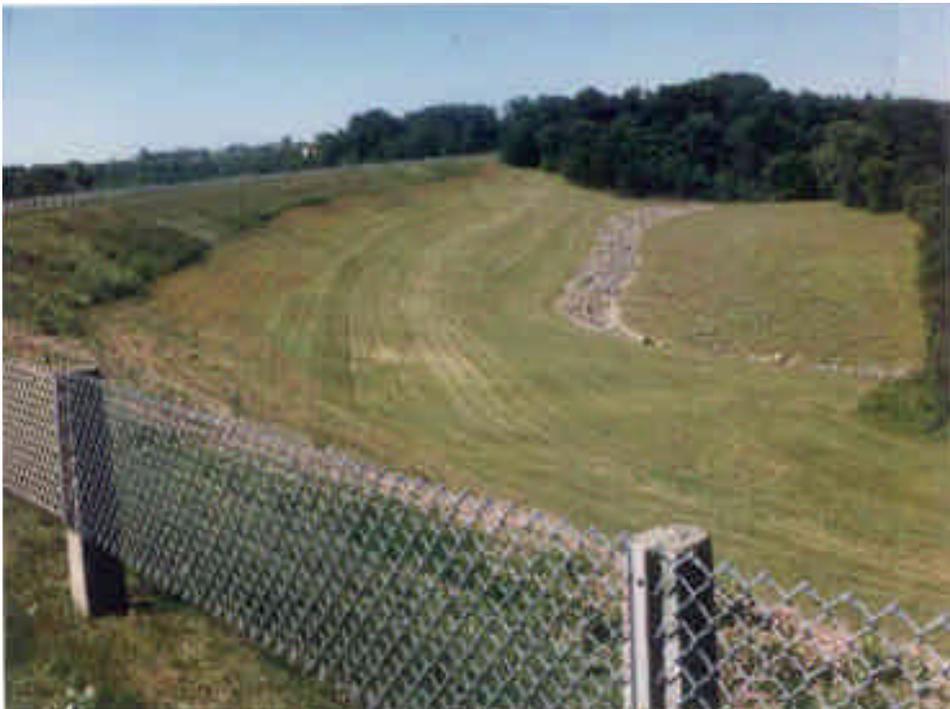
PHOTO NO. 66 **BOLIVAR DAM, OHIO** **17 MARCH 1982**
Same view as photograph No. 64 – four years later. Pool El. 897.51

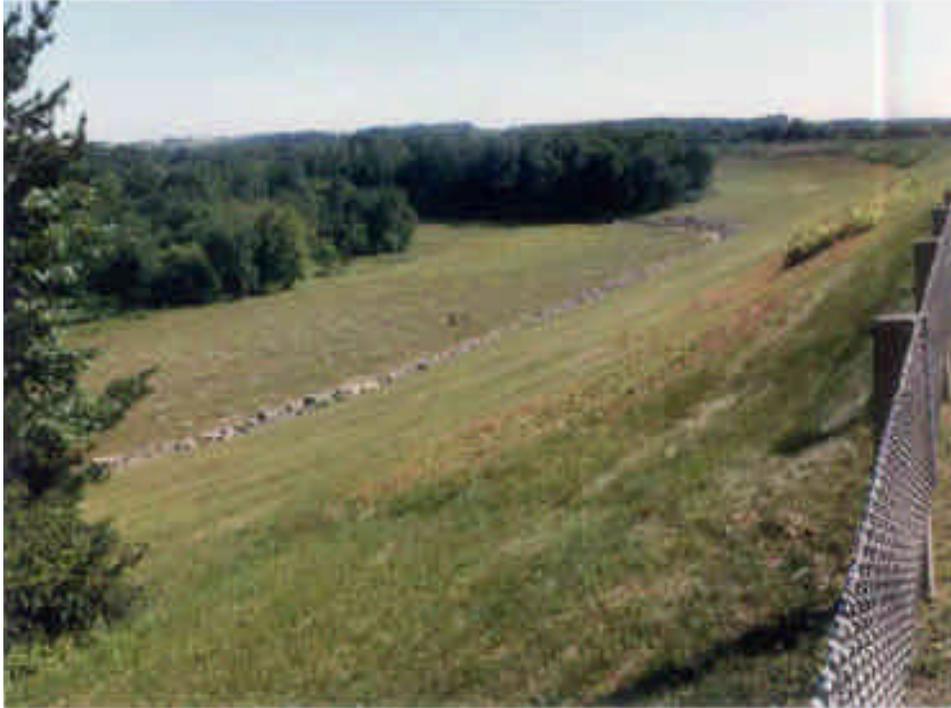
PHOTO NO. 67 **BOLIVAR DAM, OHIO** **17 MARCH 1982**
General view of D/S slope of the main embankment and D/S toe area, as seen from the left abutment. Pool El. 897.51

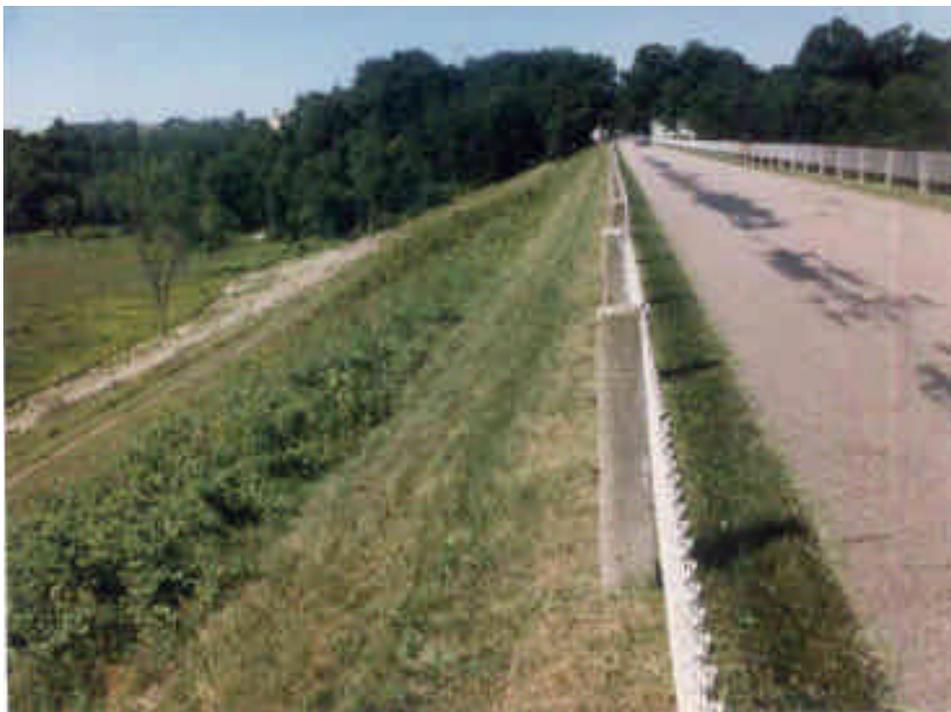
PHOTO NO. 68 **BOLIVAR DAM, OHIO** **17 MARCH 1982**
Upstream slope of the main embankment and crest. View is toward the left abutment. Pool El. 897.51

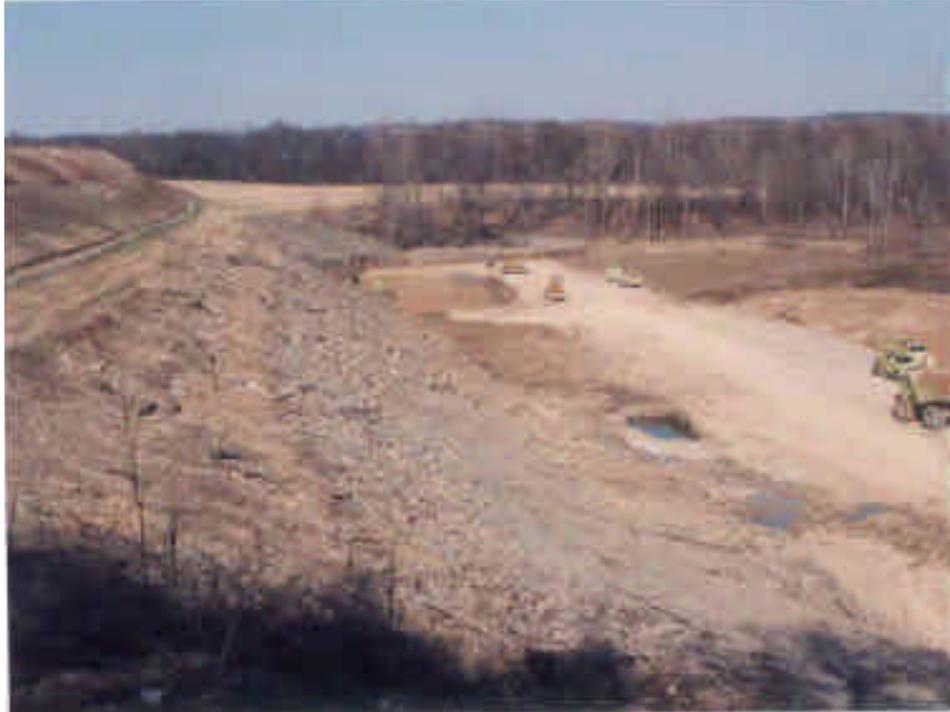
PHOTO NO. 69 **BOLIVAR DAM, OHIO** **30 MARCH 1988**
Construction work on the upstream berm, as seen from the upstream side
of the left abutment area. Pool El. 897.47

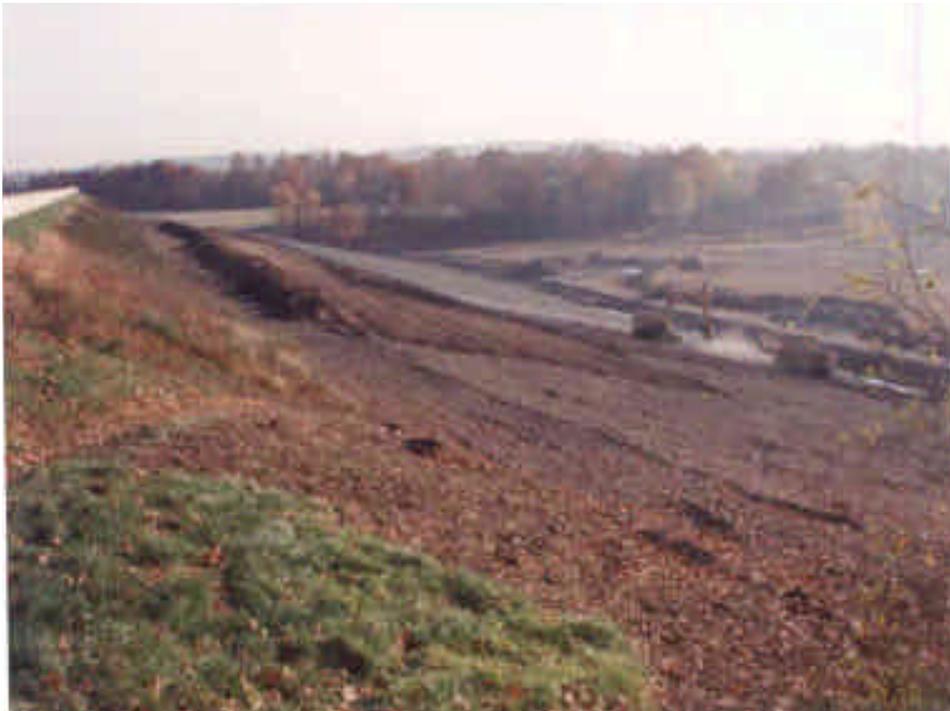
PHOTO NO. 70 **BOLIVAR DAM, OHIO** **27 OCTOBER 1988**
Construction work on the upstream berm as it nears completion.
Pool El. 897.47

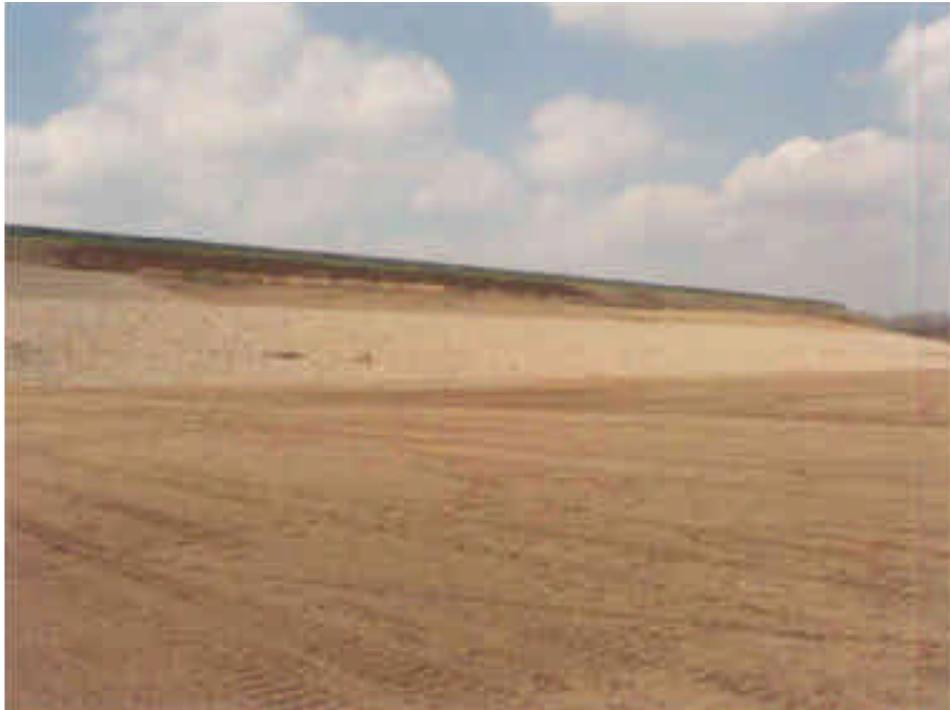
PHOTO NO. 71 **BOLIVAR DAM, OHIO** **20 APRIL 1989**
Looking toward the left abutment contact. Riprap covered toe area in foreground. Pool El. 897.47

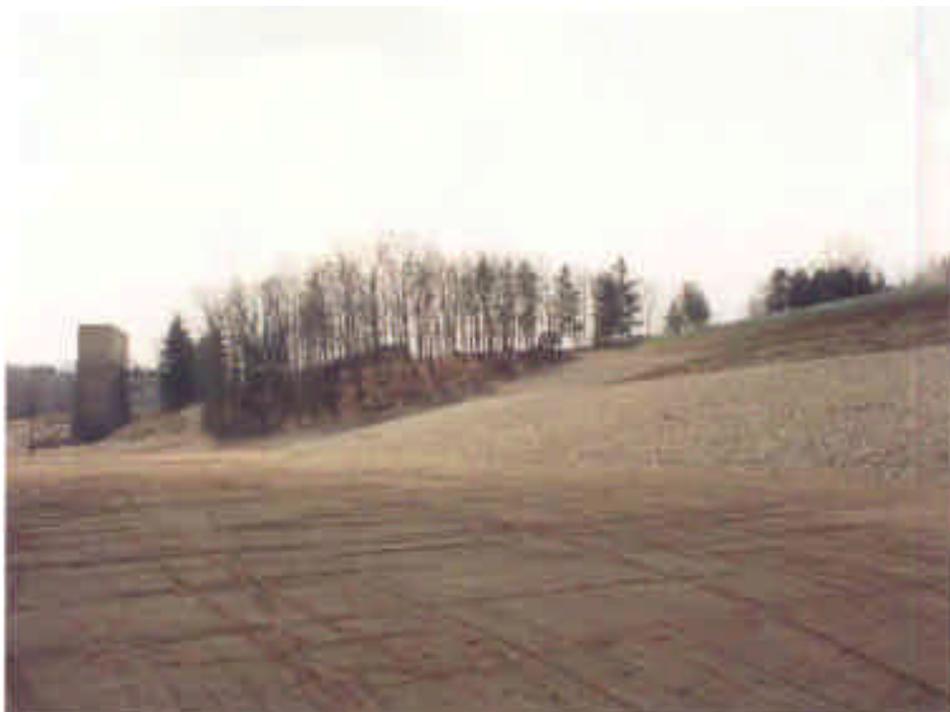
PHOTO NO. 72 **BOLIVAR DAM, OHIO** **20 APRIL 1989**
Upstream berm. Looking toward the left abutment. Note intake structure in the left background. Pool El. 897.47
