PERFORMANCE HISTORY

Zoar Levee

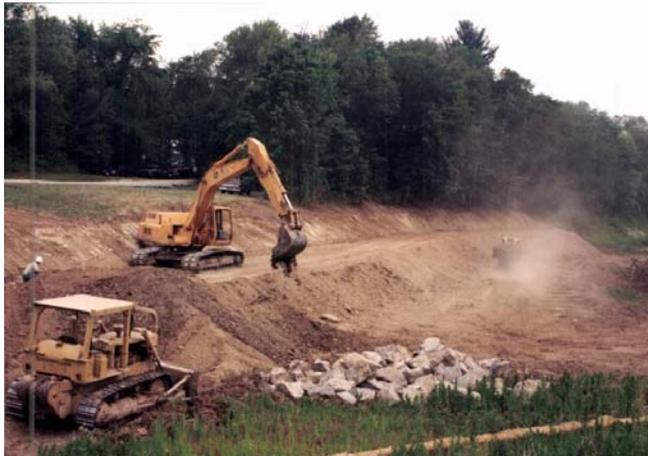
In 1997, an analysis was completed to study Zoar Diversion's flood storage capacity and potential for being overtopped. This study recommended that the impounded Goose Run Lake be drained and a permanent lake no longer retained. The gate has remained open ever since, and the only known pools retained occurred in spring 2011 (3 very flashy pools as high as el. 909). No concerns were noted during these pools, but only limited observation was possible due to the lack of warning.
