Huntington District

PERFORMANCE HISTORY

Zoar Levee

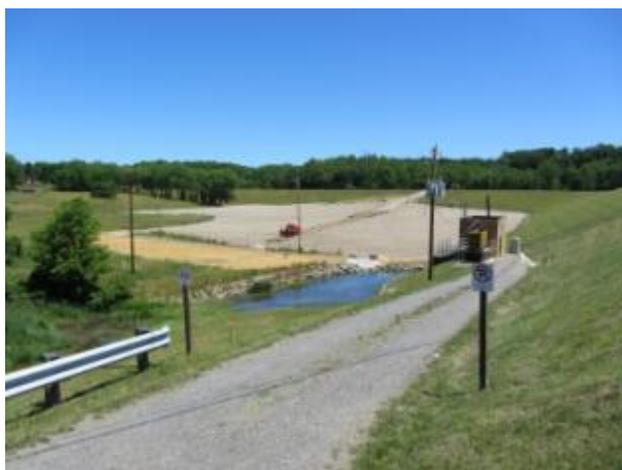
At the same time, widespread small boils and pervasive area seepage were again observed on the Ball Field reach of the levee, but no immediate flood fighting actions were taken. This scenario was very similar to what occurred in 2005. The boils were monitored for about three and a half weeks, but did not expand.

This event resulted in Zoar Levee and Diversion Dam being reclassified as a DSAC 1 project, as progression toward failure was believed to be potentially occurring.

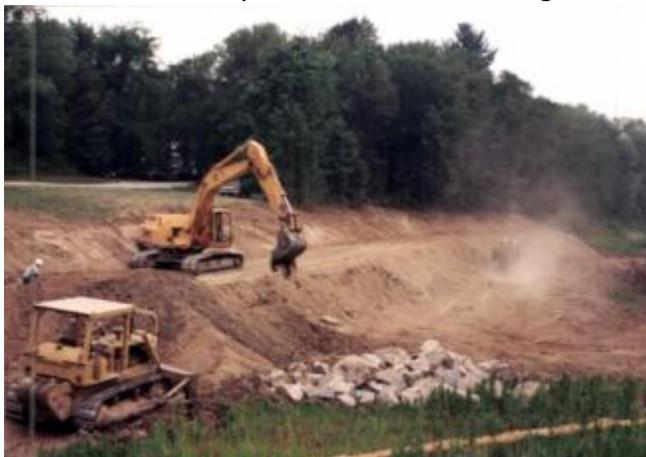
In 1997, an analysis was completed to study Zoar Diversion's flood storage capacity and potential for being overtopped. This study recommended that the impounded Goose Run Lake be drained and a permanent lake no longer retained. The gate has remained open ever since, and the only known pools retained occurred in spring 2011 (3 very flashy pools as high as elevation 909 feet). No concerns were noted during these pools, but only limited observation was possible due to the lack of warning.
