Kingwood Center Gardens

50 Trimble Road, Mansfield

Appendix B

Water Resources Map

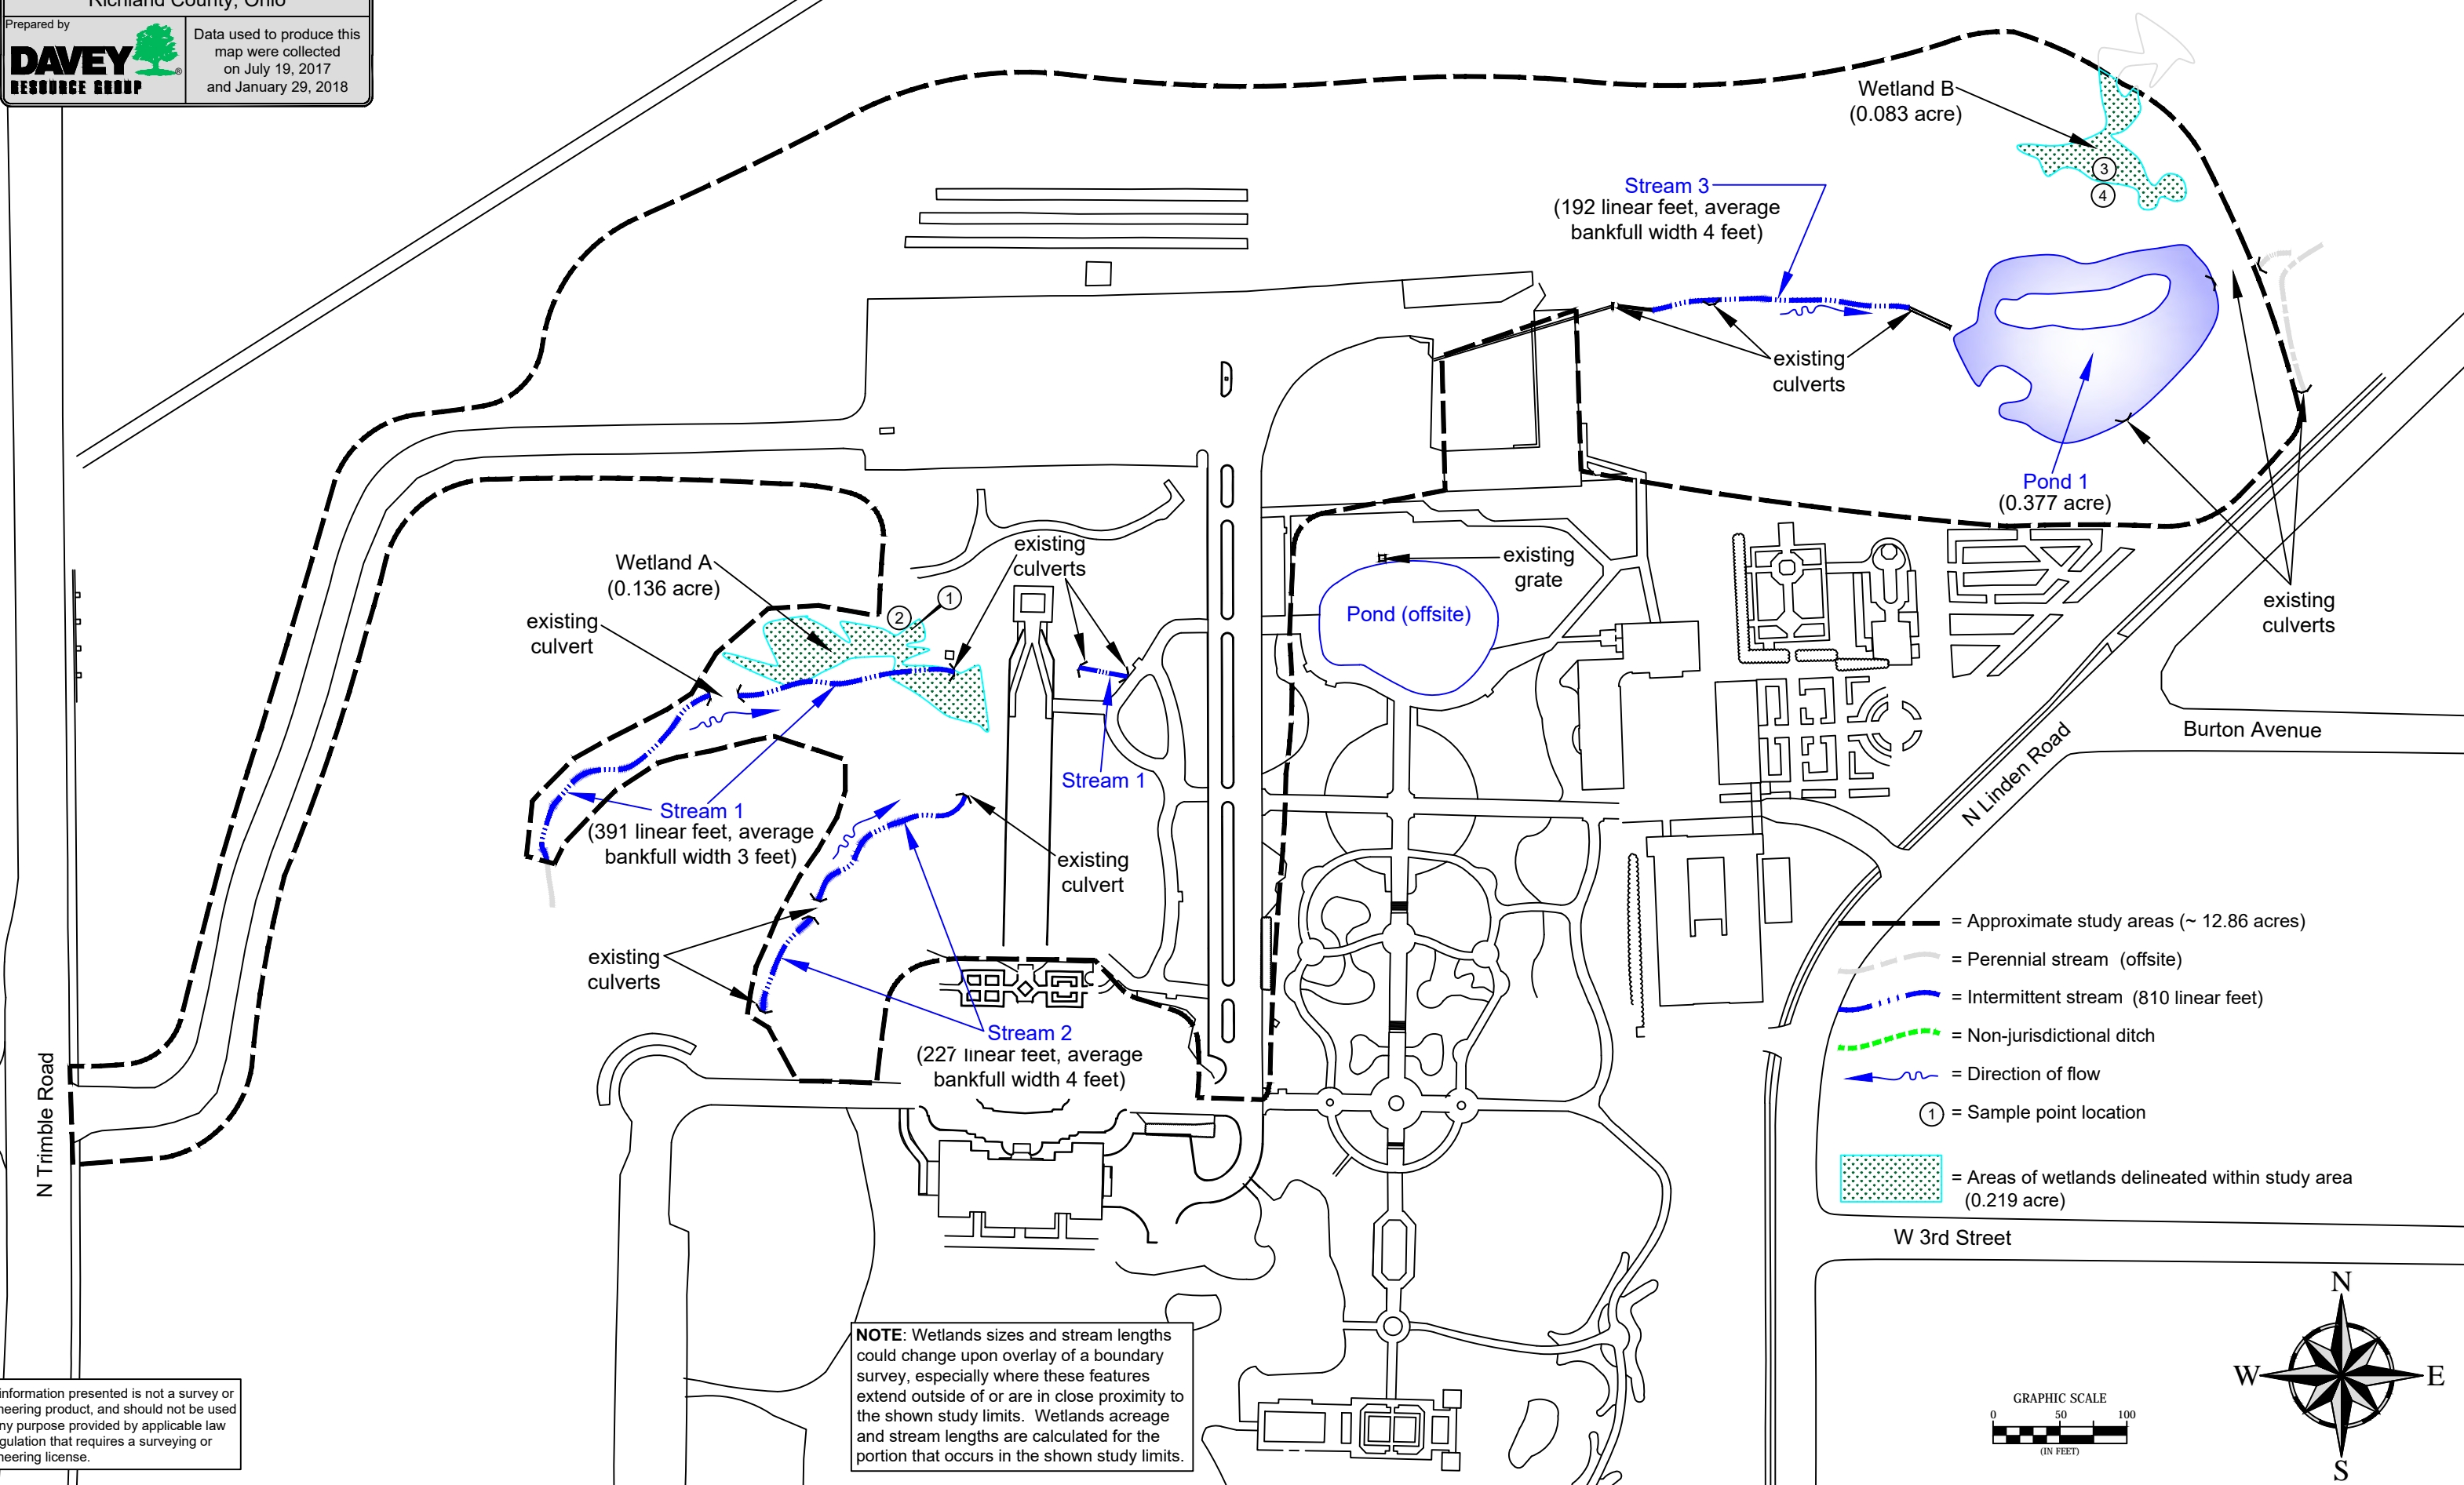
Data used to produce this map were collected on July 19, 2017 and January 29, 2018

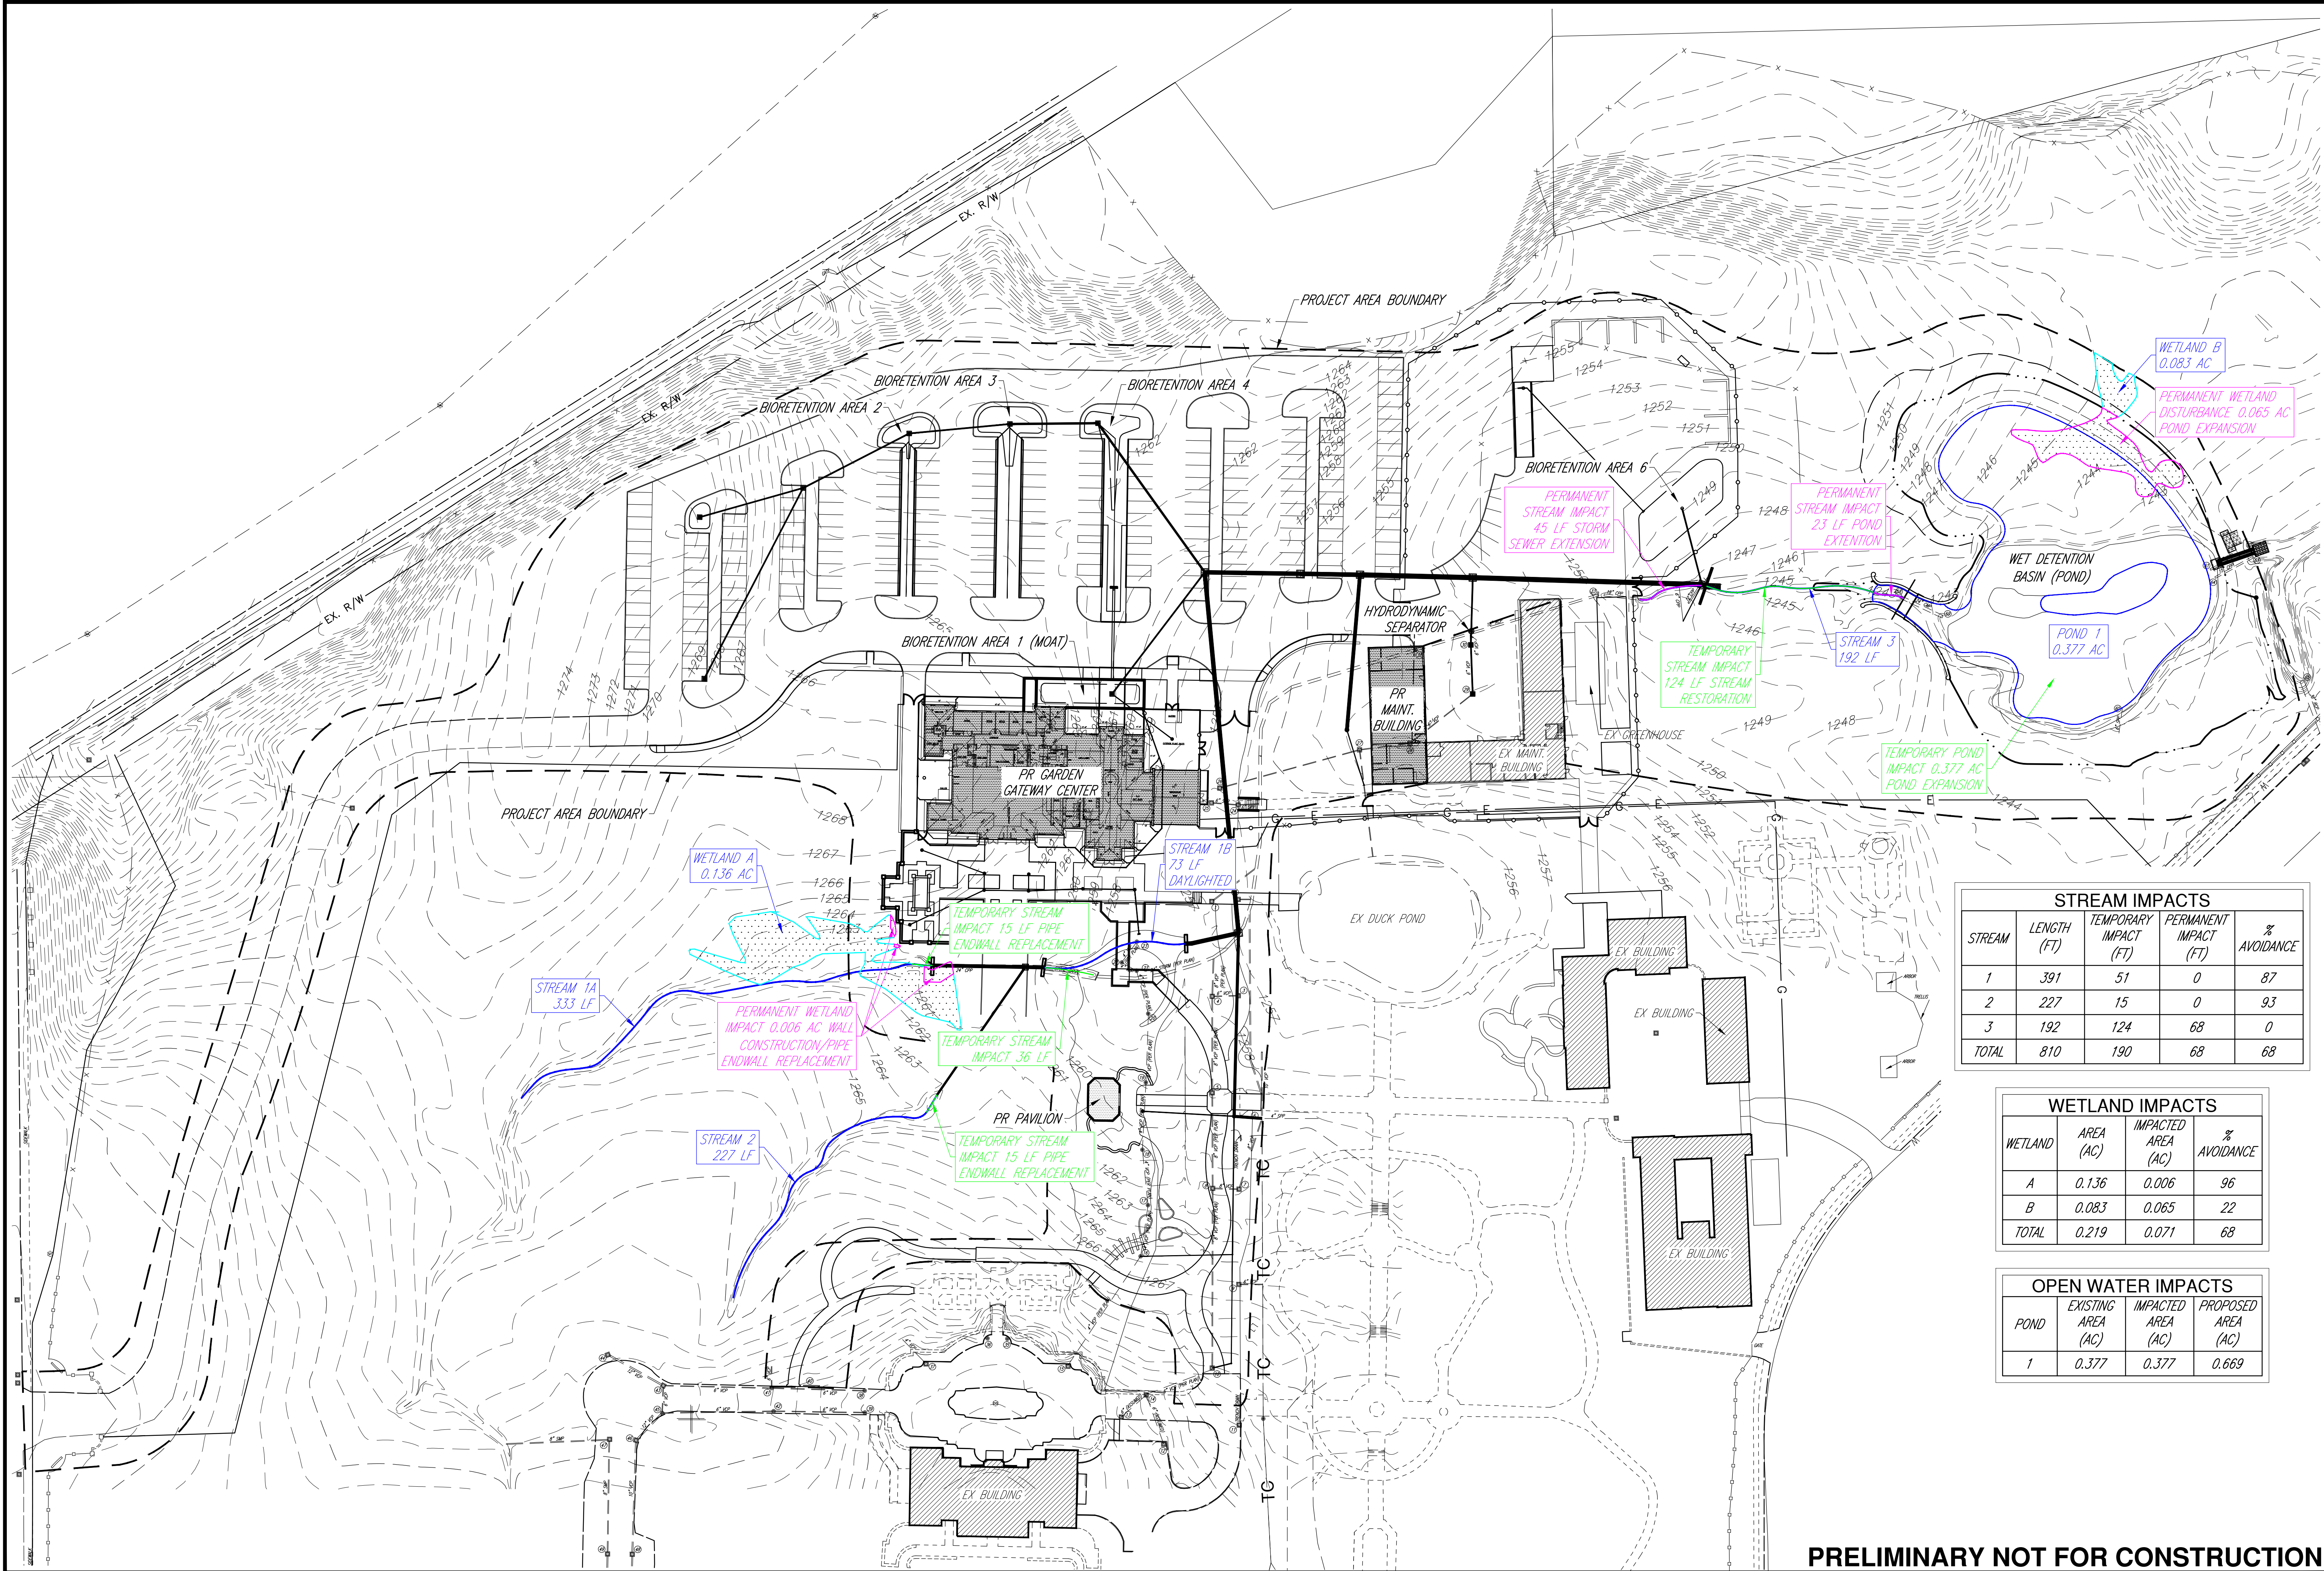
STREAM IMPACTS				
STREAM	LENGTH (FT)	TEMPORARY IMPACT (FT)	PERMANENT IMPACT (FT)	% AVOIDANCE
1	391	51	0	87
2	227	15	0	93
3	192	124	68	0
TOTAL	810	190	68	68

WETLAND IMPACTS			
WETLAND	AREA (AC)	IMPACTED AREA (AC)	% AVOIDANCE
A	0.136	0.006	96
B	0.083	0.065	22
TOTAL	0.219	0.071	68

OPEN WATER IMPACTS			
POND	EXISTING AREA (AC)	IMPACTED AREA (AC)	PROPOSED AREA (AC)
1	0.377	0.377	0.669
