Environmental Assessment

Jenkins House Preservation Actions

R.C. Byrd Lock and Dam Replacement Project
Cabell County, West Virginia

▪ **HISTORIC PRESERVATION PLAN** ▪
ACTIONS AND TREATMENTS

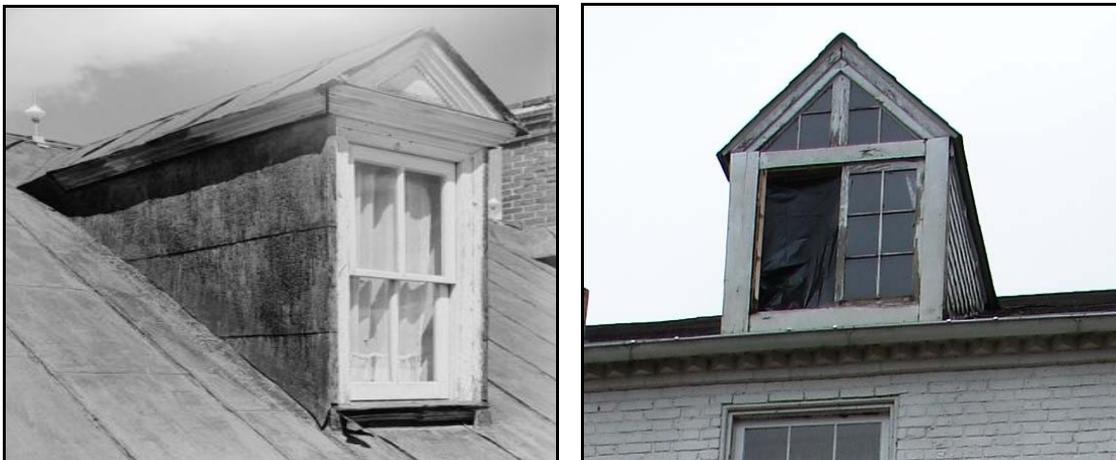
Figure 2. *Side by side comparison of a typical Federal style dormer (Green Hill Plantation, Virginia) and a Jenkins house dormer, right. The Jenkins dormer has uncharacteristically crude framing and pediment glazing, and the gable lacks strong classical moldings expected of Federal style buildings. Poor construction allows a number of cracks and openings where water penetrates.*

simplicity of the Federal style house. Most importantly, because the dormers admit rainwater, there is no justification for repairing and retaining them, and their removal is therefore recommended. Removal should be undertaken as a deconstruction in order to prevent any damage to the original fabric of the attic. Once removed, resulting voids will require patching.

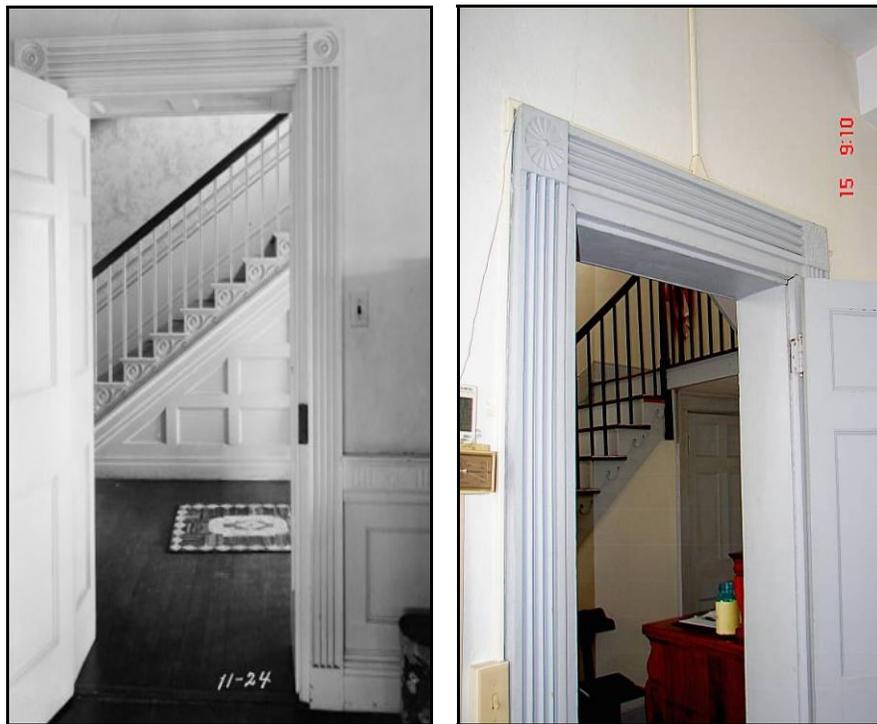
Figure 12. At left, a well preserved interior door frame from Dan's Hill, Virginia, reveals that the west room entry details at the Jenkins House are faithful to the Federal design period, and can serve as an original template for the restoration of interior finish details, when needed. (author)

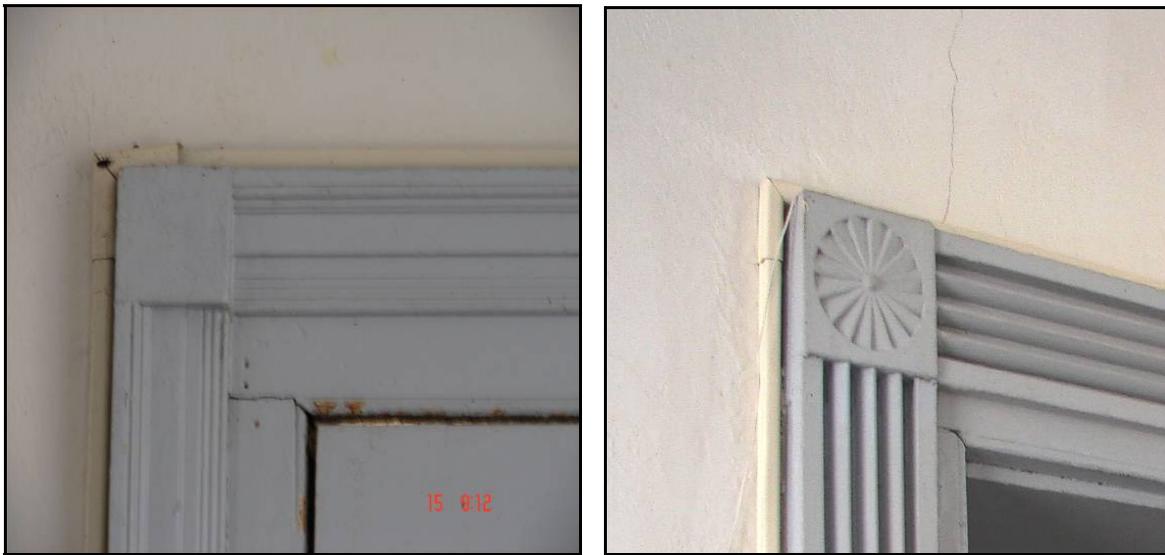
Figure 13. The anachronistic door framing detail (left) suggests that some first floor moldings have been replaced; while others (right) survived as representative of original design. Such original moldings and framing details should be captured in measured drawings. (author)

Examination of interior spaces reveals an array of features – moldings, door framing, and fireplaces – that points to a repair and rehabilitation effort that may have followed severe floods of the 1800s, turn of the nineteenth century and 1930s. If flood waters rose into the first story, it holds that some of the lower woodwork and plaster was damaged beyond repair and required replacements. A number of door frames and casings are indicative of 1930s-era carpentry and design, though much of the original fabric survives.

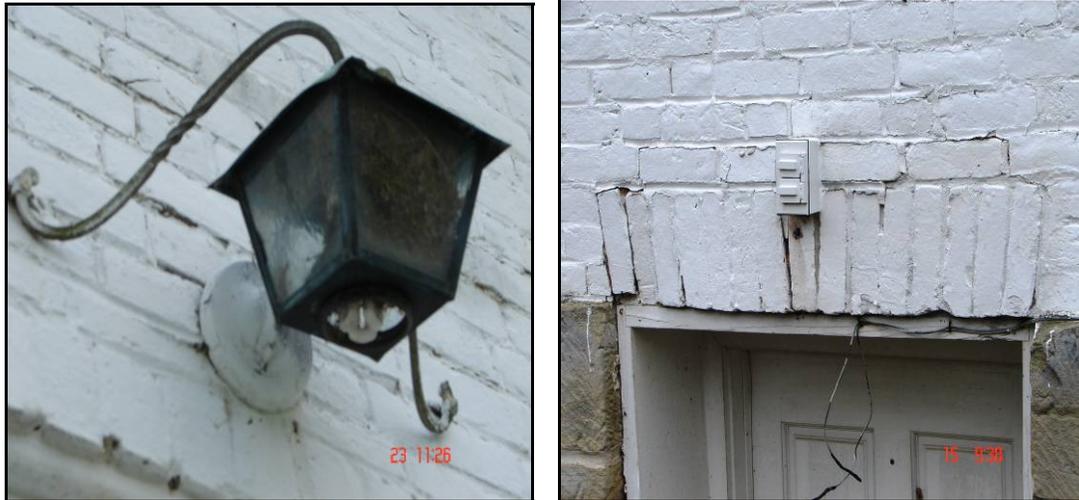
Figure 15. The front entrance light fixture and rear basement door outlet should be removed to prevent water migration through openings, and oxidation staining and mortar deterioration. (author)

- Utility Upgrades (Safety and Hazard Considerations) – attention to relevant electrical system upgrades identified by a certified electrical engineer is proposed to ensure proper function of electrical systems. (This includes minor actions to upgrade or replace circuit breakers, outlets, etc.) Removal of non-historic exterior electrical fixtures is proposed to stop water from migrating into masonry.

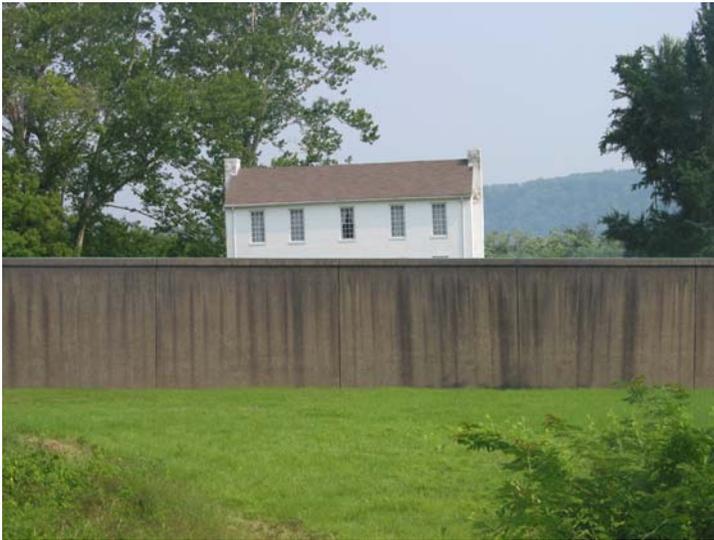
Figure B.1. Simulated floodwall surrounding the Jenkins House.

This alternative entails placing a T-Wall around the grounds with a gate closure at the entrance drive. The top of wall elevation would be 562.0, making the average height of the wall 14 feet above existing ground. Approximately 1,210 linear feet of wall would be needed. A storm drainage system including catch basins, pipe, portable pumps, and headwalls would be required. The edge of the floodwall would be range from 70-260 linear feet from the perimeter of the Jenkins House. Additional operation and maintenance would include pump mobilization and demobilization, pump upkeep, and the gate closure. (See Exhibit CGA03).
