WHAT WE'VE DONE TO REDUCE RISK

Zoar Levee

Huntington District

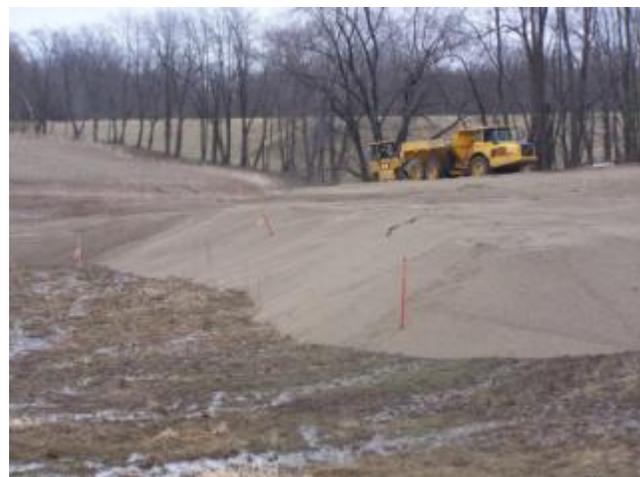
2008 Installation of Emergency Granular Seepage Blanket: **COST \$1.26 MILLION.** In response to an emergency situation in March of 2008, a granular seepage blanket

was placed on the interior toe of the Rock Knoll reach.

The placement of the 2008 emergency blanket prevented Zoar Levee from potentially failing and damaging Zoar Village.

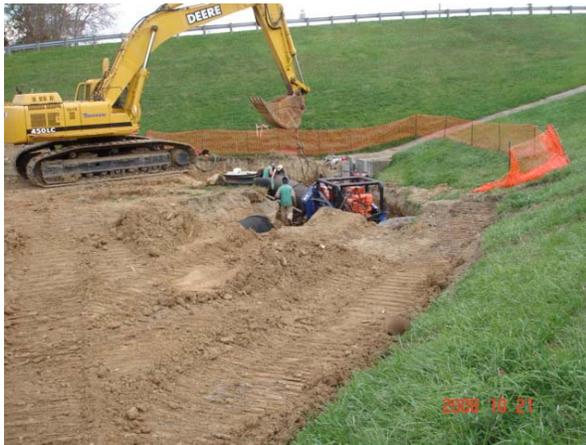
2008-2009 Seepage and Drainage Collection System: **COST \$1.8 MILLION** A seepage collection system on the interior toe of the Ball Field reach has been constructed along with a larger storm drainage culvert under Route 212. The seepage collection system consists of a perforated pipe within a granular trench that provides for relief of seepage pressure at the toe of the levee and collects flow from the relief wells.

This drain intercepts and collects under seepage that will reduce pressure at the toe of the levee, increasing its stability. Further, the collection and discharge of this seepage to the Zoar Pump Station should enhance surveillance activities by reducing standing water on the interior of Zoar Levee.

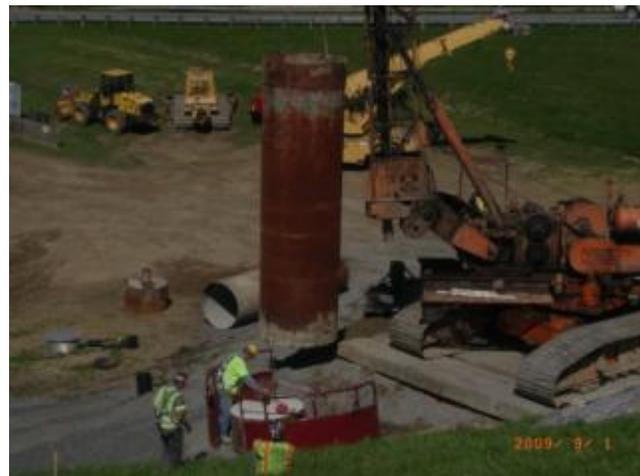
2009 Assessment and Rehabilitation of Existing Relief Wells: **COST \$655,000.** The construction of the seepage and drainage collection system enabled the well outlet elevations to be lowered an average of 3 ft. Two new relief wells were installed as replacements to existing wells in the spring of 2009. The existing wells were not producing as much flow as nearby wells. Five existing wells were plugged and abandoned, four of which were underneath the expanded levee footprint and posed potential seepage/piping hazards. All remaining wells were mechanically and chemically rehabilitated to improve efficiency.

This rehabilitation will allow Huntington District to characterize and quantify pre- and post- well condition and pumping efficiency, giving a level of confidence that under seepage pressures are being properly relieved, thereby reducing the potential for piping due to under seepage.

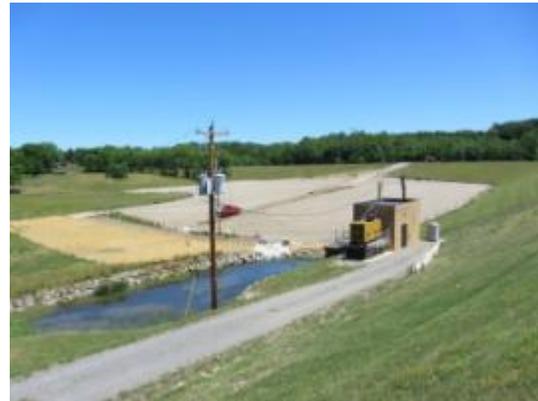
2011 Upgraded Pump Station with 3rd Pump: **COST \$777K (Including New Emergency Generator Listed Below).** A third pump has been added to the pump station reducing the need to retain water at the Diversion Dam. Electric service to the station was also upgraded to accommodate the additional pump. Total pumping capacity has been increased from 30,000 gpm to 45,000 gpm.

The addition of a third pump reduces the risk of interior flooding, providing additional pumping capacity, and assists in pumping the additional discharge from the relief wells out of the interior of the levee. This may help increase the success of visual inspections and other site monitoring activities. The third pump may also reduce the need to close the gate at the Diversion Dam to alleviate interior flooding in Zoar Village.

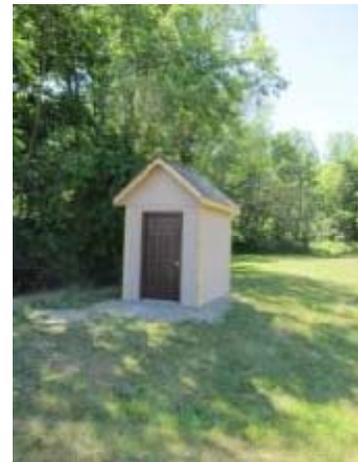
2012 Install Pool Gage with Alerting Capability: A gage has been installed to record the reservoir level at the Diversion Dam and automatically alert Huntington District staff to levels exceeding an established elevation. This gage will transmit a signal through a Geostational Orbiting Environmental Satellite (GOES) to Huntington District water management web pages and operations staff office and mobile phones. Along with this device, the control gate at the diversion dam is now powered by commercial power. However, an outlet for a portable diesel generator will be maintained in case of a loss of commercial power.

These upgrades were considered essential. In 2011, the diversion dam impounded water at least three times due to intense, isolated rain events that showed no measurable differences at nearby stream gages on the Tuscarawas River. These inadvertent impoundments occurred with the control gate open and in at least one instance, caused approximately 9 feet of water to be impounded upstream of the Diversion Dam.

In each instance, Huntington District personnel were alerted of the impoundments by local residents, which reduced the ability to monitor the Diversion Dam's performance. The pool gage and alerting system will provide Huntington District personnel with the ability to reach the site in time to monitor the project performance and increase warning time for emergency action and evacuation, if necessary.
