**Environmental Assessment**

**Jenkins House Preservation Actions**

**R.C. Byrd Lock and Dam Replacement Project**  
**Cabell County, West Virginia**

**May 2008**

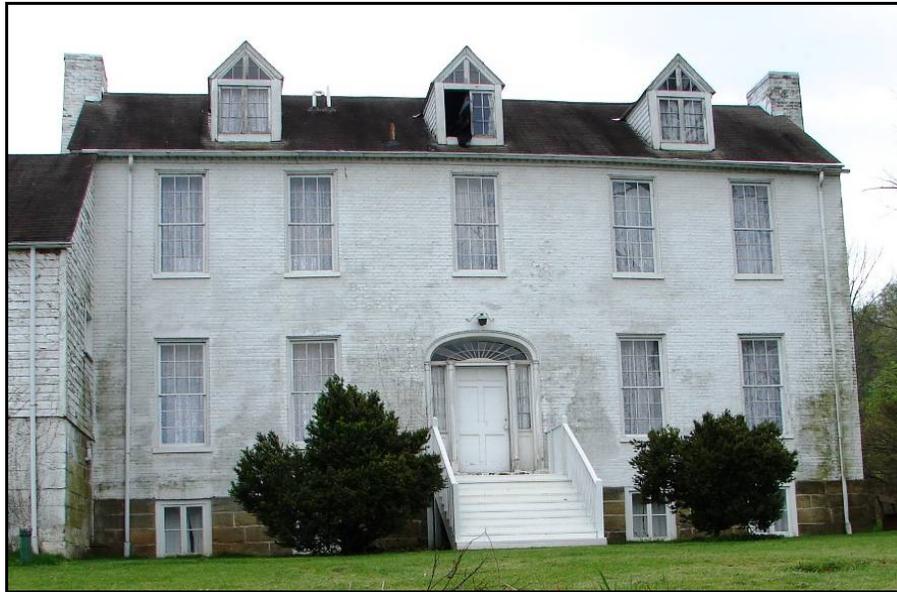
**Figure 1.** *On the North elevation, the awkward placement of dormers disrupts the alignment of the Federal window program below (author).*

It has been shown that the dormers lack a sound association with the period of significance or with any other known historical event of merit. Structurally deficient, they lack flashing at roof junctures, and the casement windows themselves are damaged in many places and unable to close with a tight seal. All of these factors have conspired to permit water into the attic of the house. In addition, because the features exhibit poor craftsmanship and project awkward junctures that are disharmonious with the rest of the Antebellum design, they undermine the

simplicity of the Federal style house. Most importantly, because the dormers admit rainwater, there is no justification for repairing and retaining them, and their removal is therefore recommended. Removal should be undertaken as a deconstruction in order to prevent any damage to the original fabric of the attic. Once removed, resulting voids will require patching.

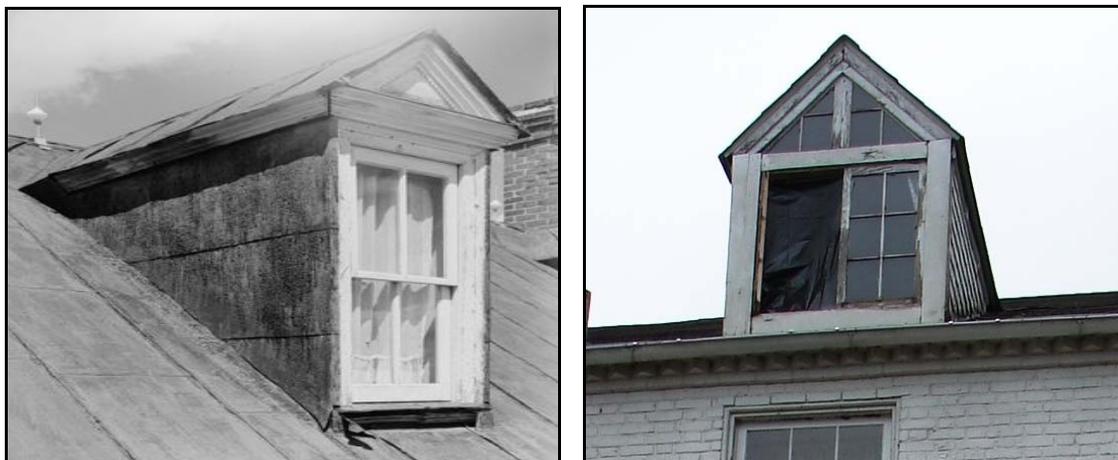
**Figure 2.** *Side by side comparison of a typical Federal style dormer (Green Hill Plantation, Virginia) and a Jenkins house dormer, right. The Jenkins dormer has uncharacteristically crude framing and pediment glazing, and the gable lacks strong classical moldings expected of Federal style buildings. Poor construction allows a number of cracks and openings where water penetrates.*

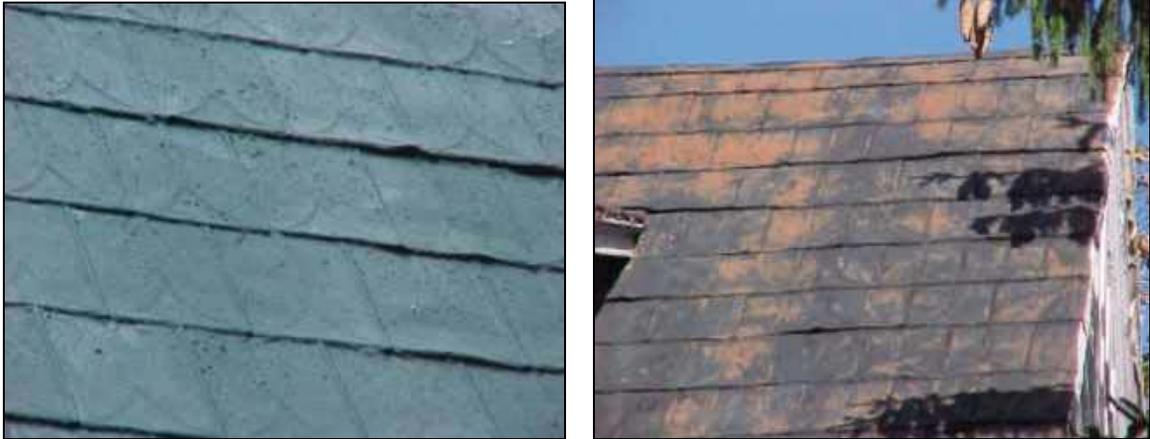
**Figure 3.** Two examples of late nineteenth century textured tin shingles found on Virginia houses. The circa 1906 photo of the Jenkins House (below) depicts a replacement roof with a similar use of metal shingles, applied as flat sheets stiffened at ridges with a protective material.

Given the chronology of the Jenkins House, it is highly probable that the home's original roof had deteriorated by the late nineteenth century, during the period in which these inexpensive metal options were widely available. A photo of the Jenkins House dating to 1906 depicts a roof cladding that, while not fully readable, suggests six rows of a material that may be metal or board roofing (Figure 4).

Although metal or board roofing may have been used to replace the original roof around the end of the nineteenth century, metal or other materials such as slate were not recovered in archaeological investigations. Regardless, it can be credibly determined that the original roofing material for the period of significance would likely have been wood shingles, possibly of local oak. This conclusion is mostly supported by the archaeological record in and around the site.

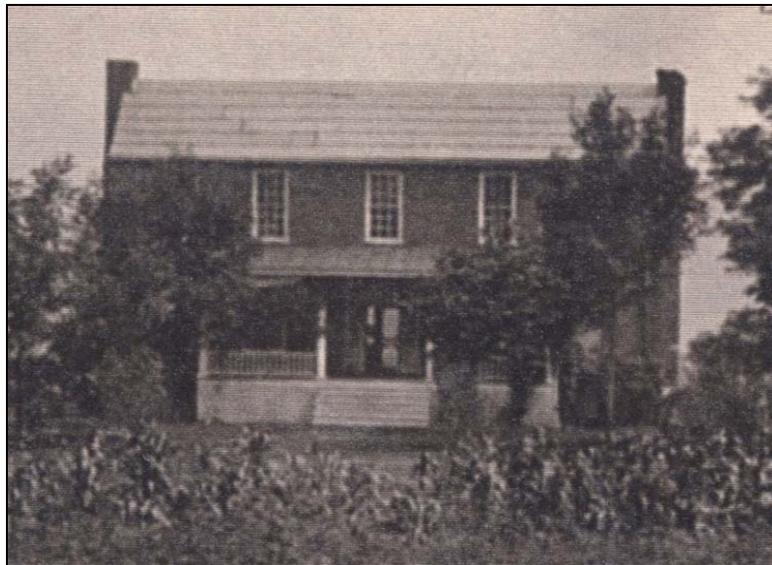
**Figure 4.** The only photograph currently available that reveals the status of the roof during the home's brief occupation by the F. A. McDonald family between 1905 and 1906. The dormers had not yet been installed. Although the image depicts six rows of roofing material with some texture, it is not clear whether this cladding was wood shingle, wood board, or metal, however the evenness of the horizontal lines and the wide vertical size of the rows suggest metal.

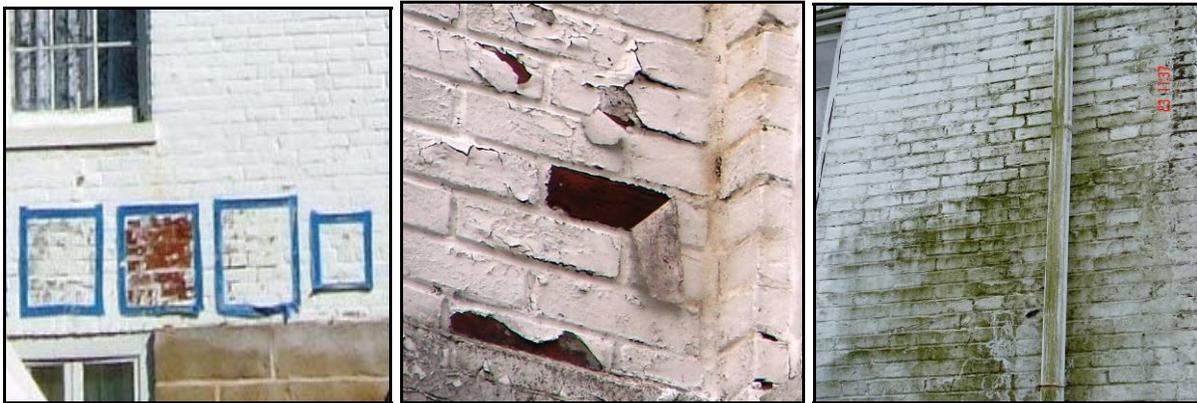
**Figure 5.** Masonry analysis conducted in August 2007 identified problems associated with painted brick, and involved several test patches to determine the most successful paint removal solution (left, center), and also noted mortar damage from water erosion and leaking downspouts. A suggested mortar formulation for re-pointing is included, with recommendations for preparation and application. (author)

removal/cleaning method. Mortar and masonry sampling on all elevations was conducted to assess moisture content and potential capillary or other water migration issues, and to formulate a compatible replacement mortar mix with respect to compressive strength, sand and aggregate types and ratios, and texture and appearance. The resulting data and reporting informs the repair work that should be undertaken on mortar joints and brick repairs to chimneys.

Based on the findings of the report, the field application of mortar (re-pointing) should be conducted under the direct training and supervision of contracted experts in masonry restoration and conservation. Mortar preparation should be performed off-site with a standardized

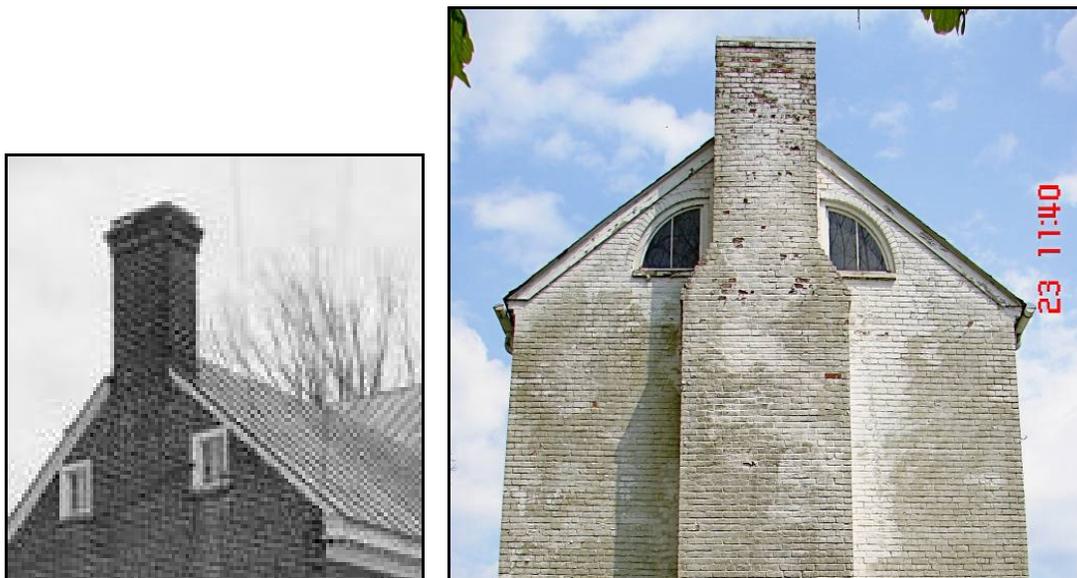
**Figure 6.** An end chimney on Green Hill Plantation House, Virginia terminates in a typical Federal style corbelled cap (left). Similar capping reconstruction is recommended for both chimneys on the Jenkins House (right) in order to deflect water away from brick surfaces below.

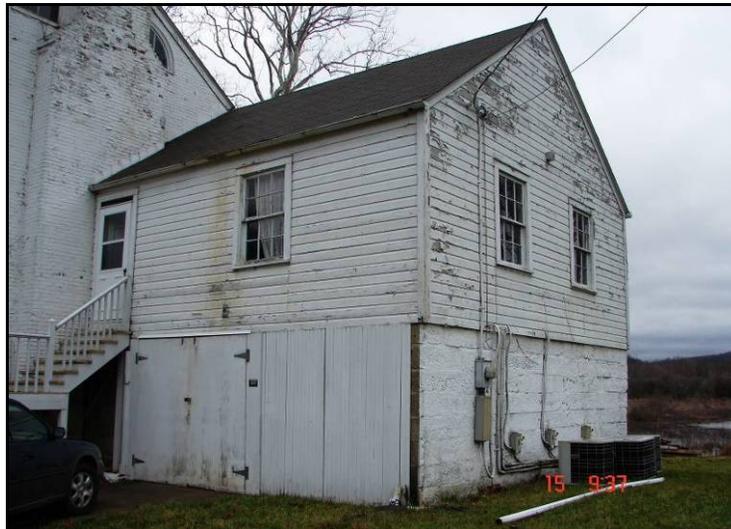
*Figure 8. Addition looking northwest, showing juncture with original building and use of stone blocks salvaged from demolished outbuildings. (author)*

It is recommended that the early twentieth century addition be removed to allow access to masked stone and brick surfaces, and to enable comprehensive and consistent paint removal and re-pointing throughout the house. This measure will also return the building to the stand-alone appearance of the period of significance. Careful removal of foundation stones should anticipate

storing the blocks for re-use, should they be needed for future repairs to the house foundation. Once the addition is removed the brick and stone surfaces of the house will be revealed and accessible for inspection. If the masonry materials exhibit deterioration, repair and re-pointing of mortar joints should be undertaken following methods prescribed for the rest of the house (U.S. Heritage Group).

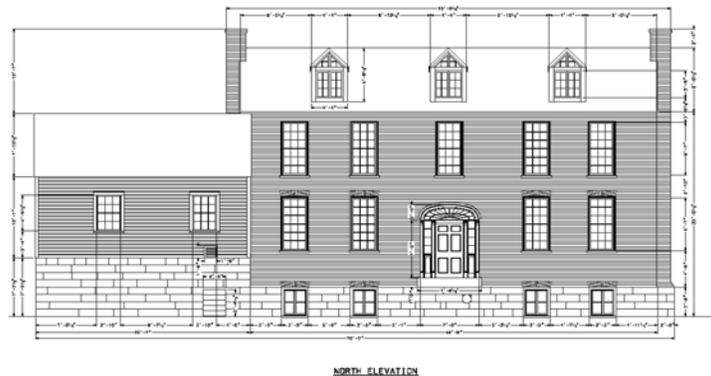
**Figure 10.** Jenkins House, north elevation. Example of measured elevation drawing to document and record original materials, scale, proportions, and features for restoration efforts when needed. (Huntington District, U.S. Army Corps of Engineers, August 2007)

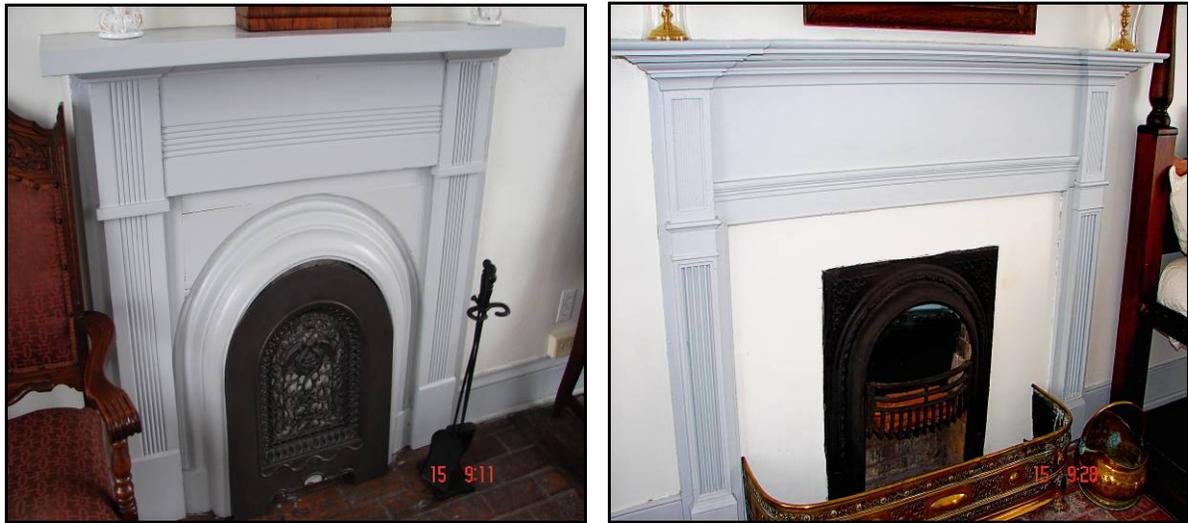
**Figure 11.** The first floor, east fireplace surround (left) was salvaged from a local property and installed in the 1990s.<sup>8</sup> However, because it lacks the delicate classical proportions of the home's other Federal fireplaces (right), the unit should be replaced, based upon drawings prepared for original surrounds. (author)

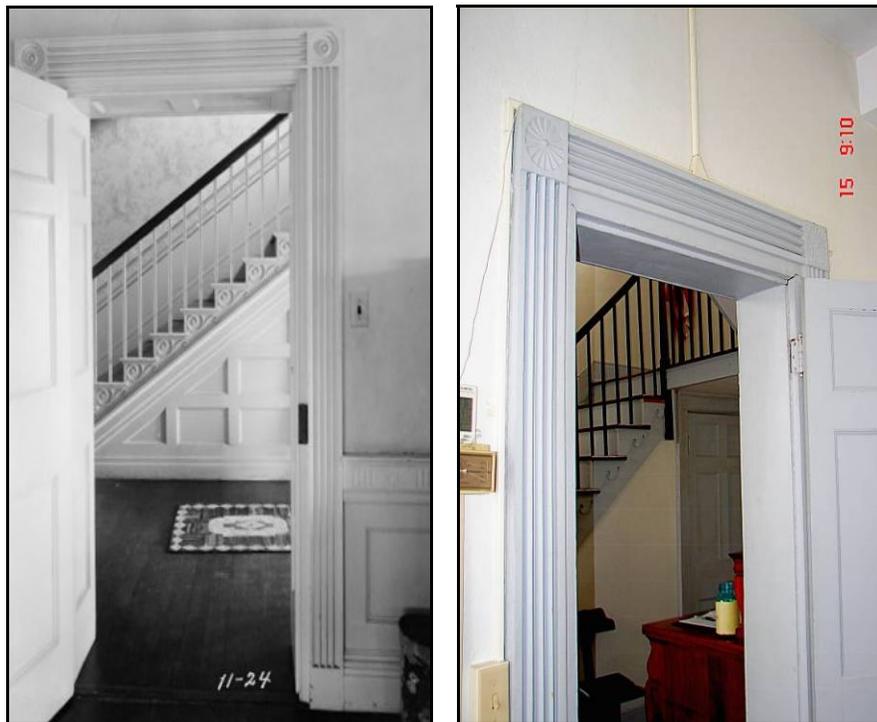
**Figure 12.** At left, a well preserved interior door frame from Dan's Hill, Virginia, reveals that the west room entry details at the Jenkins House are faithful to the Federal design period, and can serve as an original template for the restoration of interior finish details, when needed. (author)

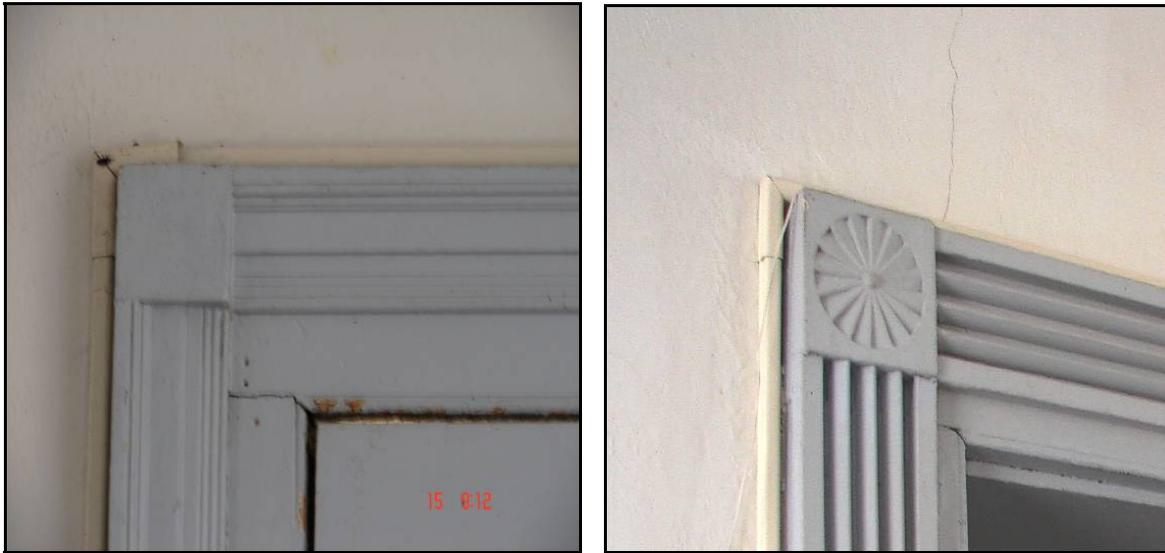
*Figure 13. The anachronistic door framing detail (left) suggests that some first floor moldings have been replaced; while others (right) survived as representative of original design. Such original moldings and framing details should be captured in measured drawings. (author)*

Examination of interior spaces reveals an array of features – moldings, door framing, and fireplaces – that points to a repair and rehabilitation effort that may have followed severe floods of the 1800s, turn of the nineteenth century and 1930s. If flood waters rose into the first story, it holds that some of the lower woodwork and plaster was damaged beyond repair and required replacements. A number of door frames and casings are indicative of 1930s-era carpentry and design, though much of the original fabric survives.

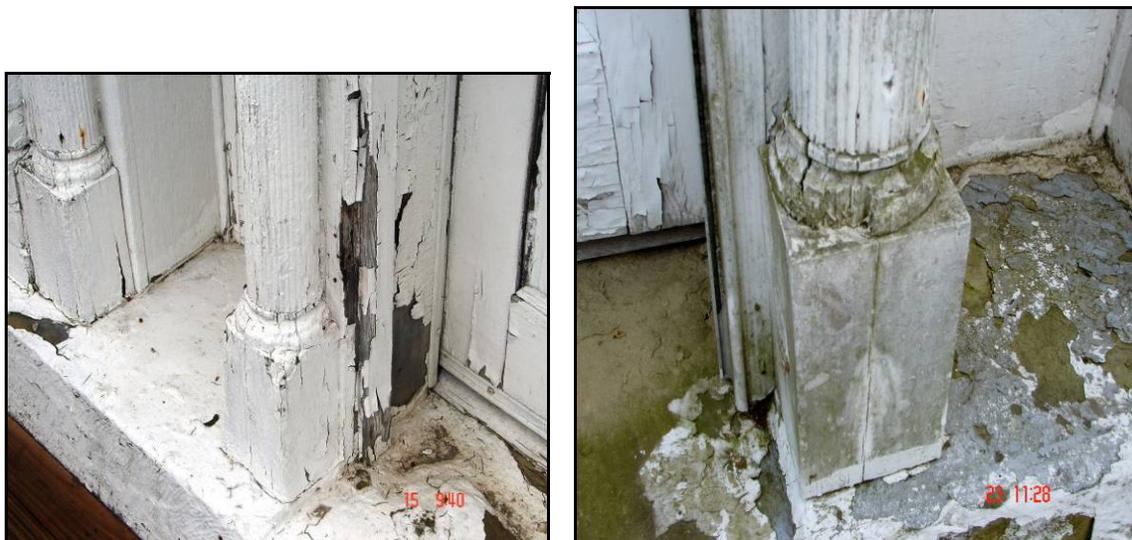
*Figure 14. Deteriorated front and rear entrance details such as these pilasters should be documented to guide the authentic replacement of these features. (author)*

Among the original features, representative examples should be recorded in measured drawings, including one drawing of a representative interior window surround, pilasters; fireplace surround (one of each type); and interior back stairway. In addition, black and white photographs (at least medium format) should be taken of exteriors and interiors, to include the house in its setting and landscape, and close-in details of both exterior and interior features of significance to support the record. This documentation package will safeguard the authentic appearance, measurements, proportions, and design qualities of original components, should any of them be lost to gradual deterioration, or to flooding or other catastrophic event.

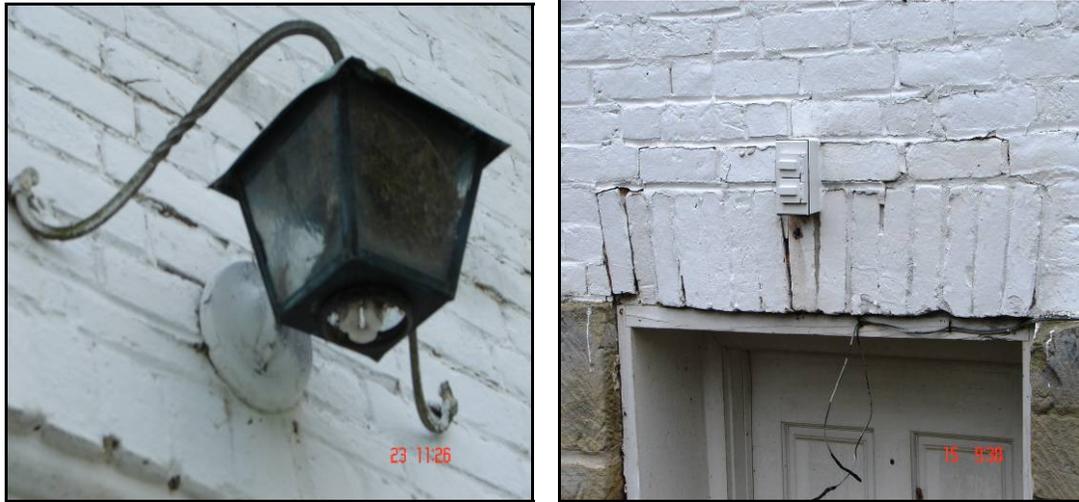
**Figure 15.** The front entrance light fixture and rear basement door outlet should be removed to prevent water migration through openings, and oxidation staining and mortar deterioration. (author)

- Utility Upgrades (Safety and Hazard Considerations) – attention to relevant electrical system upgrades identified by a certified electrical engineer is proposed to ensure proper function of electrical systems. (This includes minor actions to upgrade or replace circuit breakers, outlets, etc.) Removal of non-historic exterior electrical fixtures is proposed to stop water from migrating into masonry.

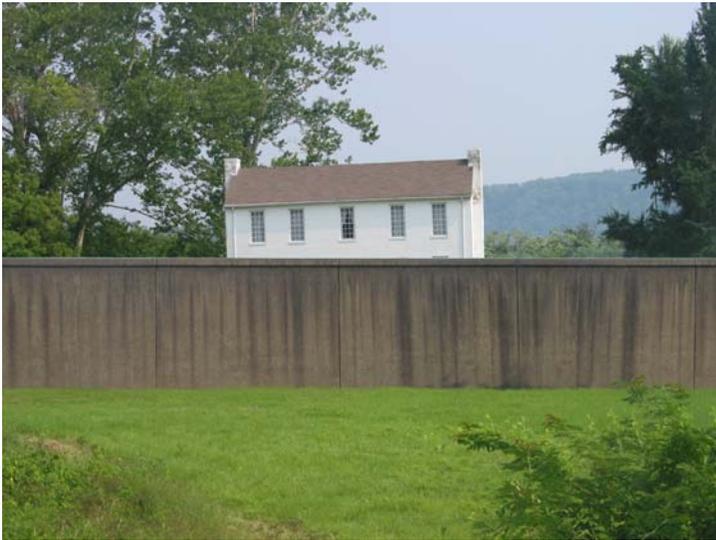
**Figure B.1.** Simulated floodwall surrounding the Jenkins House.

This alternative entails placing a T-Wall around the grounds with a gate closure at the entrance drive. The top of wall elevation would be 562.0, making the average height of the wall 14 feet above existing ground. Approximately 1,210 linear feet of wall would be needed. A storm drainage system including catch basins, pipe, portable pumps, and headwalls would be required. The edge of the floodwall would be range from 70-260 linear feet from the perimeter of the Jenkins House. Additional operation and maintenance would include pump mobilization and demobilization, pump upkeep, and the gate closure. (See Exhibit CGA03).
