**Final Detailed Project Report
and Integrated Environmental Assessment
Guyandotte River, Water Street
Village of Barboursville, Cabell County, West Virginia
CAP Section 14 Emergency Streambank Protection Project**

Water Street Subsidence and Partial Closure

July 2017

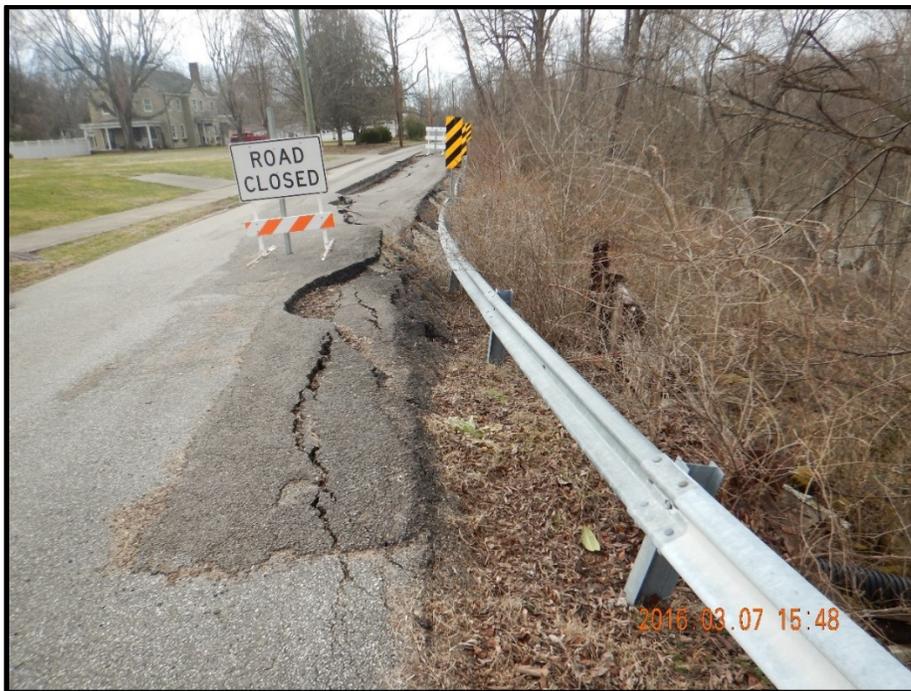
Figure 2 – Water Street road subsidence and partial closure.

The project area is located along the right descending bank of the Guyandotte River, within the Village of Barboursville. Water Street is located along the top of bank. Included in the project area is approximately 850 LF of streambank which is affected by flood flow-related erosion and recession. Water Street, along with adjacent public utilities serving residents of the Village of Barboursville, are endangered by this flood related erosion and bank failure and are in need of immediate stabilization. Historically, Water Street and the adjacent properties included lumber and grist mills, boat yards, seasonal recreational facilities, and wells which supplied raw water for the community, a university, railroad maintenance facilities, foundries, and brickyards. Figures 2 and 3 show active failure conditions along Water Street.

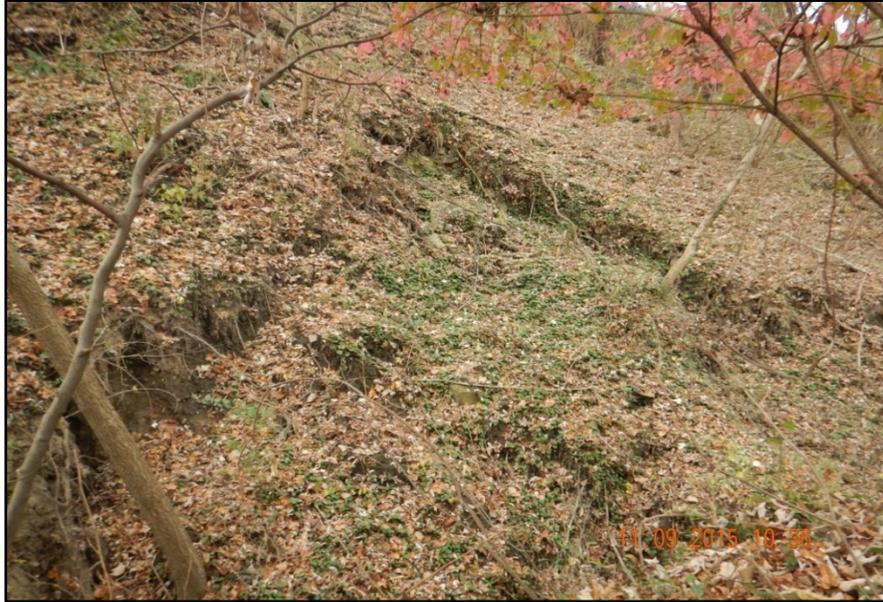
Figure 3 – Slope erosion and failure features.

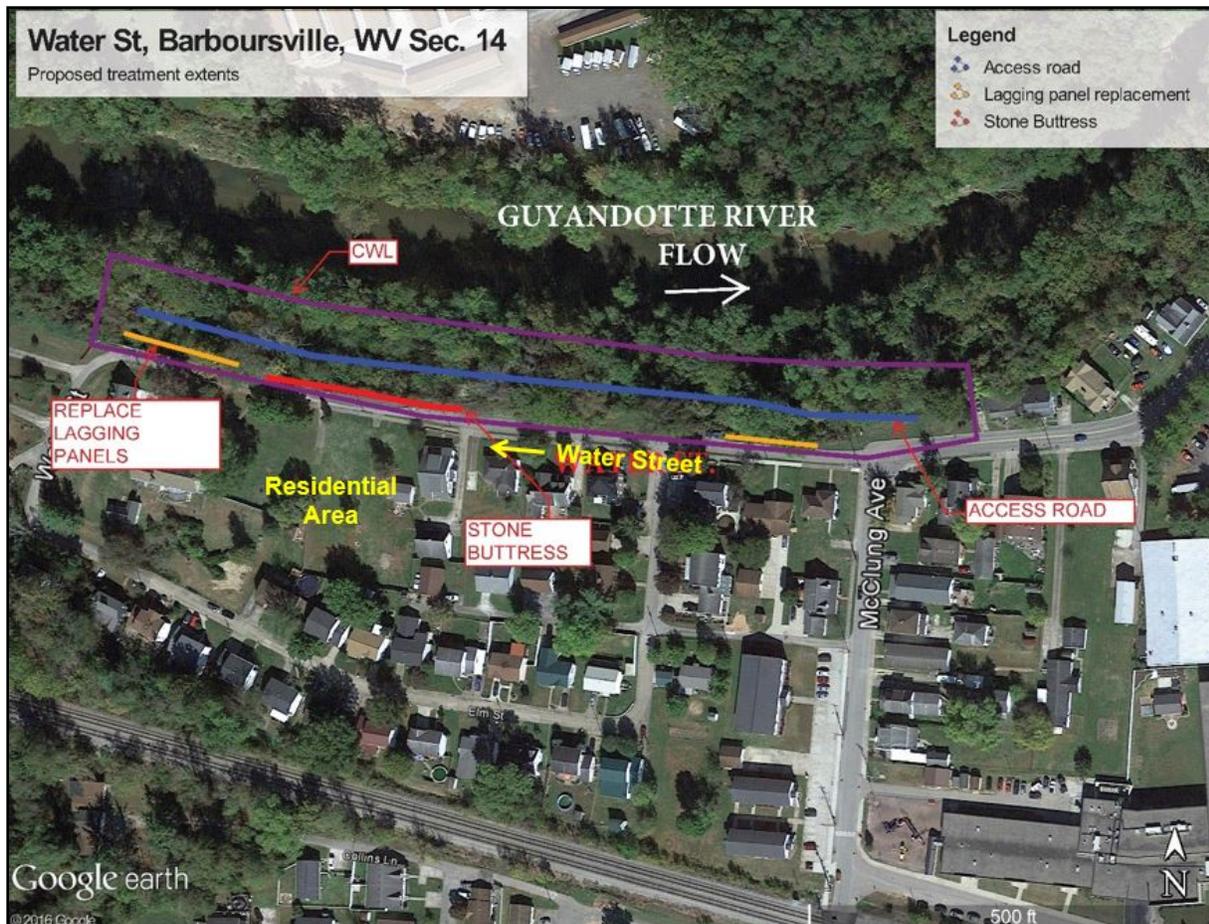
Figure 4: Recommended Plan

Alternative Plan A has been chosen as the Recommended Plan. Requirements for the construction of this alternative would include the construction of a stone buttress, replacement of timber lagging panels, the replacement of a catch basin, and storm drain extensions to the Guyandotte River. Within the approximately 240 LF reach where Water Street has subsided and breached, failed soils and rubble will be excavated to form a placement surface for geotextile reinforcement fabric and Corps of Engineers (COE) 15 inch stone buttress construction. The District has determined that gradational requirements for commercially available stone sources as specified by West Virginia Division of Highways and others are suitable for project use, since these gradations exceed the requirements as established by the previously referenced hydraulic analysis methods. Stone with these gradations have been placed by WVDOH at proximate downstream bridge piers and abutments. These armoring features have remained in place during numerous bankfull and flood stage events. An existing road cross drain will be extended through this feature and a headwall will be installed at the outlet discharge location. Grout will be placed to form a splash pad at the cross drain outfall located on the stone buttress. Within two (2) reaches of adjacent in-place H-pile and lagging walls (400 LF total), timber lagging panels have deteriorated with the resulting loss of road fill and related subsidence. This lagging will be replaced with reinforced concrete lagging panels. The existing H-piles are as-constructed and not misaligned. Existing storm outfalls will be located and extended through the treatment to headwalls placed at the Guyandotte River. Pavement replacement along 240 LF of Water Street will require off-site disposal of asphalt materials at an approved facility and the placement of sub-base, base, and pavement. Curb replacement on the landward and riverward limits of the travelway will be required together with the installation of guardrail along the stone buttress. The construction staging area will be located channelward and adjacent to the McClung Avenue intersection. Site access will require an approximate 1,100 LF temporary road along the lower terrace to permit equipment and materials delivery, use during excavation and the construction of a stone buttress together with placement of catch basin, storm drain extensions, and outfalls. Appendix A includes estimated line item quantities. The total project cost of the Recommended Plan at a conceptual level is estimated to be \$2,676,000.

Alternative A (Stone Buttress and Lagging Panel Replacement) is least costly and has the least construction risk associated with the plan and has been recommended. Construction of this alternative will require limited clearing of vegetation and includes the construction of a stone buttress along the approximately 240 LF reach of Water Street that has subsided and is partially breached. Within two reaches of adjacent in-place H-pile and lagging walls, where loss of panel integrity has resulted in loss of road fill, concrete panels will be installed. Storm drains will be extended through the treatment to Guyandotte River outfalls.
